LOG: H-2

TARGET: C1078 TAG #

LEFT HAND HORIZ. STABILIZER SECTION, ELEVATOR STATION 106.362 TO OUTBD EDGE.

HORIZONTAL STAB
LEFT SIDE

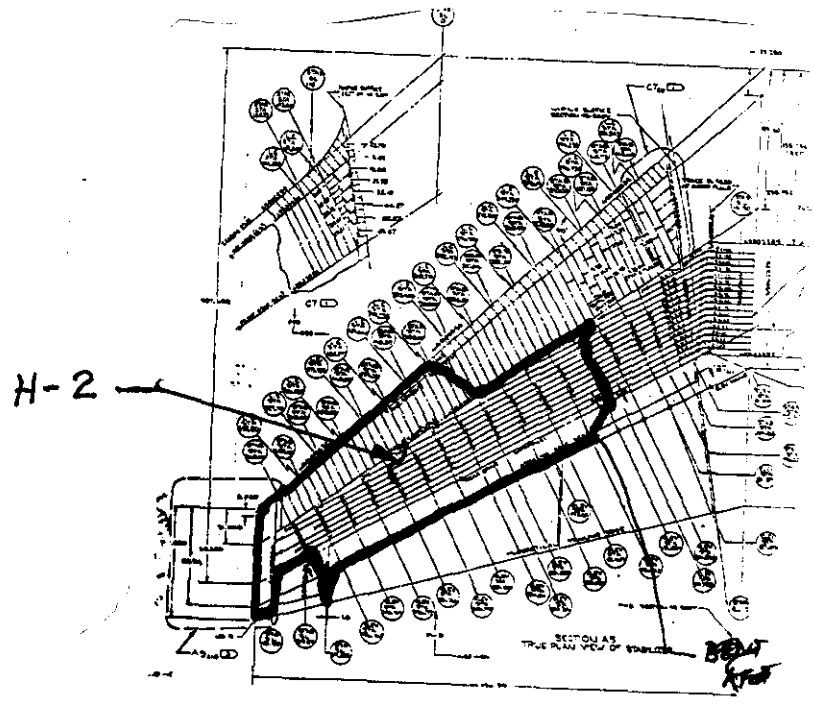
DESCRIPTION: LEFT HAND HORIZONTAL STABILIZER SECTION, ELEVATOR STATION ^{STAB STA 235 OR} 106.862 OUTBD ALONG FRONT SPAR TO E.S. 231.920, OUTBD AND FORWARD TO STABILIZER STATION 285.00, OUTBD ALONG LEADING EDGE, AFT ALONG OUTBD EDGE, INBD ALONG TRAILING EDGE TO STABILIZER B.L. 421.50, FORWARD TO REAR SPAR, INBD TO STAB. STATION 382, AFT TO STAB. STATION 372, FORWARD TO TRAILING EDGE BEAM, INBD TO ELEV. STA. 156.813, FORWARD TO REAR SPAR ELEV. STA 131.854, FORWARD TO STRINGER 10 AND INBD FORWARD TO ELEV. STA. 106.862.

- a) NO BURN. DAMAGE.
- b) SOME UPPER/LOWER SKIN PUNCTURE.
- c) DAMAGE AND DETAIL FRACTURES ~~APPEAR TO BE~~ AERODYNAMIC AND IMPACT RELATED.

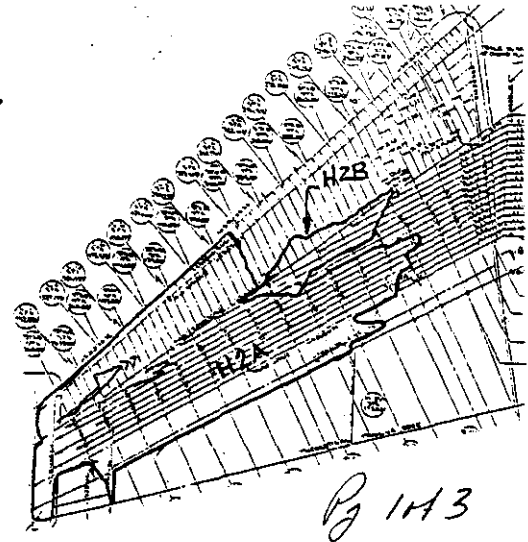
PART H2B → GREEN TAG # 22546

Part H2A is a section of the left hand horizontal stabilizer, extending from the most inboard location at Stab Sta 230 approx at Str 5 lower to the outboard tip.

The periphery of the part can be described as follows; Starting at Stab Sta 230 approx, Str 5 lower forward to Str 7 lwr at Stab Sta 230, outboard along Str 7 to Stab Sta 260 approx, forward to Str 8 at Stab Sta 260, outboard along Str 8 to Stab Sta 335, turning forward to Str 9 at Stab Sta 340 approx, turning forward to the Front Spar at Sta 360. The leading edge is attached from Leading edge Sta 373.4 outboard to the tip. The region of the leading edge from L.E. Sta 373 to 26 inches outboard, has the upper skin torn and the lower skin missing. The outboard tip is predominately intact, inboard to Stab B.L. 421.5, going forward along that B.L. to the Rear Spar, inboard along the Rear Spar to Stab B.L. 392 approx, diagonally back to the trailing edge at Stab B.L. 372, forward to the hinge line at Elev Sta 156. Mainly, only the lower chord of the trailing edge beam is present between Elev. Sta 231 & 156. Part periphery continues along the inboard edge of Elev. Sta 181 to the Rear Spar, inboard along the Rear Spar to Stab Sta 260 approx and turning inboard and forward in a jagged manner back to Stab Sta 230, Str 5 (i.e. the starting point).

The upper and lower skins remain attached to the Front and Rear Spar and 3 stringers. The lower skin and the stiffeners at the inboard end are bent up at Stab Sta 240 to 285. The Rear Spar remained intact from the tip to Stab Sta 275 and is bent forward 45 degrees at Stab Sta 287. The corresponding upper stringers near the Rear Spar are predominately bent forward. The Front Spar remained intact from the tip to Stab Sta 347 and exhibits slight aft bending at the bottom of the spar web. The leading edge remained attached to the Front Spar from Stab Sta 372 to the stabilizer tip. The outboard and inboard ends of the leading edge upper surface from Stab Sta 372 to 400 and Stab Sta 400 to the tip are torn in numerous locations and directions. The area around the tears is corroded. From Stab Sta 525 to 560 a section of the leading edge bull nose is crushed aft and inboard end of the crushed section exhibits evidence of witness marks in the lateral direction. There are numerous punctures on the upper skin surface.

There is a small piece of seat track segment entrapped in the part at Stab Sta 285 near the lower surface.

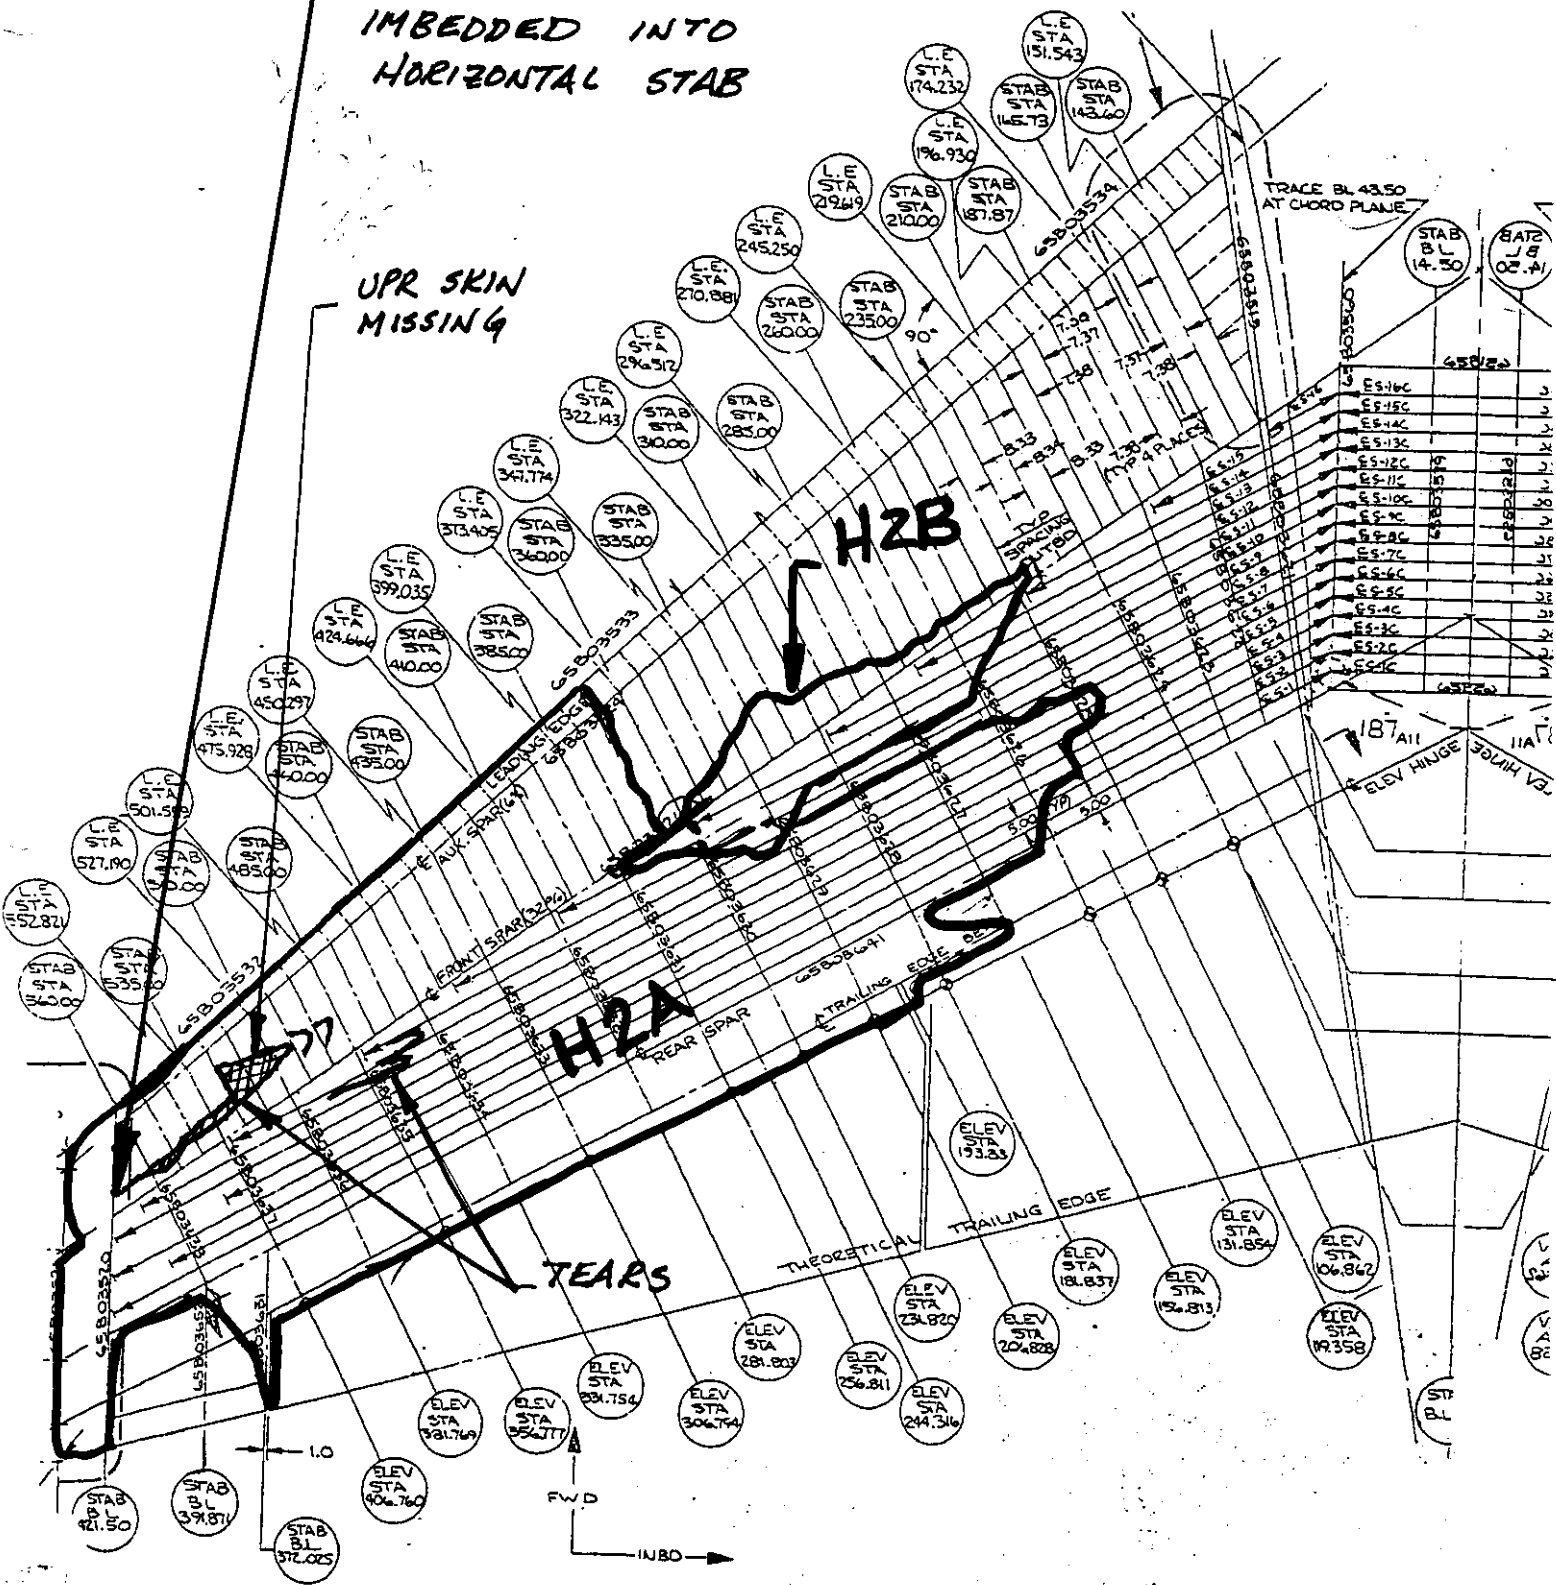
One of the tears extends from Stab Sta 485 outboard to Stab B.L. 421.5 common to the leading edge area-see sketch. In this area the upper skin is missing and the ribs in the torn area are deformed outboard. At the most outboard end of this tear is a piece of unidentified web and chord segment imbedded in the tip of the stabilizer. This piece of structure is approximately 60 inches long and 10 inches wide. TEARING DAMAGE CONTINUES INTO LWR SURFACE IN THIS SAME AREA & OUTB'D SLIGHTLY.

BOTH PARTS 2HA & 2HB EXHIBIT COMPRESSION FAILURE ON UPPER SURFACE & TENSION FAILURE ON LOWER SURFACE, AT STAB STA 360 APPROX PER METALURGIST, WES KENNEDY. } RA 12/12/96

THERE IS NO OBVIOUS SIGNS OF SOOTING NOR FIRE DAMAGE COMMON TO EITHER PART.

UNIDENTIFIED PIECE
OF STRUCTURE
IMBEDDED INTO
HORIZONTAL STAB

UPR SKIN
MISSING
