LOG H-3 (SHEET 1 OF 2)

TARGET C 1028 TAG#

DEBRIS FIELD GREEN

RIGHT HAND HORIZONTAL STABILIZER SECTION, ELEVATOR STATION ~~206.828~~ ^{181.8 RA 12/10/96} TO OUTBOARD EDGE.

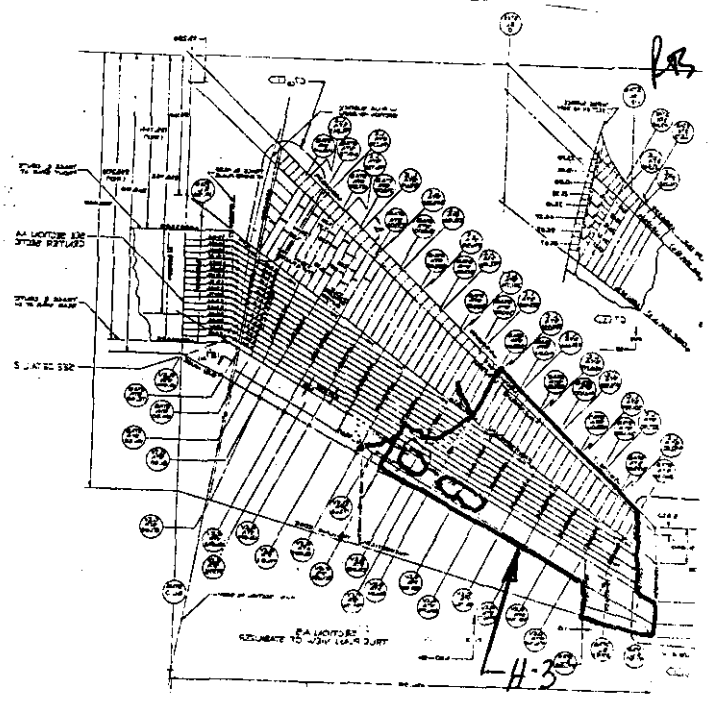
- a) UNSUPPORTED PORTION OF REAR SPAR ELEVATOR STATION 206.828 EXTENDING INBOARD 30 INCHES, BENT AFT 60 DEGREES.
- b) UNSUPPORTED PORTION OF FRONT SPAR ELEVATOR STA 231.82 EXTENDING INBOARD, BENT FORWARD 45 DEGREES.

c) OUTBOARD HORIZONTAL STABILIZER TIP (HONEYCOMB STRUCTURE) SECTION TORN AWAY, REAR SPAR FORWARD TO LEADING EDGE, APPROXIMATELY 12 INCHES INBOARD TO FIRST OUTBOARD RIB.

d) NO BURN DAMAGE.

e) SOME UPPER AND LOWER SKIN PUNCTURES.

f) DAMAGE AND DETAIL FRACTURES ~~APPEAR TO BE IS~~ ^{PH 12/11/96} IMPACT RELATED.

The outboard section of the right horizontal stabilizer (H3) from stab sta 310 (elev sta 181.837) to the tip remained in one section. The leading edge remained attached with this section of the horizontal stabilizer from the tip to stab sta 385. It is crushed at the inboard end. The leading edge bull nose exhibit numerous dents along its length and one puncture hole at approximately stab sta 520. The outboard end of the leading edge, about 12" in length, is crushed aft and in an outboard direction. This area exhibited black rub marks on the outer skin in the outboard direction. The rear spar at the inboard end is bent aft. The front spar just inboard of the stab sta 385 is bent forward. An engine stator blade is imbedded on top surface of outboard aft section at approximately stabilizer station 535. The leading and trailing edges upper surfaces have considerable glitter adhering to them. H3 MATES WITH H6. INBD END EXHIBITS COMPRESSION FRACTURES ON UPR SURFACE, TENSION ON LWR SURFACE.
