LOG H-9

TARGET C226 ← TAG#

DEBRIS FIELD GREEN

DESCRIPTION: LEFT SIDE LOWER SKIN FRONT SPAR AFT
 TO STRINGER 9, STAB. BL. ^{40 RH 12/11/96} 43.50 OUTBD TO STAB.
^{230 RH 12/11/96} STA. 247.50.

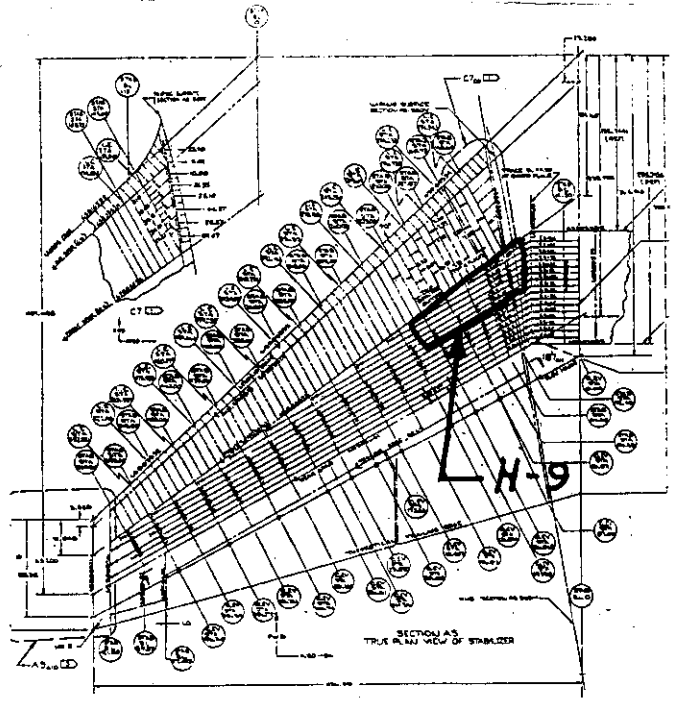
H9

- a) NO BURN DAMAGE
- b) STRINGERS 11, 12, 13, 14 AND 15 ATTACHED STAB. STA 184.70 OUTBD TO STAB. STA. 247.50.
- c) PANEL RELATIVELY FLAT EXCEPT INBD EDGE CURLED
^{90° RH 12/11/96} DOWN 180 DEGREES.
- d) DAMAGE ^{15 RH 12/10/96} ASSUMED TO BE IMPACT RELATED.

Lower skin from front spar aft to stringer 9 and from LBL 48 to stabilizer sta 230. Stringers 11-15 attached or partially attached. Panel is relatively flat except inboard fifteen inches is bent 90 degrees down. Some black marks exist on the inner surface of skin. The black marking extends into the fractures. A spattering exists in the area. These marks run from S-15 to two inches beyond S-14 at stabilizer station 143. An additional black mark trailing aft on a rivet head located ten inches outboard of stabilizer station 177 behind front spar. Additional black mark on S-10 thirteen inches outboard of stabilizer station 187. Inward puncture between S-11 and S-12 at stabilizer station 171. Photos taken of above indications. There is a black splattering between S-10 and S-11 at approximately stabilizer station 148. *H9 MATES WITH H1 ON LOWER SURFACE*
