HORIZONTAL TAIL &
ELEVATORS

LOG# LE-1A & 1B

TARGET# C674

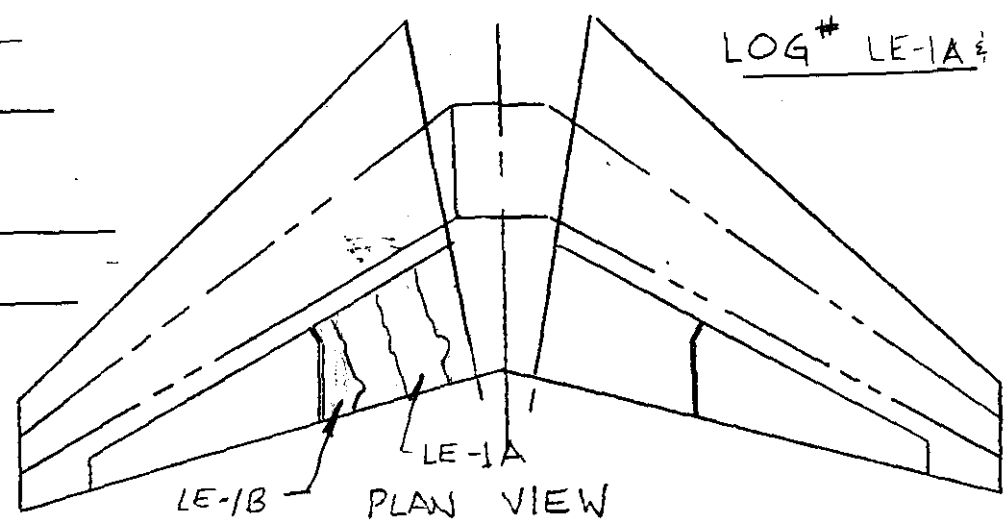
PLAN VIEW
LOOKING DOWN

LE-1A GREEN TAG # C674 FBI # 8/23/96-15

LE-1B WHITE TAG D2021 FBI # 7/19/96 LOT 5

LE-1B WAS RECOVERED VERY EARLY BY THE COAST GUARD WHICH INDICATES THAT THE PART WAS FLOATING

LE-1A) INBD PORTION OF LHS INBD ELEVATOR. PART IS RELATIVELY INTACT WITH BOTH UPPER & LOWER SURFACES, AND RIBS FROM LEADING EDGE TO AFT END OF PART FROM EL. STA 156 TO EL. STA 106 - SEE SKETCH ATTACHED

LE-1B) THIS PORTION OF LHS INBD ELEVATOR IS ALSO RELATIVELY INTACT. PART INCLUDES UPPER AND LOWER SURFACES AND RIBS FROM THE OUTBD END OF THE INBD ELEVATOR TO EL. STA 181 - SEE SKETCH

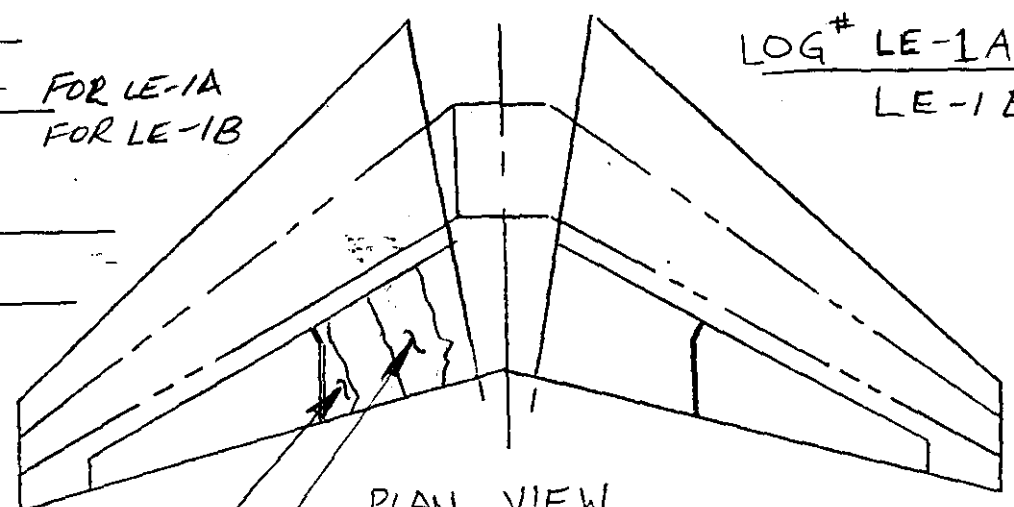
PLAN VIEW
LOOKING DOWN

LE-1A { PORTION OF LHS INBD ELEVATOR
FROM EL. STA 156 TO EL. STA 106 -
PART IS STILL CONNECTED AT
HINGE TO PART # H4 }

LE-1B { PORTION OF LHS INBD
ELEVATOR FROM EL. STA
220 APPROX TO EL. STA 181 }

LE-1A - PART IS RELATIVELY INTACT, THE LOWER FACE SHEET
IS BROKEN BTWN EL. STA 119 & 106 - SEE SKETCH, THE
LOWER SURFACE IS STREAKED. { WAS OF TYPICAL APPEARANCE
PER CONSULTATION WITH TWA MECHANIC, DUE TO HYDRAULIC
FLUID OR GREASE LEAKING ON TO SURFACE }

NO OBVIOUS SIGNS OF FIRE DAMAGE, THERE IS ONLY
VERY LIGHT SOOTING IF ANY ON PART.

LE-1B - PART IS RELATIVELY INTACT, INBD ~~FRAME~~ ^{RH 12/11/96}
~~DIAGONAL TENSION FAILURE~~, NO BURN DAMAGE,
LOWER SURFACE HAS BLACK RESIDUE DUE TO
HYDRAULIC FLUID OR GREASE LEAKING
