TARGET (-2B) C1078

DEBRIS FIELD GREEN

NOMENCLATURE:

LEFT SIDE, OUTBD ELEVATOR PORTIONS, 4 EACH.

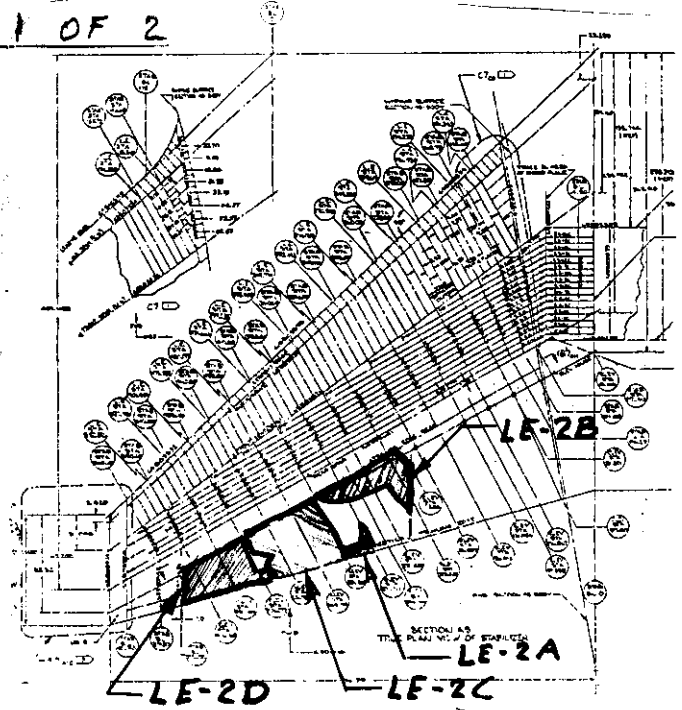
LE-2A - SMALL BACKWARD L SHAPED PORTION, BEGINNING
 ELEV. STA. 256 TRAILING EDGE RH 12/11/96
 STAB. STA. ~~335~~ V EXTENDING OUTBD 30 INCHES,
 FORWARD 12 INCHES, INBD 18 INCHES, FORWARD
 18 INCHES AND INBD 12 INCHES, TO ELEV. STA. 296 THEN AFT TO
 HINGE LINE RH 12/11/96 TRAILING EDGE
 RH 12/11/96

LE-2B - PORTION ATTACHED TO FRONT SPAR, 3 HINGE
 TAG# C1078 ELEV. STA. 206, 231 RH 12/11/96 256
 LOCATIONS, STAB. STATIONS ~~335, 360 AND 385~~.
 PORTION EXTEND AFT IRREGULAR SHAPE 3 FEET

TO 4 FEET (SEE SKETCH).
 PART EXTENDS FROM ELEV. STA. 195 (APPROX) TO 281 (APPROX) RH 12/11/96
 LE-2C - PORTION FROM CENTERLINE OF ELEVATOR HINGE
 TO TRAILING EDGE, ELEV. STA. 281 RH 12/11/96
 STAB. STA. ~~485~~ 356 RH 12/11/96 TO STAB. STA. 485 (SEE SKETCH).
 NO HINGES ATTACHED

LE-2D- PORTION FROM CENTERLINE OF HINGE TO TRAILING
EDGE, ^{ELEV - R/L 12/11/96 356} STAB. STA 485 TO ELEV OUTBD EDGE.

a) NO BURN DAMAGE.

b) NUMEROUS PUNCTURE DUE TO DEBRIS.

c) ELEVATOR CONSTRUCTION. VERY LIGHT HONEYCOMB
SKIN CONSTRUCTION AND DAMAGE TOLERATE.

d) DAMAGE ASSUMED ^{IS R/L 12/11/96} ~~TO BE~~ IMPACT RELATED.

A section of left outboard elevator from elev station 256 to elevator station 284 and from the trailing edge forward approximately 30 inches is designated LE2A. The trailing edge wedge is intact. The upper skin is approximately 20 inches chordwise by 17 inches spanwise. The lower skin is approximately 15 inches chordwise by five inches spanwise. Some indication of dirt at trailing edge area.

A section of left outboard elevator from inboard end to elevator station 281 and from the leading edge aft approximately three to four feet is designated LE2B. The aft failure line has a zig zag shape. Three hinges at elevator stations 206, 231, and 256 remain attached to H2A. In addition, the remaining elevator structure is deformed upwards relative to the actuator backup fitting at Elevator Sta 244. Part is severely deformed. Leading edge structure has some impact damage.

A section of left outboard elevator from elevator station 281 to elevator station 356 and from the leading edge to the trailing edge is designated LE2C. No hinges are attached. Skin panels have minor punctures and abrasions. Leading edge structure has some impact damage. Trailing edge wedge has area of lower skin missing. Upper skin inboard edge has area of skin missing. Some indication of dirt at the inboard trailing edge area. Counter balance weight structure at elevator Sta 321 is bent upwards.

A section of left outboard elevator from elevator station 356 to outboard end is designated LE2D. No hinges are attached. Skin panels have minor punctures and abrasions. Leading edge upper skin is damaged common to the outboard hinge location. Counter balance weight structure from Elev Sta 356 to 381 is bent upwards.

BETWEEN ELEV STA 231 & 206, THE COUNTER BALANCE WEIGHT STRUCTURE IS BROKEN AND THE CORRESPONDING LOWER PANELS BETWEEN THE HINGE LINE AND REAR SPAR ARE MISSING.
