LOG# LF1

JEKAS FIELD

FUSELAGE SEGMENT LH.

LEFT HAND
SKIN PANEL
← FWD

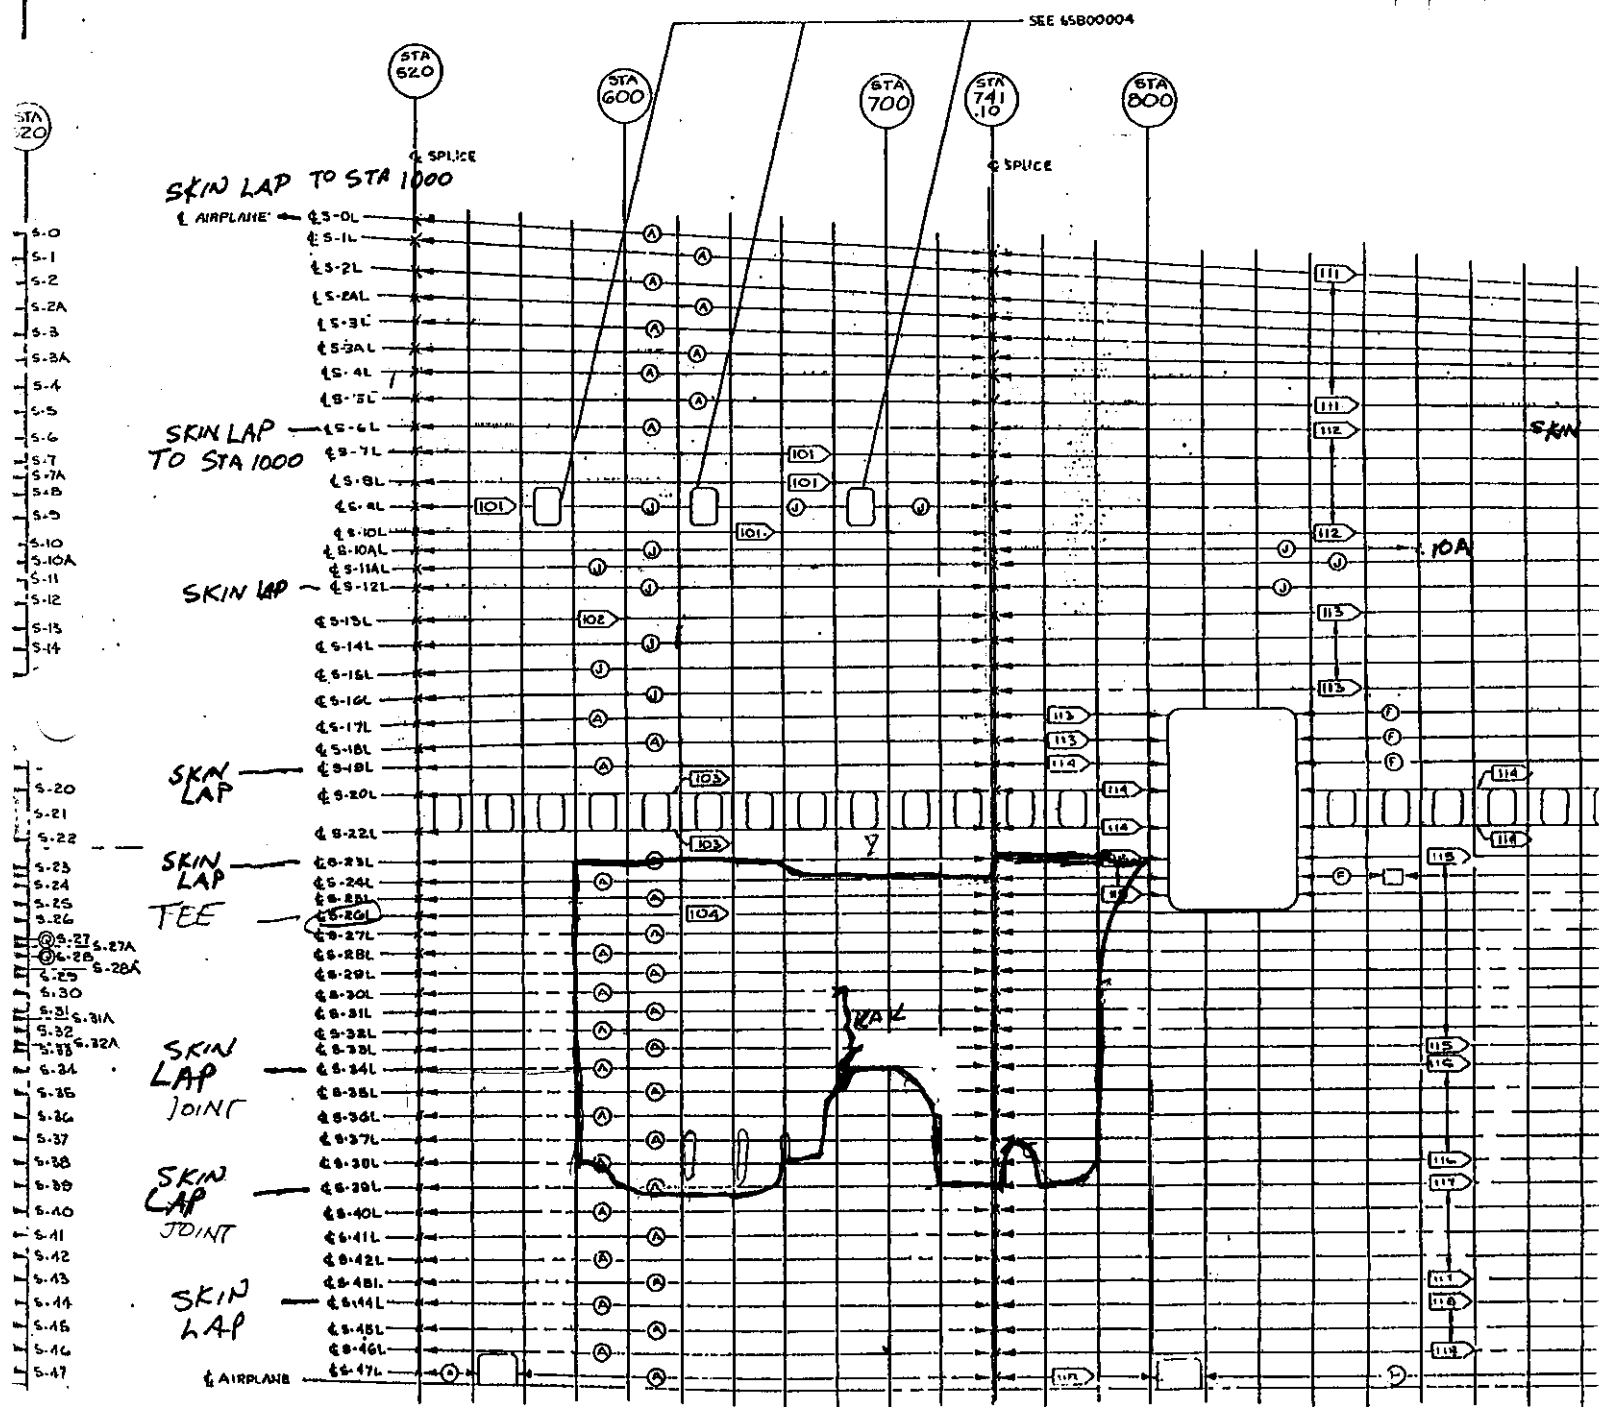
① ~~THE~~ THE FWD SECTION OF SKIN LOCATED @ FUSELAGE STATION 580 HAS FRACTURED IN A STRAIGHT LINE OVER THE 580 FORMER SHEAR TIES FROM THE STRINGER 23L DOWN TO STRINGER 38. THE STRINGERS ALSO WERE SEVERED AT THE SAME STATION.

³⁹ THE SKIN BT STRINGER 38 TO 39 ~~AT~~ STATION A ~~PORTION~~ OF 580 TO 600, HAS BEEN RIPPED AWAY. WITH AN ~~INDICATION OF~~ ~~THE~~ ~~MATERIAL~~ ~~BEING~~

③ THE SKIN IS SEVERED ALONG THE STRINGER 39 FROM STATION 600 BACK TO STATION 660. THIS BREAK IN THE SKIN HAS ROUGH TORN ~~MATERIAL~~ EDGES. THEY ARE THREE HOLES ^{TORN} ~~TEARS~~ VERTICAL OVER FORMER STA 620, STA, 640, STA 660. THE TEARS ~~ARE APPROX~~ RUN VERTICAL ^{FROM} TO STRINGER ³⁹ TO STRINGER 37, AND ~~ABOUT~~ VERY IN WIDTH FROM 6" TO 3". THE ROUGH EDGES AROUND THE HOLE TURN OB.

④ AT STATION 670, THE SKIN IS ROUGH
~~FROM~~ ^{TORN} FROM STRINGER 38 VERTICAL TO STRINGER
~~30 SKIN LAP. HAVE THE FOLLOWING.~~

THE PORTION OF SKIN FROM 670 AFT TO STA 720
AS SEEN ~~IN~~ ^{IT} ITEM 4 HAS BEEN ~~TOOK~~ ^{TORN} AWAY.

THIS SECTION ~~IS~~ ^{RUNS FROM} STRINGER 39 TO STRINGER ~~32~~ 34

STARTING AT STATION 720 THE SKIN EXTENDS
DOWN TO STRINGER 39. THE LEADING EDGE
OF THIS TEAR IS ROUGH ~~TOOK~~ ^{TORN} AND THE METAL
IS SEVERELY CRUMPLED RUNNING BACK TO STATION
780, ALL FORMERS ARE ~~TOOK~~ ^{TORN} AWAY FROM ^{the} SKIN

⑤ THE AFT SECTION SKIN IS ROUGH ~~TOOK~~ ^{TORN} FROM
STATION 780, VERTICAL TO STATION 800.
SEE ITEM 5,

⑥ THE TOP SECTION OF SKIN HAS SEVERED
ALONG THE TOP ROW OF FASTENERS IN THE SKIN
SPlice LOCATED AT STRINGER 23. THIS RUNS
FROM STA 780 FWD TO STA 740. AT
STA 740 THE SKIN IS ~~TOOK~~ ^{TORN} ALONG ^{STA} 740 DOWN
TO STRINGER 24, ~~FROM~~ FROM 740 THE SKIN

① CUT? 50% ③
 IS CUT ALONG THE ROW OF FASTENERS
 AT STRINGER 24 TO STATION STA 660
 SEE ITEM ⑦. AT STATION 660 THE CUT ①
 IS NOW MOVES VERTICAL TO STRINGER 23,
 WHERE IT IS SEVERED ALONG THE BOTTOM
 ROW OF FASTENERS IN THE SKIN LAP LOCATED
 AT STRINGER 23, THIS CONTINUES FWD TO
 STATION 580. SEE ITEM ⑧

STA-600: FORMER ATTACHED ONLY TO SKIN
 BETWEEN STRINGER 23 & 24. Former is completely
 severed at stringer 27 & AT STG 23

STA 620 Former runs from stringer 24
 to stringer 35. It is only attached to
 skin between stringer 24 and 28. all fasteners
 below stringer 25 have been sheared. ②

STA 640. Former runs from stringer 24 to
 stringer 35. It is attached from stringer 24 to
 stringer 27. All remaining fasteners sheared down
 to stringer 35. ②

Former is SEVERED AT STINGER 22^{1/2} and runs down to stinger ~~30~~^{31 L}. It is attached to the skin from stinger 24 to stinger ~~28~~²⁹.
Former 680

SEVERED ABOUT 6" ABOVE STINGER 24 and runs down to stinger ~~30~~³⁵. It is attached to the skin from stinger 24 to ~~29~~³⁰. The bottom portion of the former at stinger 32 bends about 25° aft.

Severed about 6" above stinger 24 and runs down to stinger ~~34~~³⁵ at about stinger ~~31~~²⁹. Broken and turned about 30° aft. It is attached to the skin from stinger ~~24~~³² to ~~31~~.
ALSO BROKEN AT STG 32L

Extends about 6" above stinger 24 and runs down to stinger ~~32~~³⁵. It is attached to the skin ~~and~~ from 24 to 31.

Runs from stinger ^{22 1/2} ~~28~~ to ³² ~~31~~ It is attached - RTB (7)
to the skin from 24 to ~~31~~ ³²

Runs from stinger 23 to ³¹ ~~28~~ - RTB (8)
It is attached between 23 to ²⁶ ~~28~~ and
²⁸ ~~27~~ - stinger ³¹ ~~29~~. It is completely sewed
at stinger ~~27~~ ²⁸

The OB floor beams are attached to
formers 600, 620, 640, 660, 680, ^{& PORTIONS AT STA 700, 720 & 740}
a piece of seat track is attached to the
floor beams between 640 - 680.

- (1) Cut refers to a skin fracture
- (2) Fasteners have been pulled through skin with no lateral loading - not sheared.
- (3) Very few rivet holes show any elongation.

B.H. SKIN IS CRUMPLED IN THE HOOP DIRECTION BETWEEN STG 32 AND 34 FROM STA 700 TO 760. IT IS ALSO TORN IN THIS
10/23/96 SAME STG REGION FROM STA 730 TO 760

AN APPARENT SKIN REPAIR HAS BEEN PERFORMED IN THE REGION 720 TO 740, STG 25 TO 28.
