LOG # LF10 <sup>101</sup>  
 TARGET # Bevs  
 REVI  
 COORD: LAT 40 39 71  
 LONG 72 37 27

# Aft Pressure Bulkhead Structure

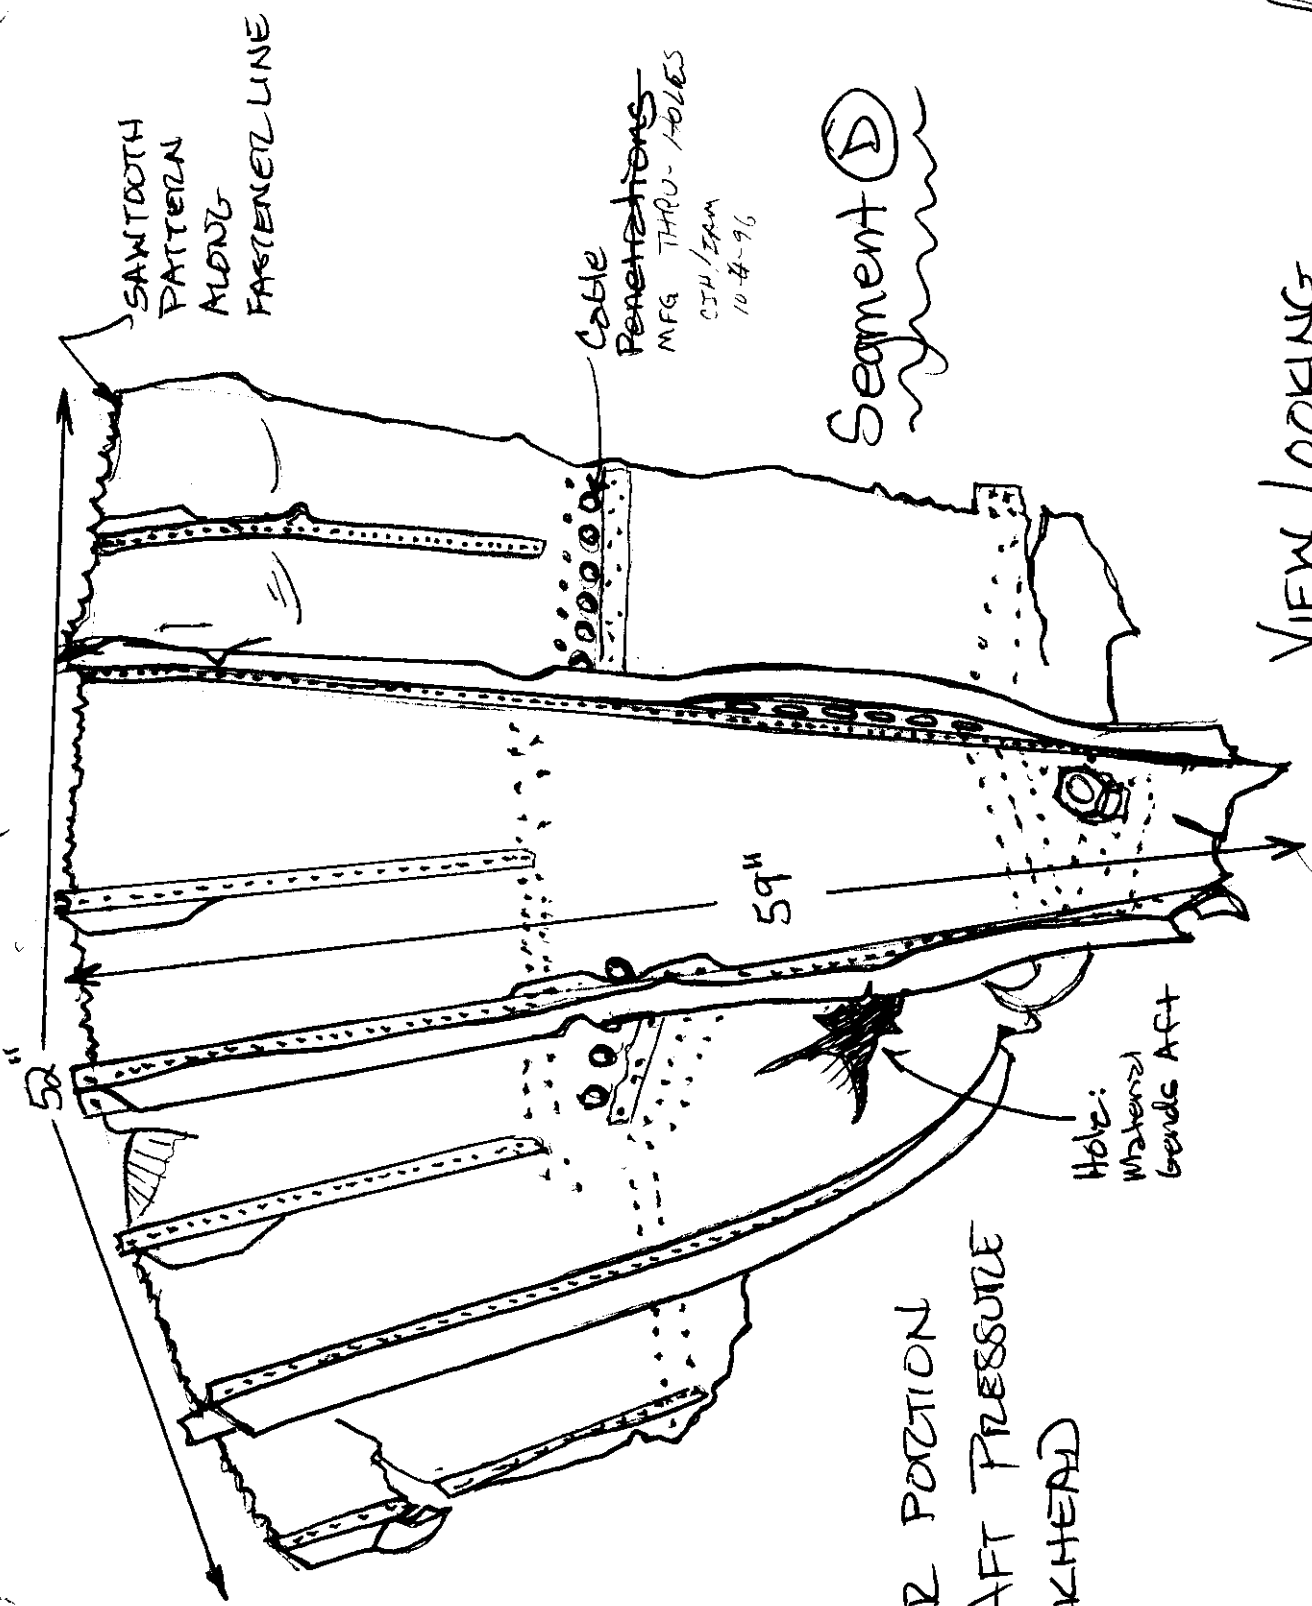
Segment D

Portion of Aft Pressure Bulkhead as shown on next sheet. Minimal deformation to central portion of segment. Small puncture area (going aft) on RHS segment. Static failure along fastener row attaching to periphery of web. No signs of fire damage.

Additional portions, (A) and (B), cover most of the remaining LHS portion of the Bulkhead. Part labeled (C) was attached by wires to part (B) but does not appear to be bulkhead structure. See sheet 6 for locations of

segments (A), (B), and (D)

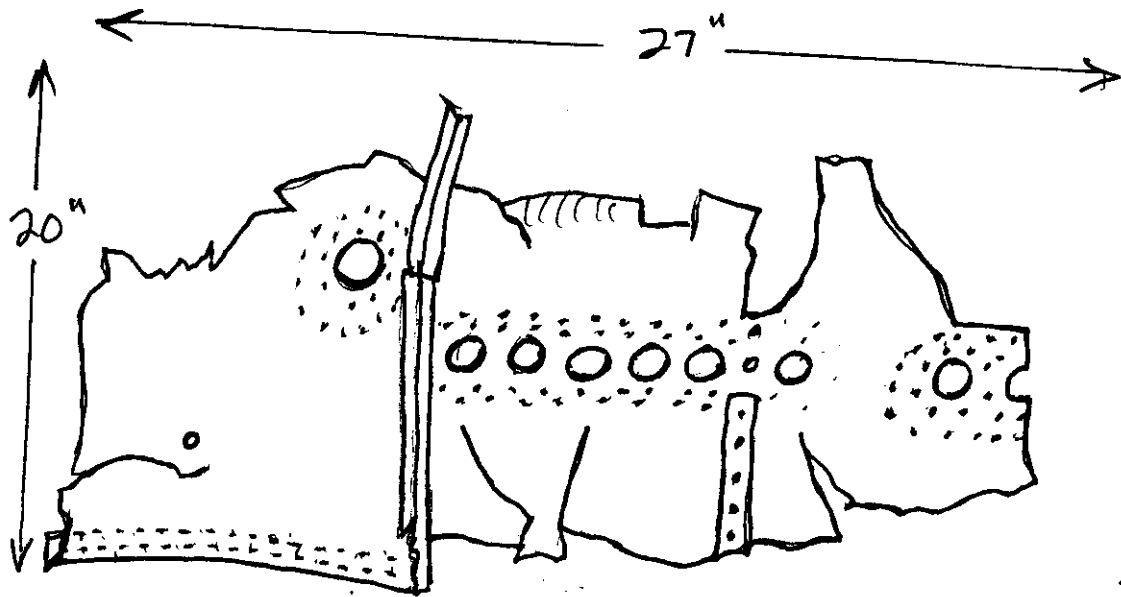
Segment ©  
VIEW LOOKING  
Aft

This small segment attached to segment © by a large bundle of wires. Also attached are mounting shelves for transponder, etc. Other panels (such as P/N 65B40520-20 electrical panel) still attached to segments by wires.

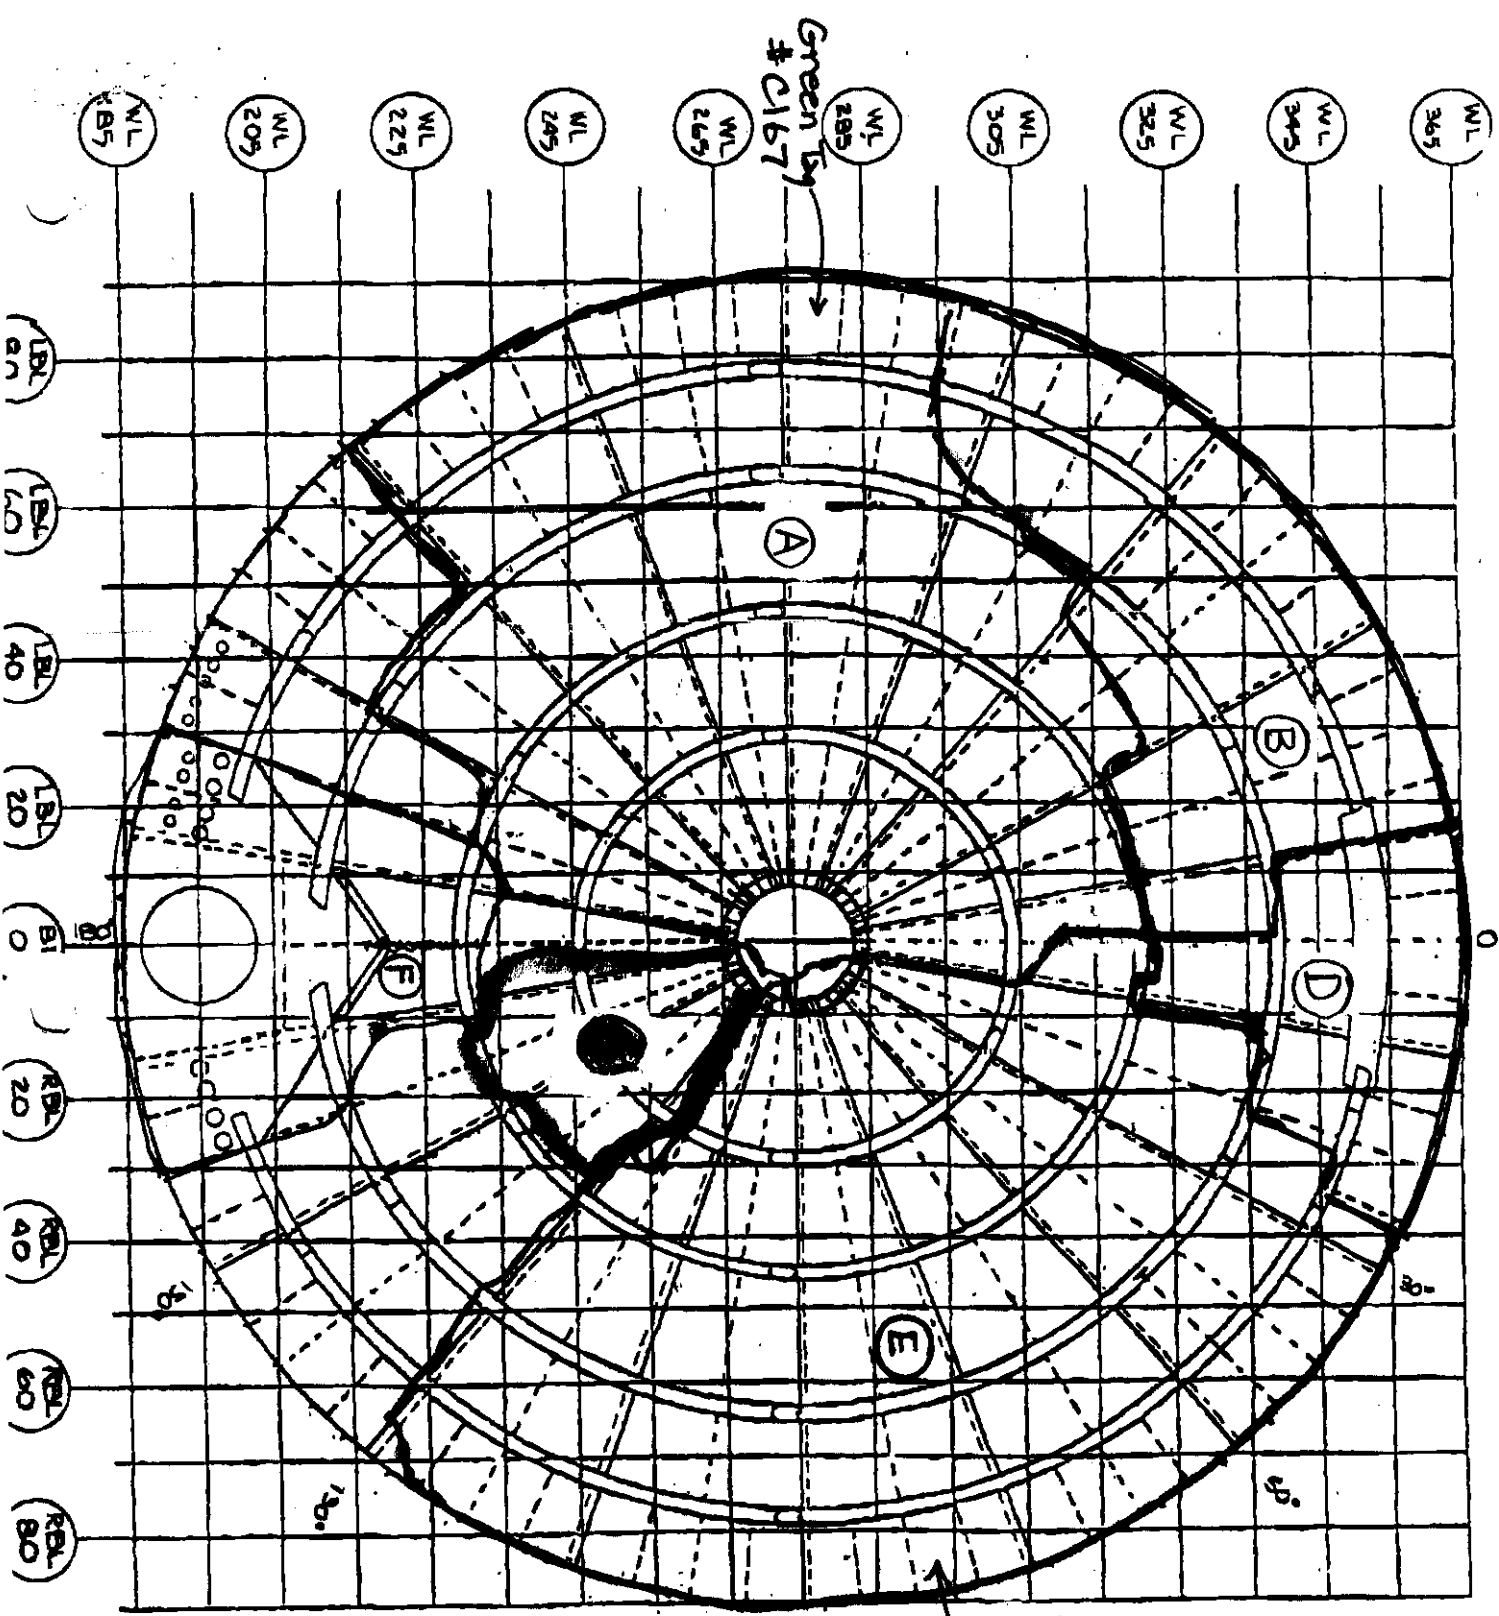
Green Tag # C044

Additional portion (E) also recovered from green area. Overall dimensions are as shown on sheet 6. This part extends from center ring to outboard edge. Same sawtooth pattern as other segments. This portion is folded radially\* very similar to segment (A) (see sheet 3 for sketch of segment (A)).

\* i.e., COMPRESSED CIRCUMFERENTIALLY B.H.  
11/2/96

Additional portion (F) also recovered from green area. Overall dimensions are as shown on sheet 6. This part encompasses the APU cutout at lower center. Unlike the other pieces, this portion includes the Y-ring and 18 section 46 stringer end fittings. Small portions of skin FWD of STA 2360 are also attached. The entire segment is badly damaged common to the web. The duct work, fuel line, lav service panel, and other tubing are still attached.

There is no evidence of fire damage or sooting.

ALSO SHOWS RADIAL  
COMPRESSION.
