LOG # LF102  
 TARGET # Z 3005  
 COORD: LAT \_\_\_\_\_  
 LONG \_\_\_\_\_

SEGMENT OF  
 PRESSURE DECK  
 WEB, STA 1265 TO  
 1322, LBL 83 TO S.O.B.

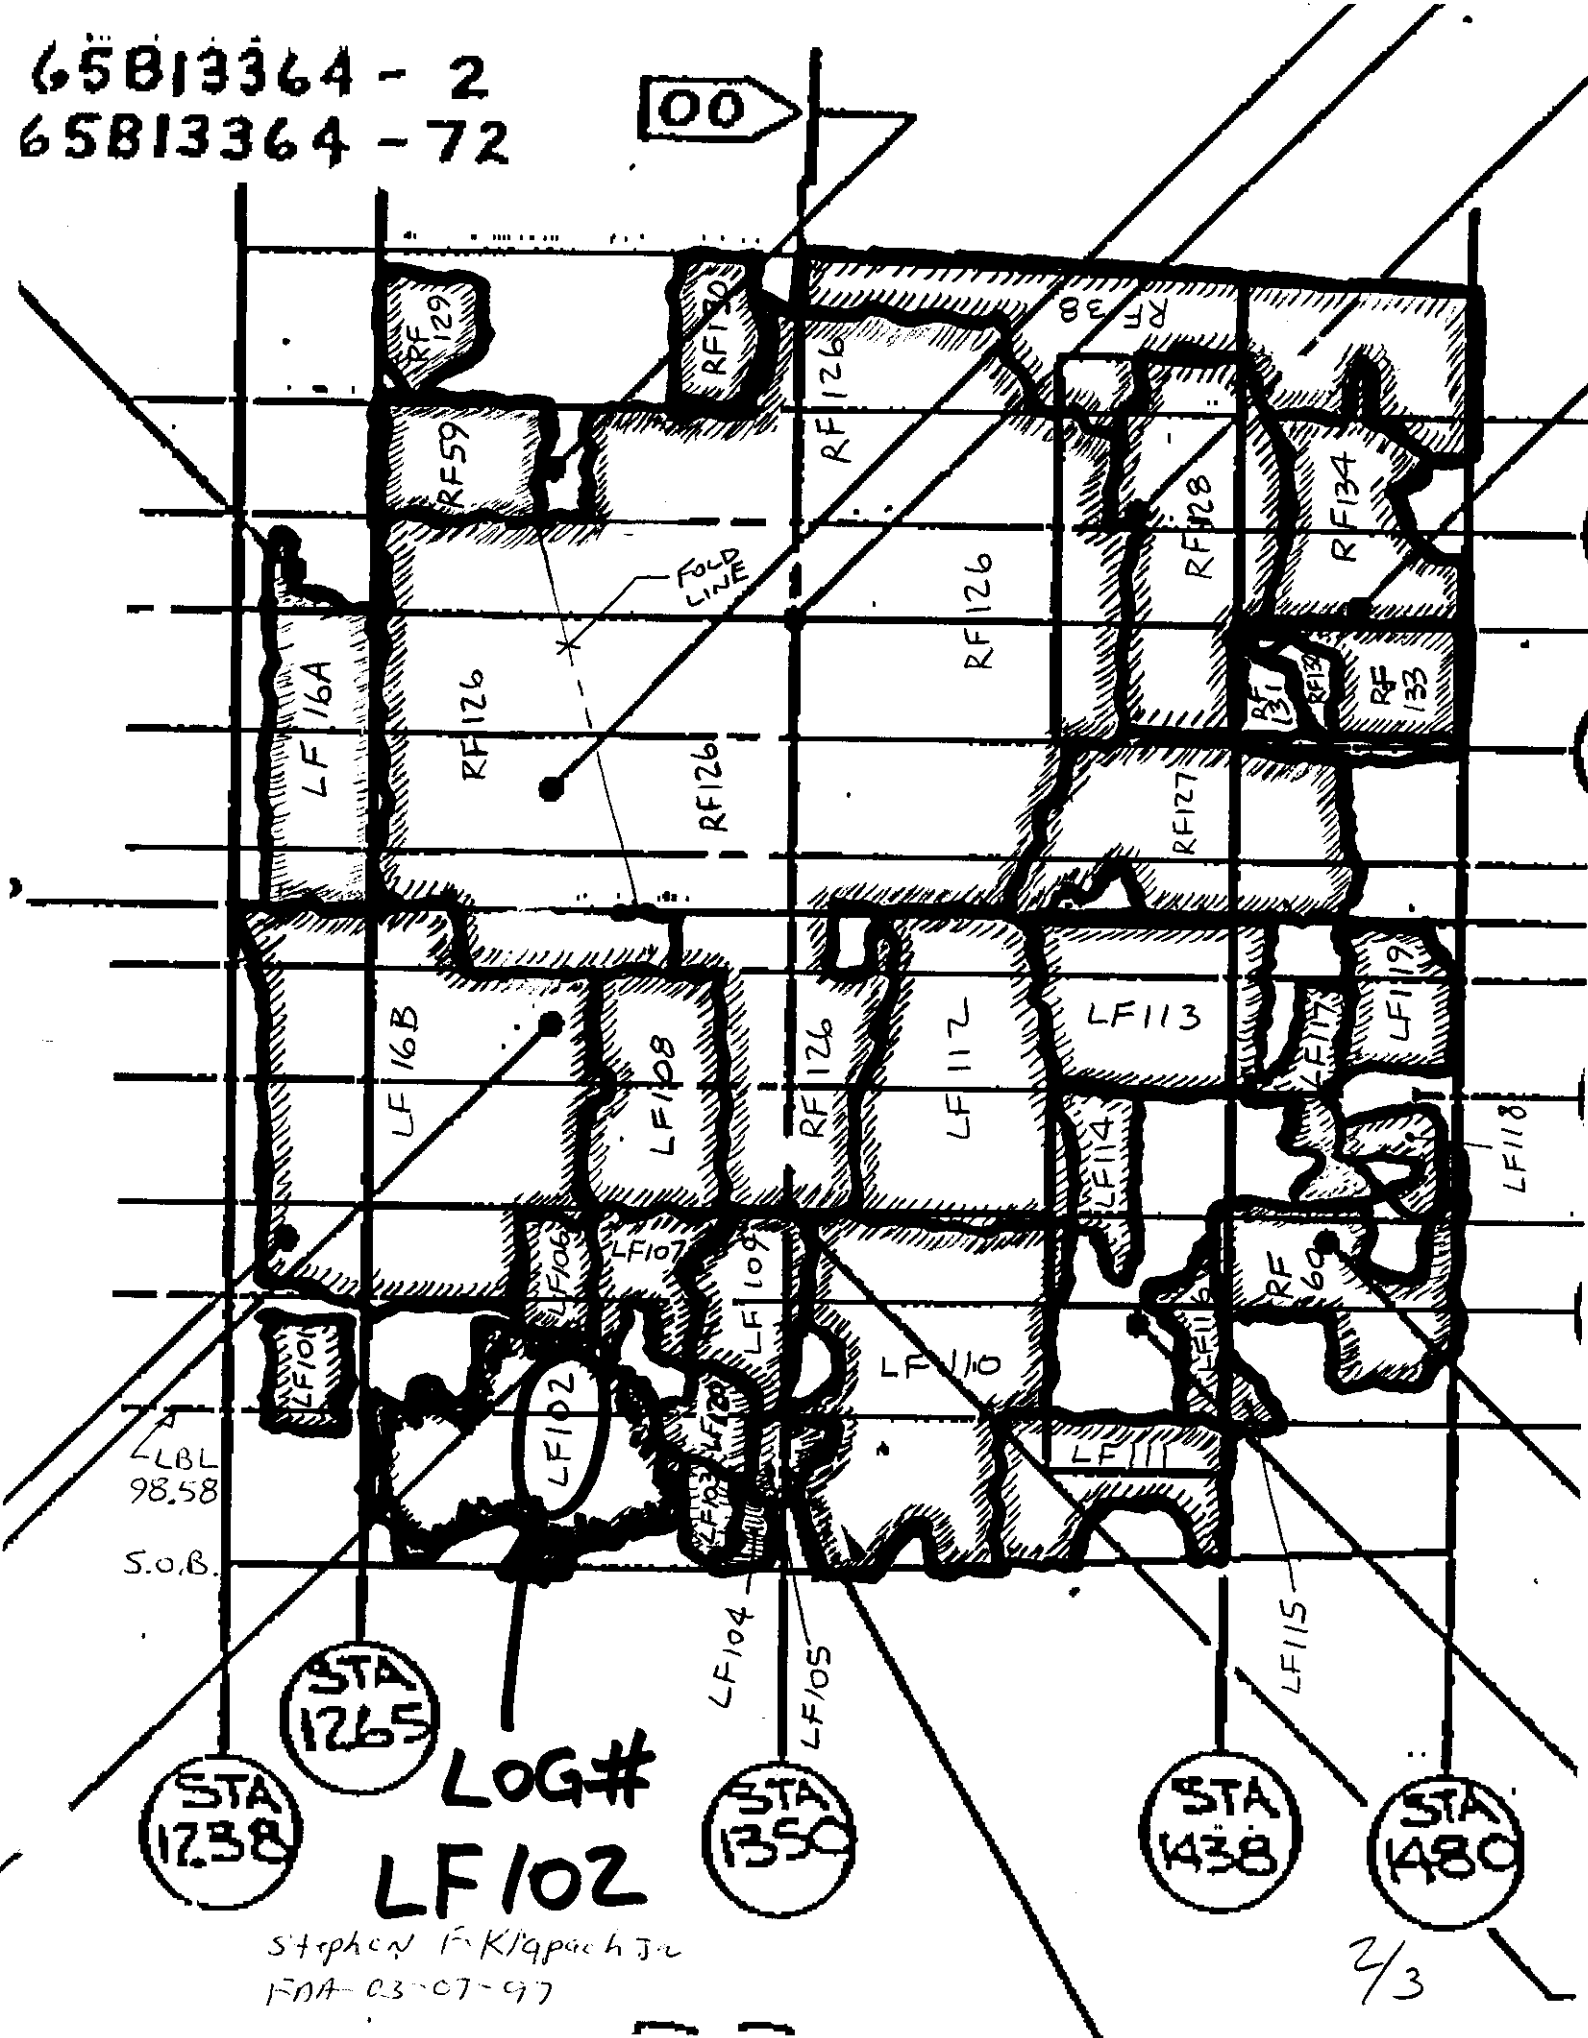
PLAN  
 VIEW

WEB  
 CRACK

NO APPARENT  
 SOOTING OF  
 SURFACES.

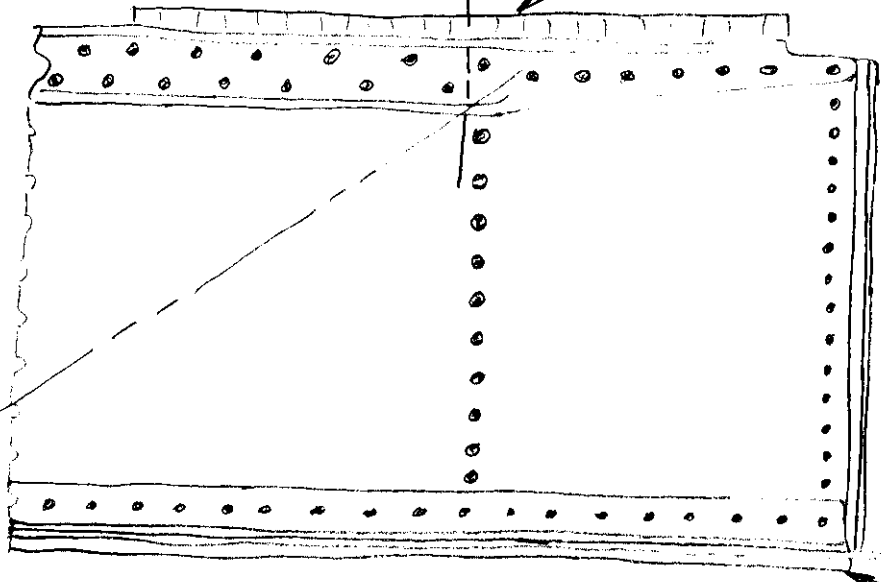
## VIEW B-B

UPPER CHORD  
CRACKED HERE

PRESSURE DECK KNEE  
STIFFENER UPPER  
FLANGE. (INTERSECTION  
OF HORIZONTAL DECK  
& SLOPING DECK)

BEND LINE.  
UPPER PORTION  
BENT FWD  
ABOUT 80°.  
LOWER PORTION  
BENT SLIGHTLY  
AFT.

UPPER PORTION BENT INBOARD  
ABOUT 10°

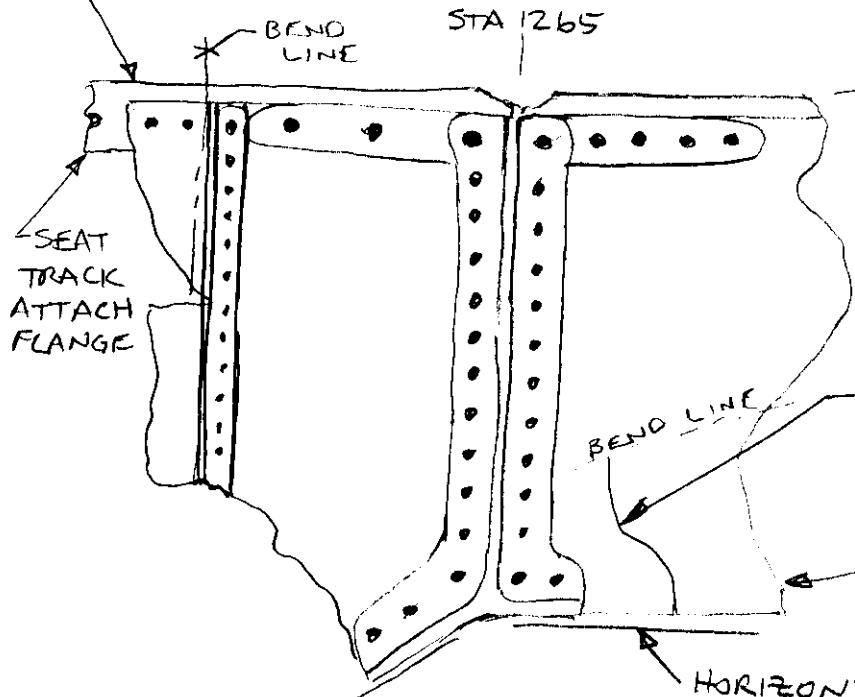
## VIEW C-C

REMNAINT  
OF LBL 98.58  
FLOOR BEAM.

LWR PORTION  
BENT OUTBOARD  
ABOUT 15°.
