LOG # LF-11

DEBRIS FIELD 2

\* NOSE WHEEL WELL STRUCTURE

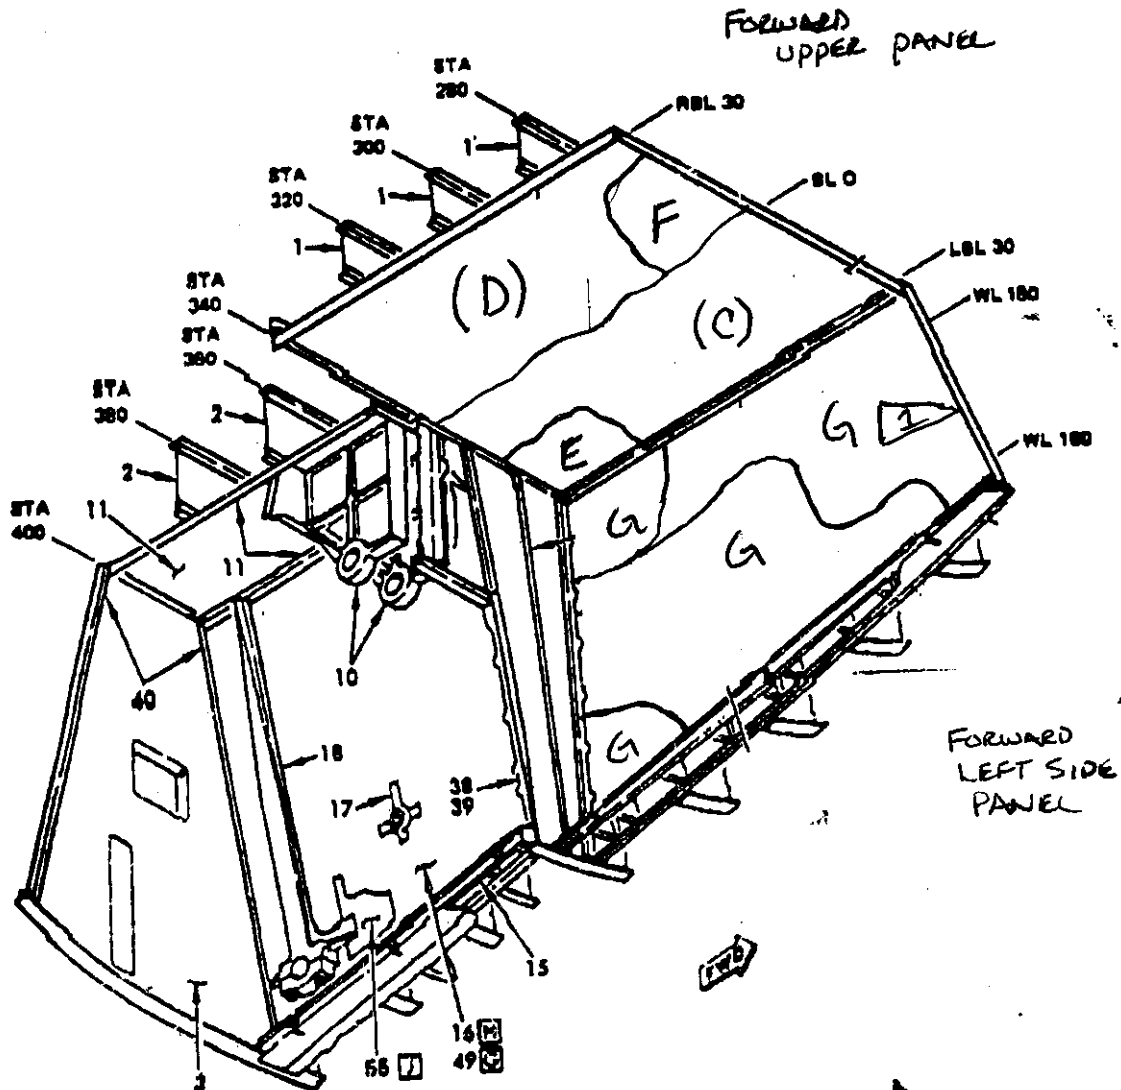
NOSE WHEEL WELL STRUCTURE  
FORWARD TOP AND LEFT SIDE PANELS

3 LINES DRAWN ON VIEW ARE FRACTURE LINES G IS ONE PIECE

THE UPPER AND LEFT PANELS WERE FRACTURED INTO SEGMENTS AS SHOWN ABOVE. ALL SEGMENTS SHOW NO SIGN OF FIRE OR SOOTING. THERE ARE NO SIGNS OF FATIGUE CRACKING AT ANY FRACTURE SURFACES.

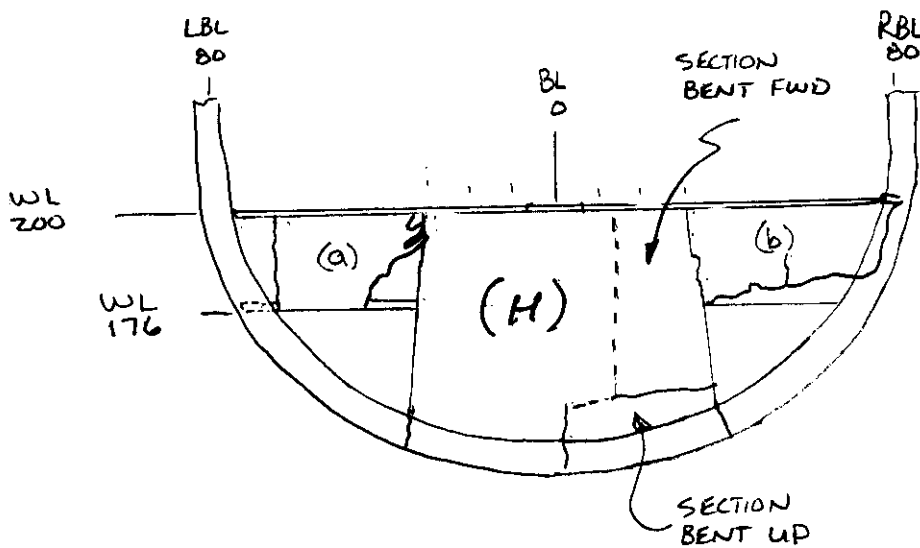
NOSE WHEEL WELL STRUCTURE  
CANTED BULKHEAD

THE SECTION OF THE CANTED BULKHEAD WHICH IS COMMON TO THE NOSE WHEEL WELL AREA SEPERATED FROM THE RIGHT AND LEFT UPPER SECTIONS SHOWN AS (a) AND (b) ABOVE.

THE WHEEL WELL SECTION RIGHT SIDE WAS BENT FORWARD & INBURED AND A SMALL LOWER RIGHT SECTION WAS BENT AFT AND UP.

FRACTURE SURFACES SHOW NO SIGN OF FATIGUE CRACKING.

NO SIGN OF FIRE OR SOOTING ON ANY PARTS.

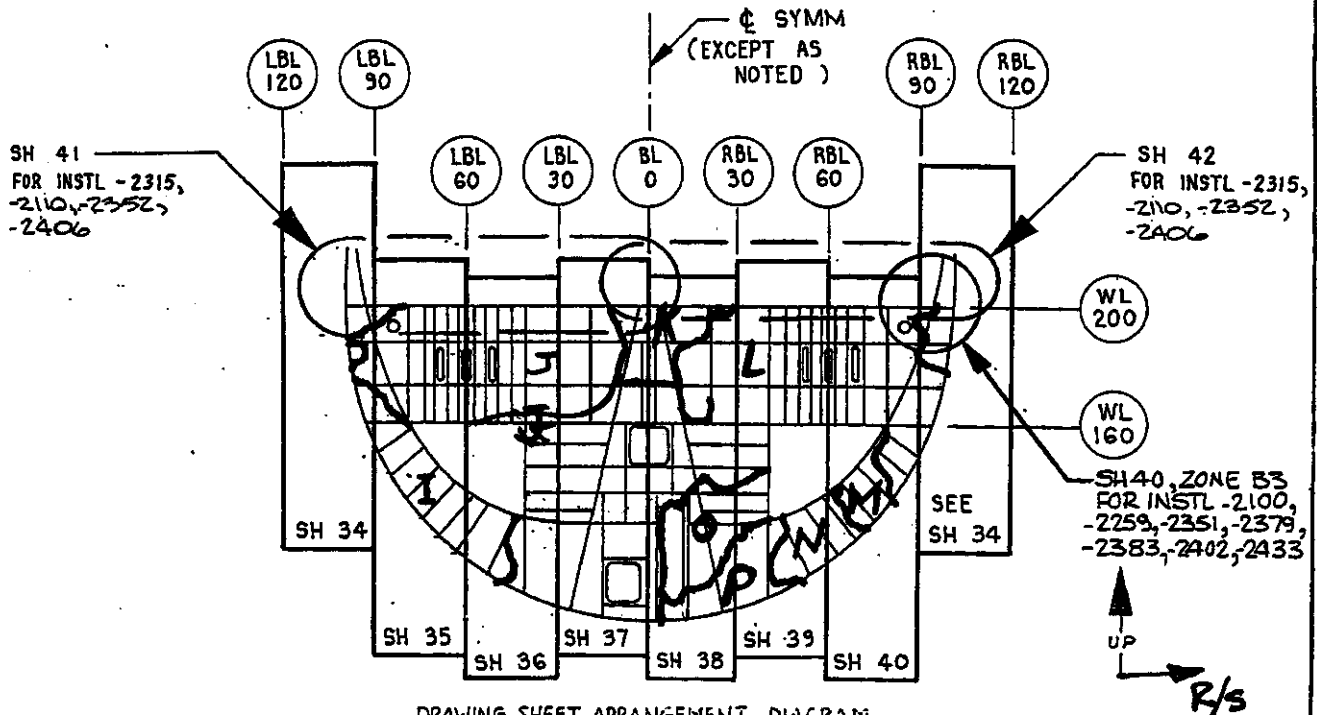
NOSE WHEEL WELL STRUCTURE  
STA-400 BULKHEAD

NONE OF THE FRACTURE SURFACES SHOW ANY FATIGUE CRACKING. THE OUTBOARD CHORD ON THE RIGHT SIDE SHOWS SEVERE IMPACT DAMAGE WHICH SHEARED OFF THE OUTSTANDING LEGS OF THE T-CHORD. SMALL STRIPS OF FUSELAGE SKIN APPROXIMATELY THE WIDTH OF THE OUTBOARD CHORD ARE STILL ATTACHED FROM RBL-60 TO LBL-60

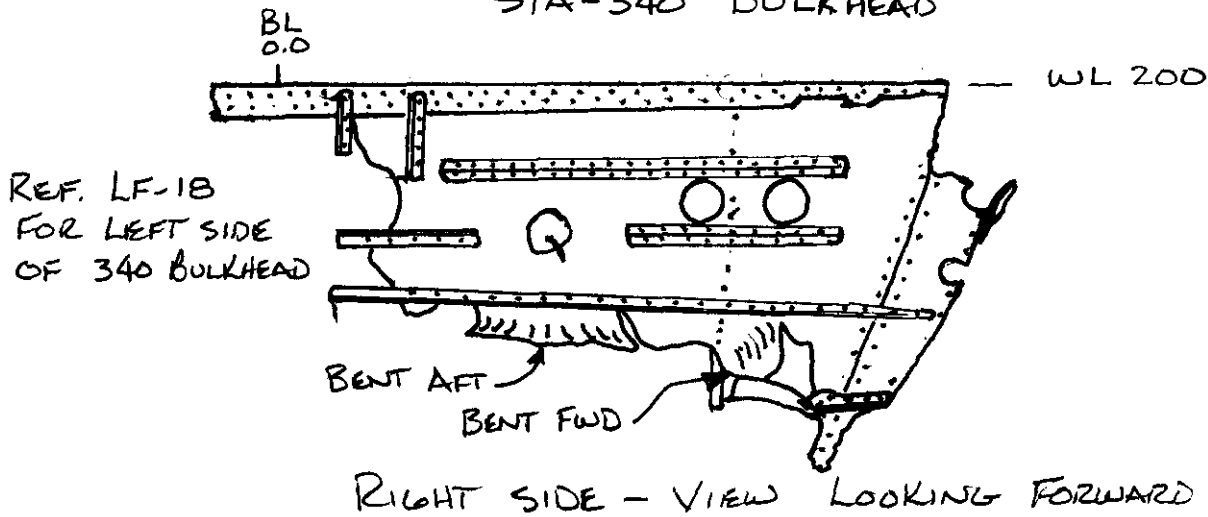
STA-340 BULKHEAD

FRACTURE SURFACES SHOW NO SIGN OF FATIGUE. FRACTURES APPEAR TO BE FROM TEARING WITH THE LOWER PORTION OF THE WEB BENT UP IN BOTH A FORWARD AND AFT DIRECTION. THERE ARE NO INDICATION OF FIRE OR SOOTING ON THE BULKHEAD OR FRACTURE SURFACES. THE LEFT SIDE OF THE 340 BULKHEAD IS STILL ATTACHED TO THE NOSE LANDING GEAR WHICH IS DESCRIBED ON LOG # LF-18.
