LOG # LF122
 TAC# TARGET # DZ106
 COORD: LAT _____
 LONG _____

MAIN DECK FLOOR BEAM

LBL 98.5B FROM STA 1298 TO STA 1325

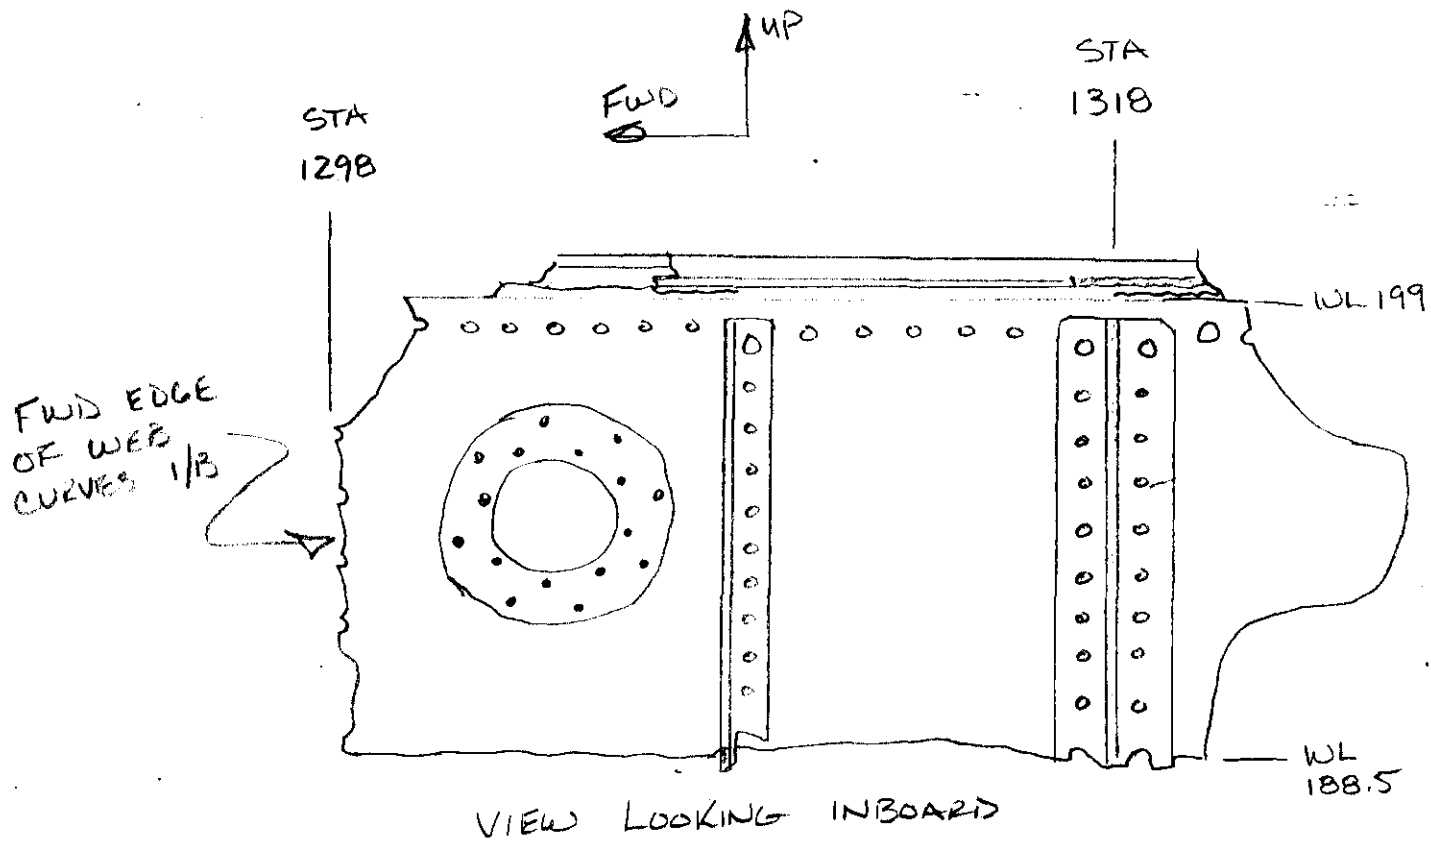
- * INDICATION OF SOOTING ON THE INBOARD SIDE OF THE FLOOR BEAM WEB FROM THE CIRCULAR CUTOUT FORWARD TO THE EDGE OF THE WEB. NOT SHOWN ON SKETCH
- * THE FLOOR BEAM WEB FRACTURED ABOVE THE LOWER CHORD VERTICAL LEG.
- * APPROXIMATELY 6.0 INCHES OF THE SEAT TRACK FAILED AT THE RADIUS, AS SHOWN ON SKETCH
- * A DARK TAR LIKE SUBSTANCE COATS THE LOWER SURFACE OF THE SEAT TRACK HORIZONTAL FLANGE AND APPEARS TO HAVE RUN DOWN THE FLOOR BEAM WEB. LOCATED ON BOTH SIDES OF THE FLOOR BEAM.
- * NO INDICATION OF ANY PENETRATIONS.
