LOG # LF 123

LBL 48.58 LONGITUDINAL FLOOR BEAM  
STA 1321 TO STA 1341

DEBRIS FIELD GREEN

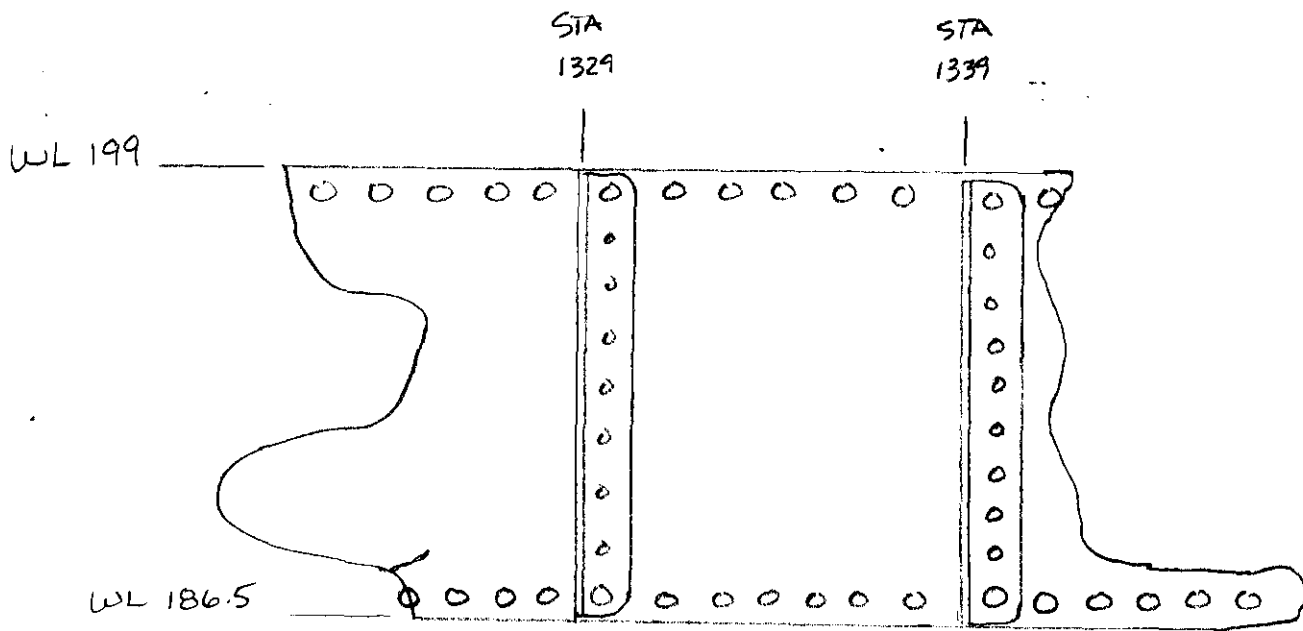
VIEW LOOKING INBOARD

- \* INDICATION OF POSSIBLE LIGHT SCOTING ON OUTBOARD SURFACE OF F/B WEB
- \* BOTH THE UPPER AND LOWER CHORDS FRACTURED AT THE RADIUS OF THE HORIZONTAL FLANGE. THE VERTICAL FLANGE REMAINED W/ WEB.
- \* THERE IS A TAR LIKE SUBSTANCE WHICH HAS RUN DOWN THE UPPER SURFACE OF THE FLOOR BEAM WEB ON THE OUTBOARD SIDE. NOT SHOWN ON SKETCH.
- \* NO INDICATION OF PENETRATIONS IN WEB.
