LOG # LT 144
 TAG # Z 2981
 COORD: LAT _____
 LONG _____

DEBRIS FIELD GREEN

LBL 98.58 LONGITUDINAL FLOOR BEAM FROM STA 1346 TO STA 1400.

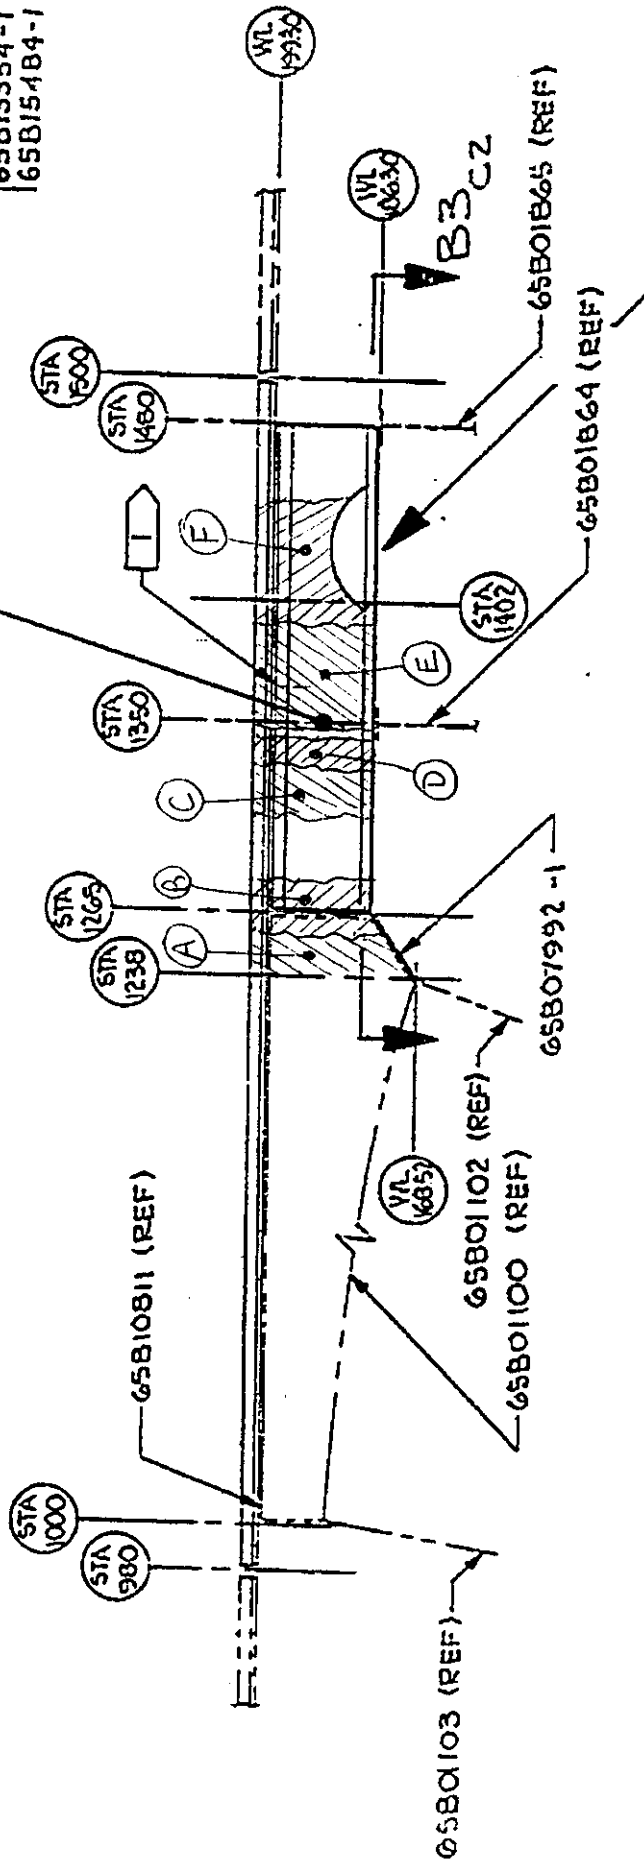
LBL 98.58
FLRBM

- * THE UPPER CHORD (SEAT TRACK) EXTENDS FROM STA 1350 TO 1400 A WITH SECTION OF PASSENGER SEAT THAT REMAINED ATTACHED FROM STA 1366 TO STA 1383.
- * THE LOWER CHORD SEPERATED AT THE RADIUS WITH THE HORIZONTAL FLANGE MISSING EXCEPT FROM STA 1346 TO STA 1360. TWO SMALL PIECES OF THE STA 1350 BULKHEAD UPPER CHORD REMAINED ATTACHED TO THE LOWER CHORD HORIZONTAL FLANGE.

- * THE WEB FRACTURED FROM THE FWD EDGE AT STA 1346 TO JUST AFT OF THE BATHTUB FITTING AT STA 1350, JUST ABOVE THE LOWER CHORD VERTICAL FLANGE.
- * THE LOWER CHORD SECTION WITH THE HORIZONTAL FLANGE STILL ATTACHED IS TWISTED APPROXIMATELY 110° TO 160° IN THE AXIS OF THE FLOOR BEAM.

- * THE FLOOR BEAM WEB HAS A JAGGED TEAR EXTENDING FROM THE LOWER CHORD AT STA 1390, UP ABOUT 3.5 INCHES THEN BACK DOWN TO THE LOWER CHORD AND AFT TO THE END OF THE FLOOR BEAM SECTION AT STA 1400.

- * THERE ARE NO INDICATIONS OF PENETRATIONS.
- * THERE ARE INDICATIONS OF POSSIBLE LIGHT SOOTING ON BOTH INBOARD AND OUTBOARD SIDES.
- * THE VERTICAL STIFFENER UPSTANDING LEGS ARE MISSING AT STA 1372 AND STA 1394
