LOG # LF 125
~~TARGET #~~ D2107
 COORD: LAT _____
 LONG _____

LBL 75.92 LONGITUDINAL FLOOR BEAM
 FROM STA 1250 TO STA 1290

DEBRIS FIELD WHITE

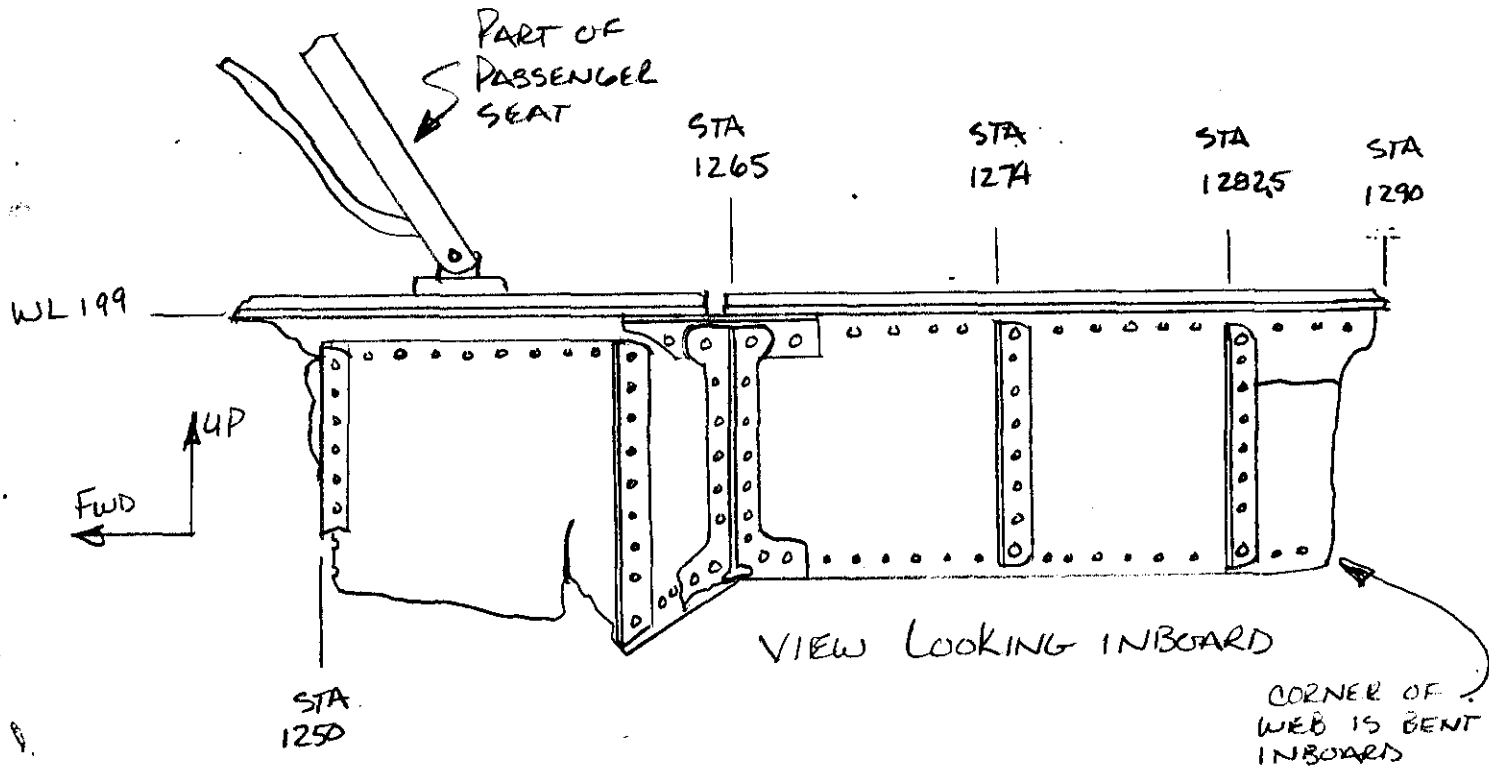
- * INDICATION OF MEDIUM TO HEAVY SOOTING ON INBOARD AND OUTBOARD SIDES OF FLOOR BEAM.
- * THE UPPER CHORD (SEAT TRACK) IS COMPLETE FROM STA 1250 TO STA 1290.
- * THE LOWER CHORD FRACTURED AT THE RADIUS WITH THE HORIZONTAL CHORD MISSING.
- * THERE IS A TAR LIKE SUBSTANCE ON THE UPPER CHORD LOWER SURFACE OUTBOARD SIDE AS WELL AS THE WEB UPPER EDGE FROM STA 1265 TO STA 1290.
- * A PASSENGER SEAT LEG REMAINED ATTACHED TO THE UPPER CHORD (SEAT TRACK) AT STA 1255.
- * THERE ARE NO INDICATIONS OF PENETRATIONS.
- * AFT LOWER CORNER OF WEB IS BENT INBOARD
