LOG # LF26 ^{SDG} ^{RTS 10-7-96}

DEBRIS FIELD #1 Green
(Far)

LHS Aft Body Skin, S-8L → 24L, STA 2285 → 2360.

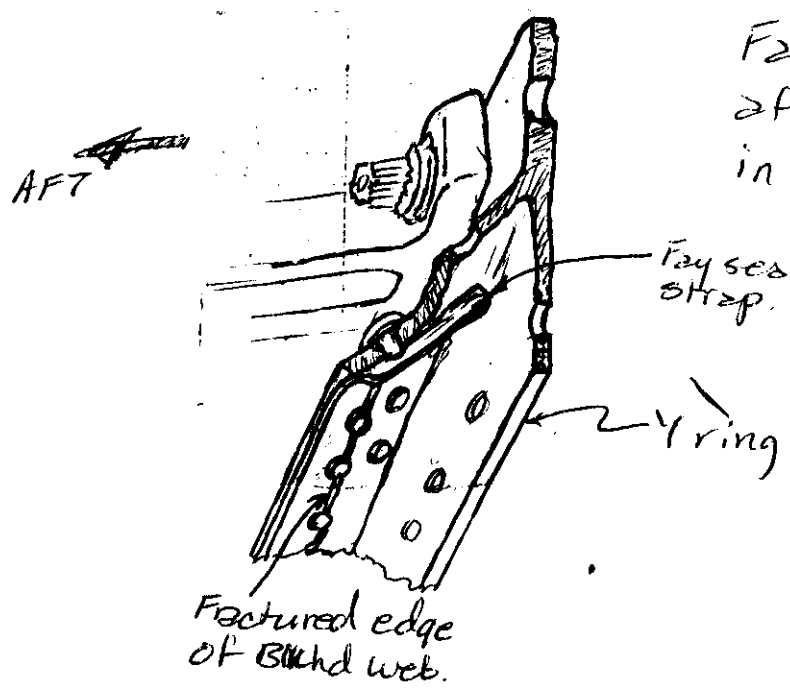
Body skin panel section includes Y ring at STA 2360 and several small portions of empennage structure as shown on next page. Upper fracture surface of Y ring is shown below. Fails through Y ring fastener holes at/near stringer attach.

Fastener common to aft leg of Y ring remain in place with Bkhd web failed at aft-most row. At this location the failure of the web is coincident with the end of a fay sealed strap between the web and chord.

There is no evidence of fire damage or sooting in this area.

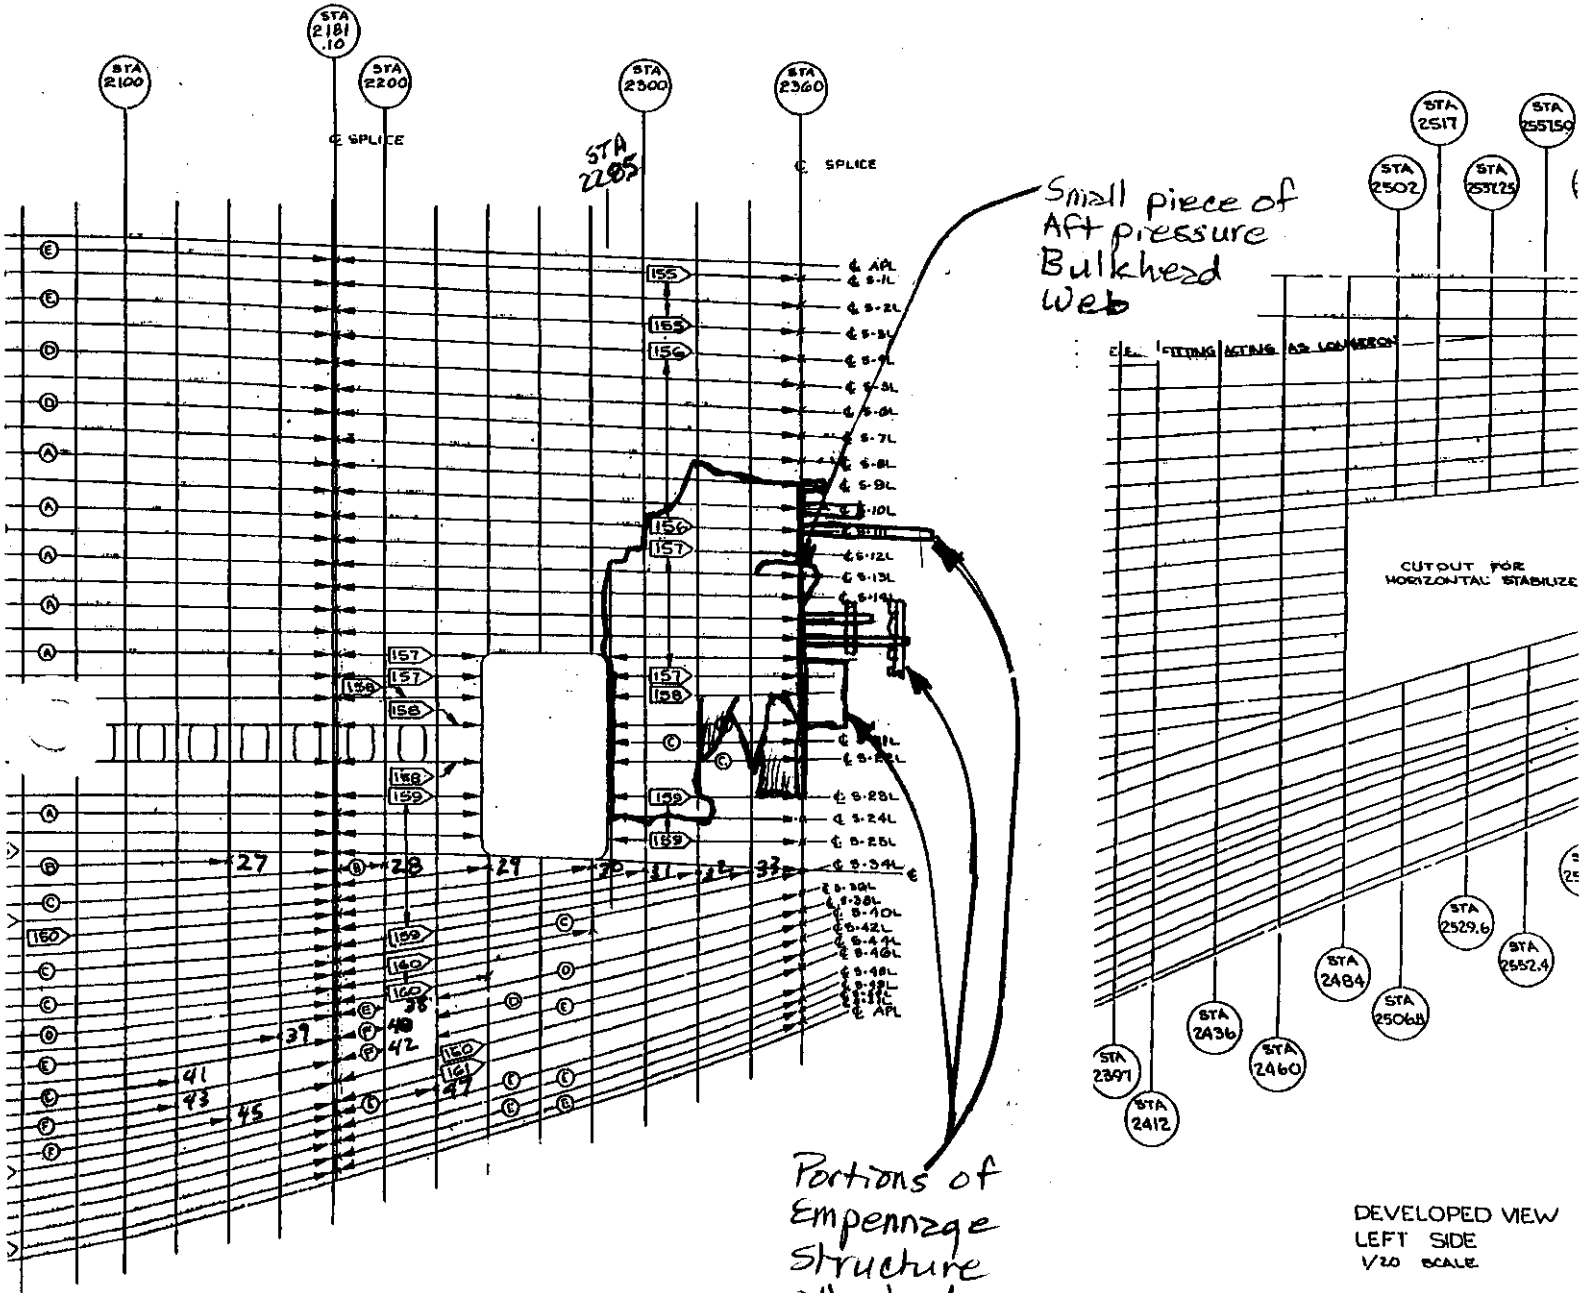
LF26

Small piece of Aft pressure Bulkhead Web

Portions of Empennage structure attached to skin segment.
