LOG # LF127

TARGET # C2455

DEBRIS FIELD GREEN

PRESSURE DECK FLOORBEAM, LBL 75.92  
STA 1439 TO 1466

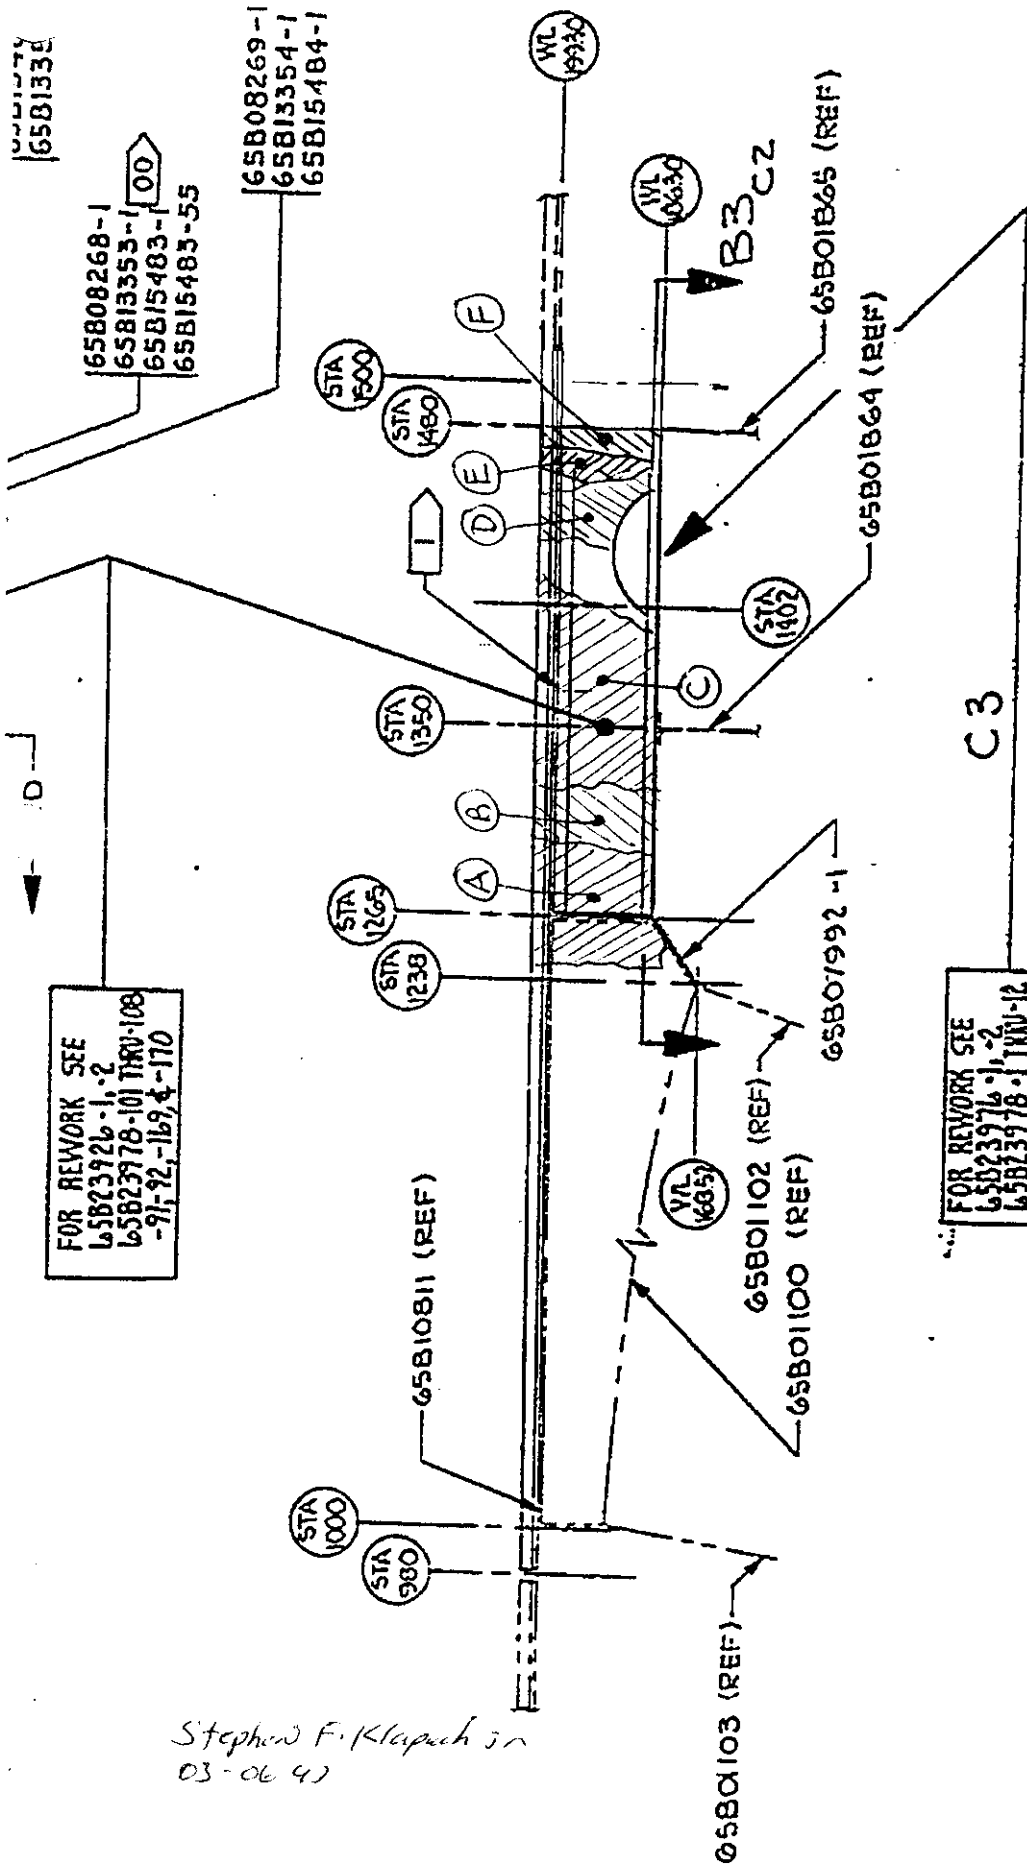
LBL 75.92  
 FLRBM

FLOORBEAM UPPER CHORD  
REMNANT, UPPER SEAT TRACK  
CROWN PORTION MISSING,

STIFFENER ON  
INBOARD SIDE  
ALSO

AFT WEB  
OVERLAPS FWD WEB

OUTSTANDING FLANGE  
BENT AFTWARD,  
WITNESS MARK  
INDICATIONS

FLOORBEAM LOWER CHORD  
REMNANT, LOWER FLANGES  
FOR ATTACHMENT TO THE  
PRESSURE DECK BROKEN  
OFF.

WEB  
CRACKED

WITNESS  
MARK  
INDICATIONS  
ON INBOARD  
SIDE OF WEB.

STA 1460 VERTICAL  
STIFFENER, LOWER  
END PADS BROKEN  
OFF. (STIFFENER  
PROVIDES BACK UP FOR  
MLG TRUNNION SUPPORT  
FITTING UPPER OBLIQUE  
TIE RODS RUNNING FROM  
STA 1480 TO STA 1460)

NO APPARENT SOOTING  
OF EITHER INBOARD OR  
OUTBOARD SURFACE.
