LBL 33.99 LONGITUDINAL FLOOR BEAM
FROM STA 1273 TO 1303.5

LOG # LF 132
TARGET # D 2111
COORD: LAT _____
LONG _____

DEBRIS FIELD WHITE

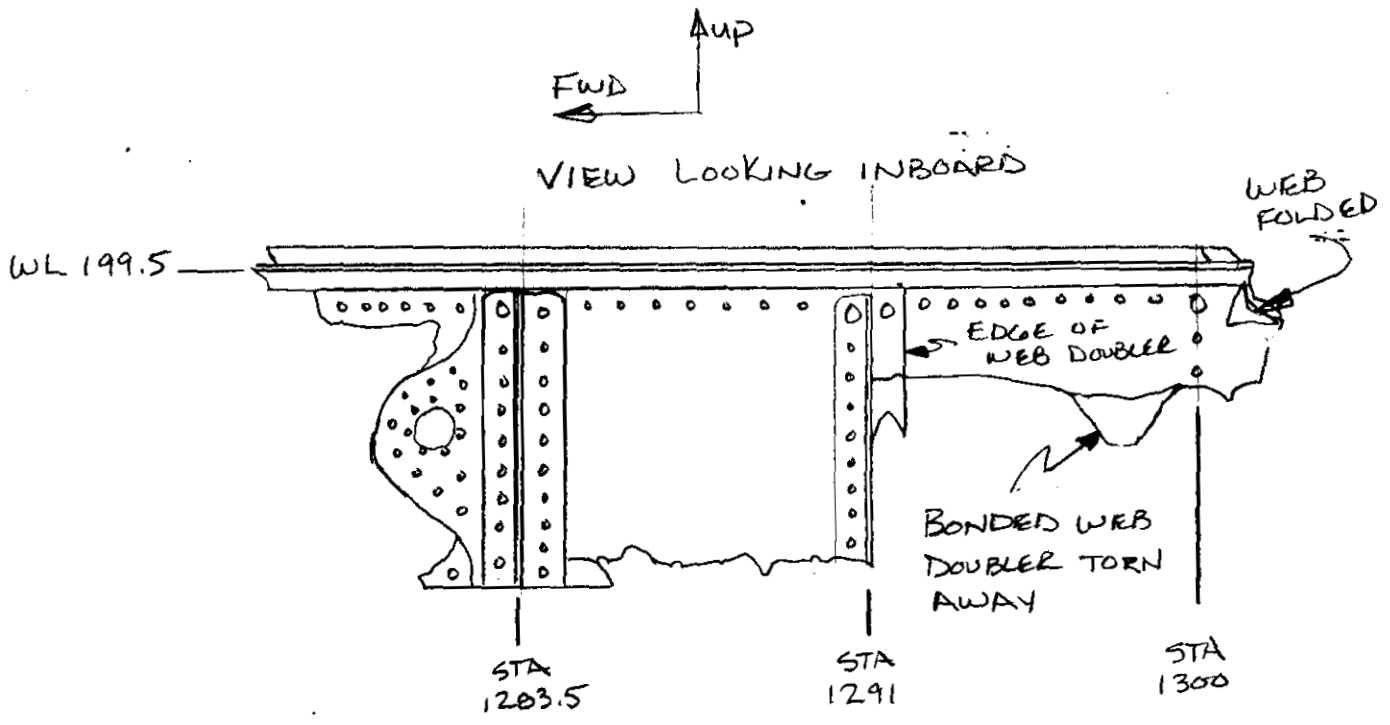
- * NO INDICATION OF ANY PENETRATIONS IN WEB.
- * INDICATION OF POSSIBLE LIGHT SOOTING AND OR DIRT ACCUMULATION ON BOTH THE INBOARD AND OUTBOARD SIDES.
- * SEALANT AROUND THE EDGE OF THE WEB CIRCULAR CUTOUT SHOWS INDICATION OF SOOT AND OR LIGHT CHARING ON THE OUTBOARD SIDE ONLY.
- * THE WEB LOWER EDGE FAILED ALONG THE FASTENER LINE COMMON TO THE LOWER CHORD EXCEPT AT THE STA 1283.5 STIFFENER WHERE A SMALL SECTION OF THE LOWER CHORD VERTICAL FLANGE REMAINED ATTACHED.
