LOG # LF137  
 TARGET # C2457  
 COORD: LAT \_\_\_\_\_  
 LONG \_\_\_\_\_

DEBRIS FIELD GREEN

PRESSURE DECK WEB SEGMENT  
 STA 1442 TO 1465, LBL 100 TO 120

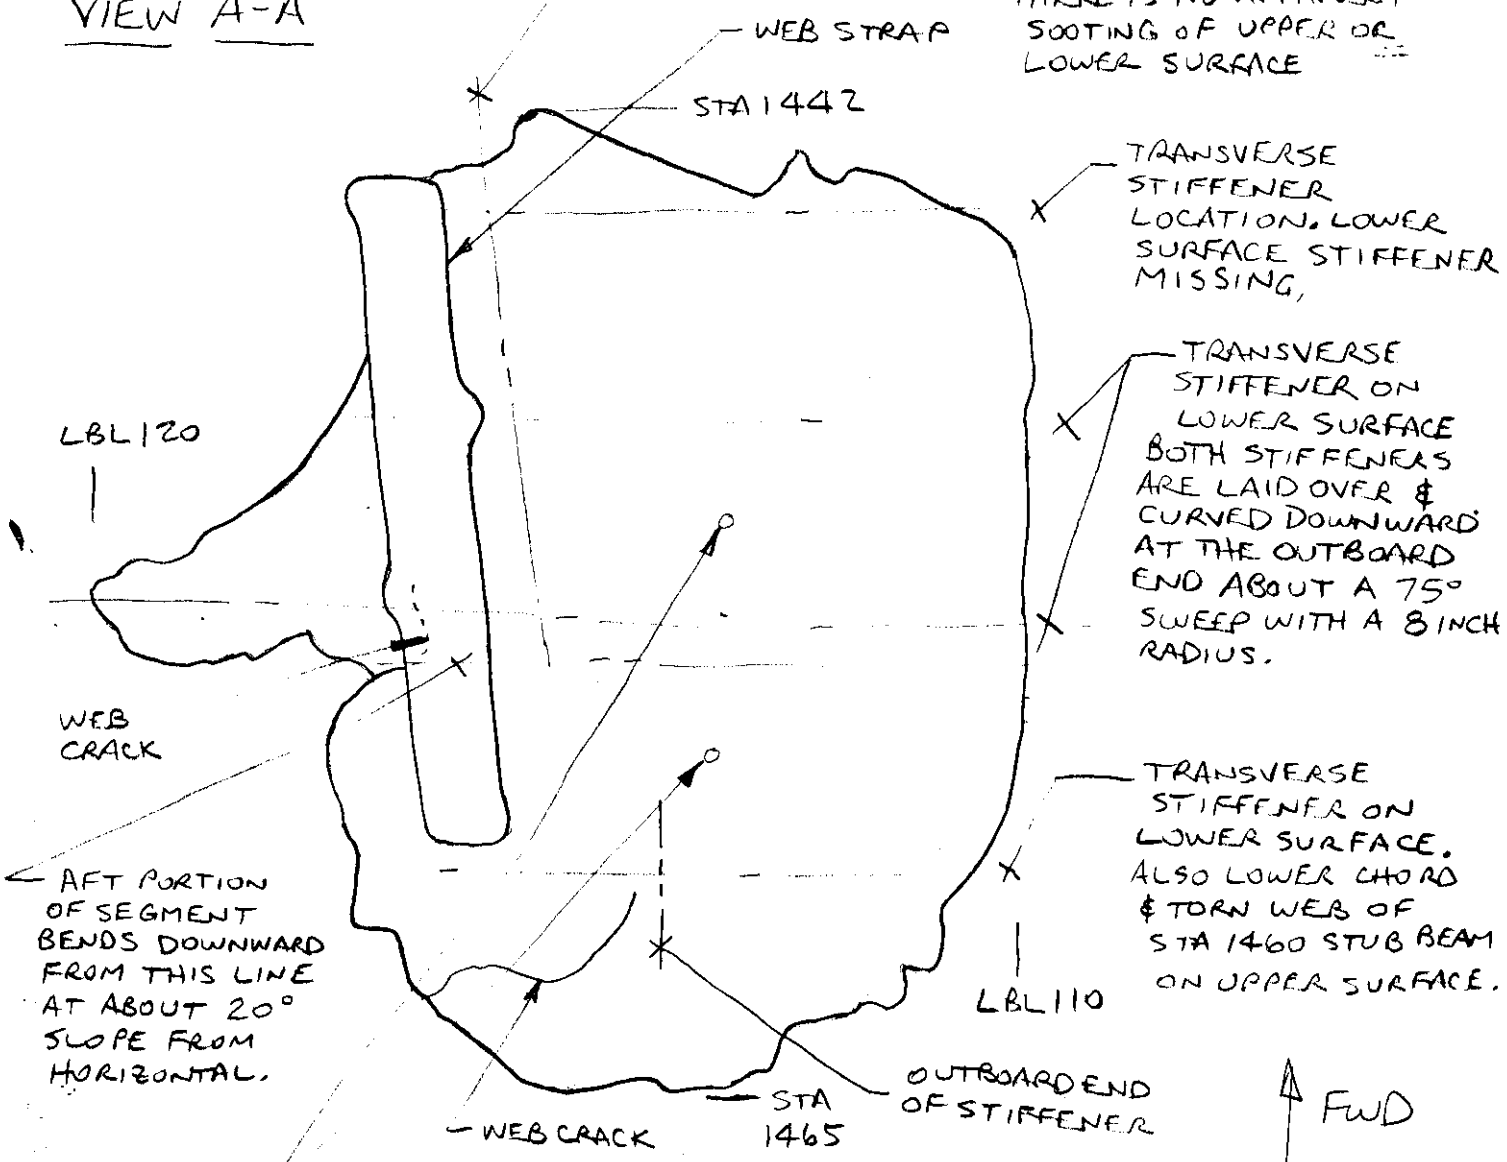
VIEW A-A

OUTBOARD WEB & STIFFENERS BEGIN DOWNWARD BEND AT THIS LINE.

THERE IS NO APPARENT SOOTING OF UPPER OR LOWER SURFACE

TRANSVERSE STIFFENER LOCATION, LOWER SURFACE STIFFENER MISSING,

TRANSVERSE STIFFENER ON LOWER SURFACE BOTH STIFFENERS ARE LAID OVER & CURVED DOWNWARD AT THE OUTBOARD END ABOUT A 75° SWEEP WITH A 8 INCH RADIUS.

TRANSVERSE STIFFENER ON LOWER SURFACE, ALSO LOWER CHORD & TORN WEB OF STA 1460 STUB BEAM ON UPPER SURFACE.

AFT PORTION OF SEGMENT BENDS DOWNWARD FROM THIS LINE AT ABOUT 20° SLOPE FROM HORIZONTAL.

WEB PENETRATIONS, APPEAR TO BE CIRCULAR IN SHAPE AND ABOUT THE SIZE OF A 3/16 DIA RIVET, EDGES HOWEVER ARE NOT SMOOTH LIKE OTHER STIFFENER ATTACHMENT HOLES WHICH ARE MISSING RIVETS. THE FORWARD HOLE APPEARS TO INDICATE DOWNWARD FLANGING.
