KEEL BEAM BOX
SEE SKETCH ON
NEXT PAGE

LOG # LF-14 Rev A ^{SDG} ^{RTS 10-1-96} ^{RHS}

Rev A added extra segments
depth of structure
now have Parts A, B, C & D
Added Pages 1a, 9-12
Revised Pages 1, 5, 6

LF 14 Rev A
ROAD MAP

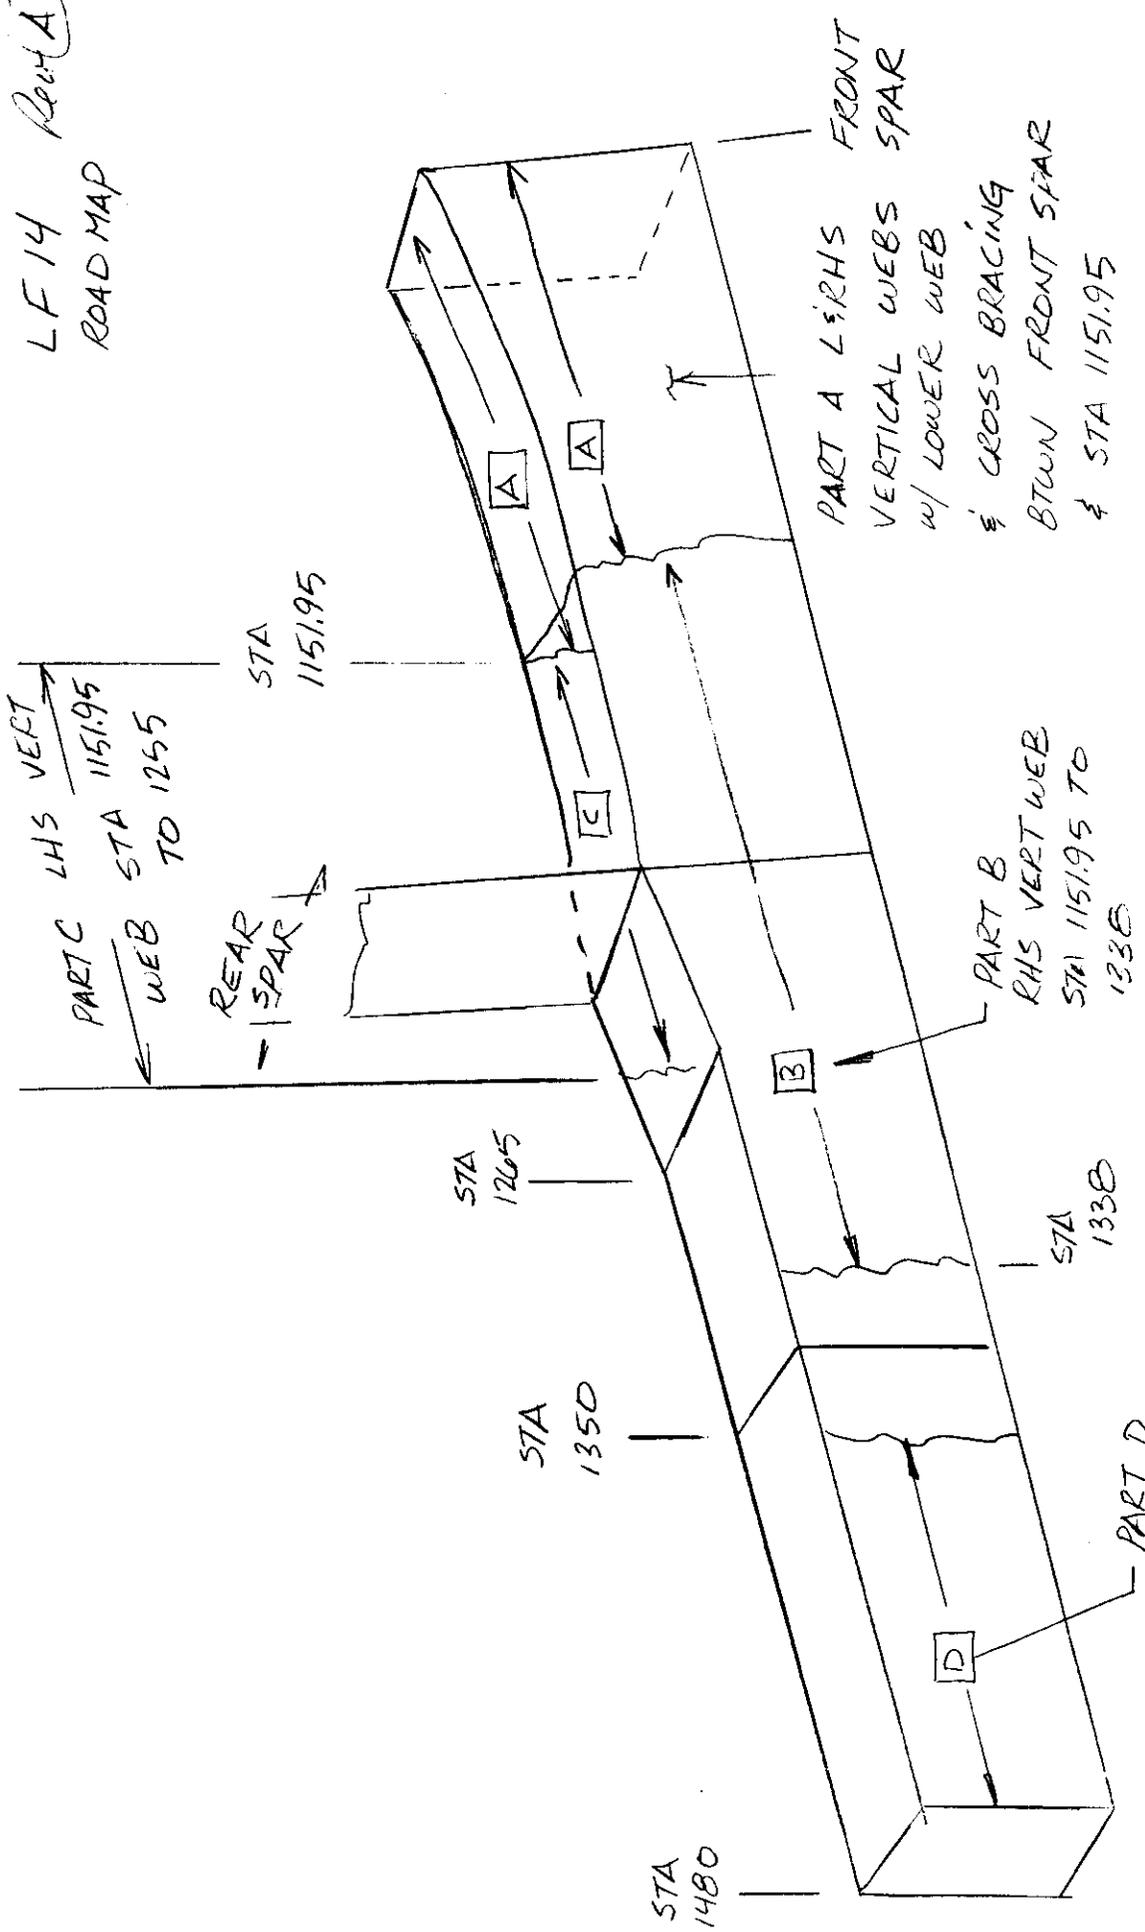
- THE LOWER HORIZONTAL WEB BETWEEN KEEL CHORDS AFT OF STA 1144 IS MISSING.

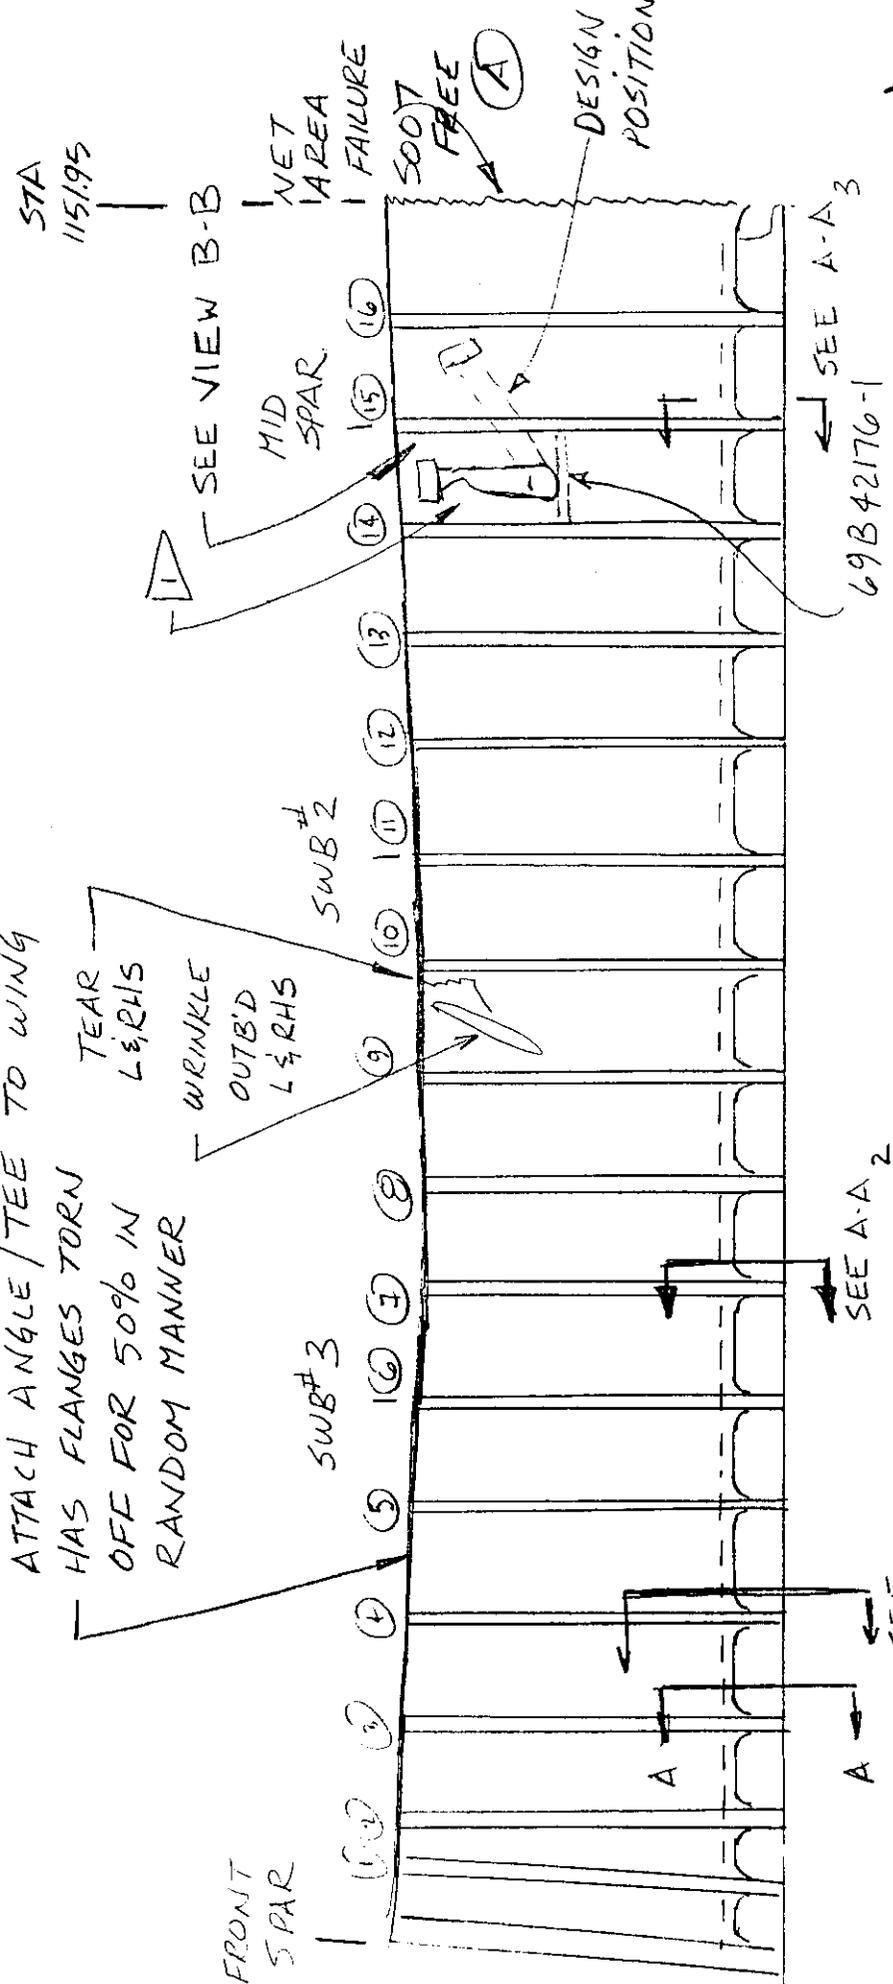
LF14A

SIDE VIEW OF BOX (LHS)

ATTACH ANGLE / TEE TO WING
HAS FLANGES TORN
OFF FOR 50% IN
RANDOM MANNER

TEAR
L & R HS

WRINKLE
OUTBD
L & R HS

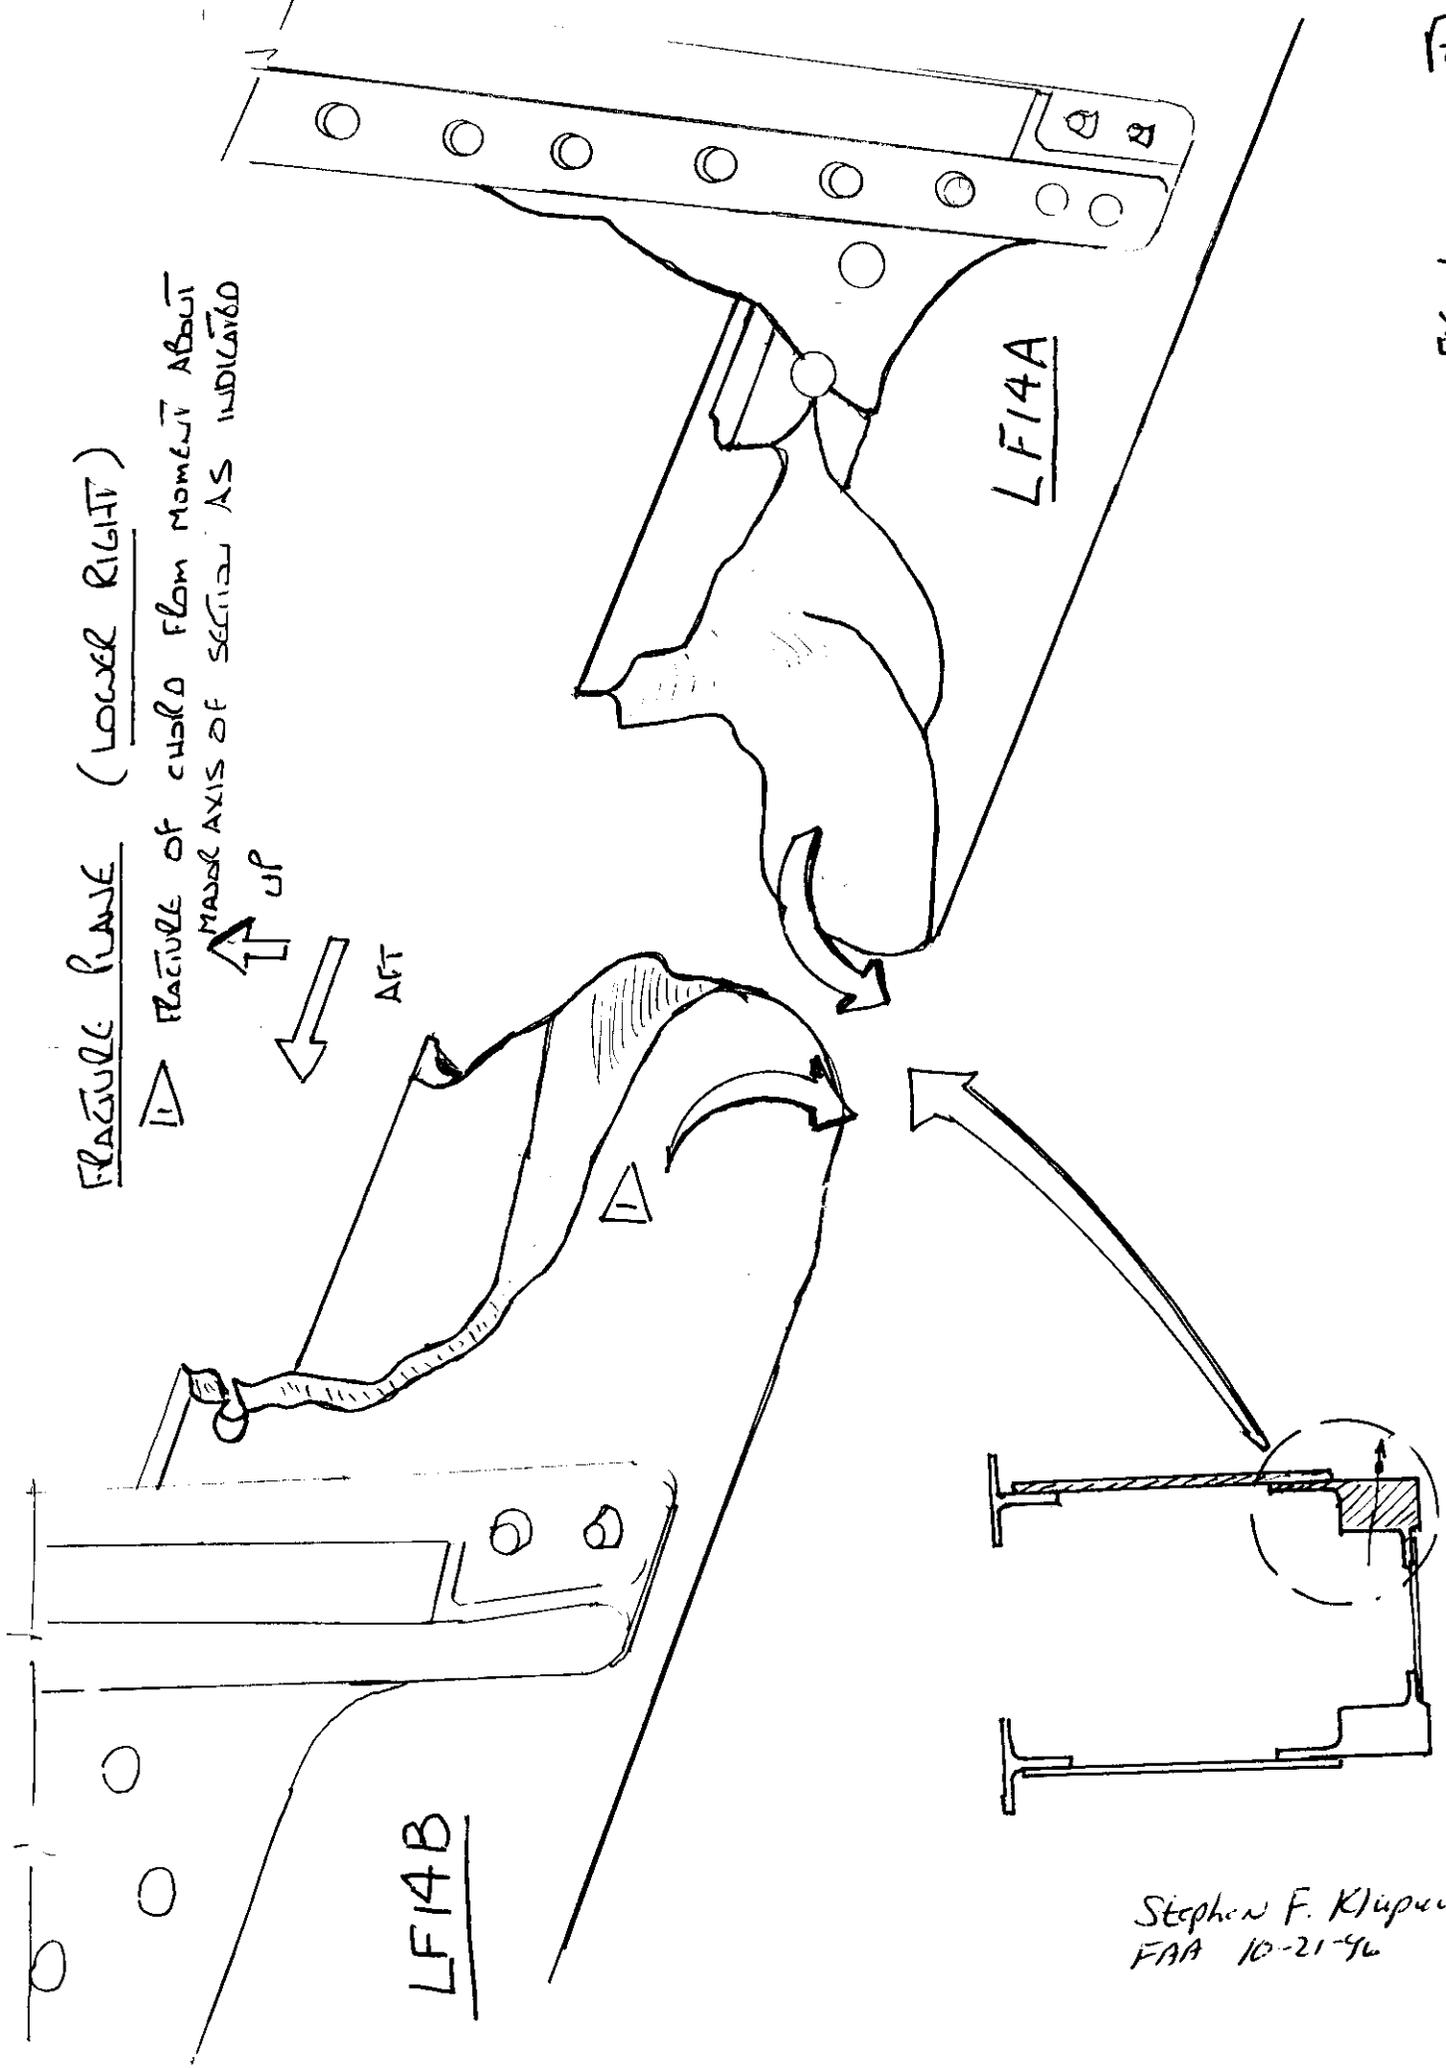
LF14 PART A

Duct is crumpled, and rotated fwd roughly 60 degrees

The upper chord of the keel beam box is buckled in the following manner;

Starting at the front spar location and moving aft, midway between Keel Beam Stiffeners (KBS) 2 & 3, there is an inward buckle, horizontal flange of upper inb'd chord is fractured. Just behind KBS 3 there is an outward buckle. Between KBS 4 & 5, there is an inward buckle. At KBS 5 there is outward buckle. 2 ½ forward of KBS 10 there is an outward deformation and at KBS 10 a minor inward deformation.

In between the front spar and KBS 1 an inward buckle, just behind KBS 3 an outward buckle. 2 " KBS 4 the start of an inward buckle which turns outward between KBS 5 & 6, coming to an apex at KBS 7. There is an inward buckle at KBS 8 with a major outward buckle at KBS 9.

@Stiffener #1, on each side one bolt broke at the thread root, the other bolt still has threads, so the nut failed. Note 2 bolts per side.

Outer surfaces of box are lightly sooted, except for the right side outer surface, centered at Sta 1129 approx, exhibited evidence of sooting in an upward/forward and aft direction. This sooting is moderate. There is light sooting on the most aft 8" of the RHS vertical web.

- @ Stiff # 3, duct supports bent forward located in bottom half of stiffener
- @ Stiffener #4 & #5, standoffs at top of stiffeners bent aft.
- @ Stiffener #7, standoff 6" from the bottom is broken off.
- @ Stiffener # 9, standoff 6" from the bottom is bent forward
- @ Stiffener # 10, bracket near top bent forward
- @ Stiffener # 11, standoff near bottom bent forward
- @ Stiffener # 13, has 3 standoffs near bottom, top bent upwards, bottom one has bolt/nut gone, and middle one looks OK
- @ Stiffener # 14, Duct bracket bent forward
- @ Stiffener #15, standoffs(2) near bottom bent forward
- @ Stiffener # 16, standoff 6" above keel chord bent aft

11 FRACTURE OF CUSHION FROM MOMENT ABOUT MASS AXIS OF SECTION AS INDICATED

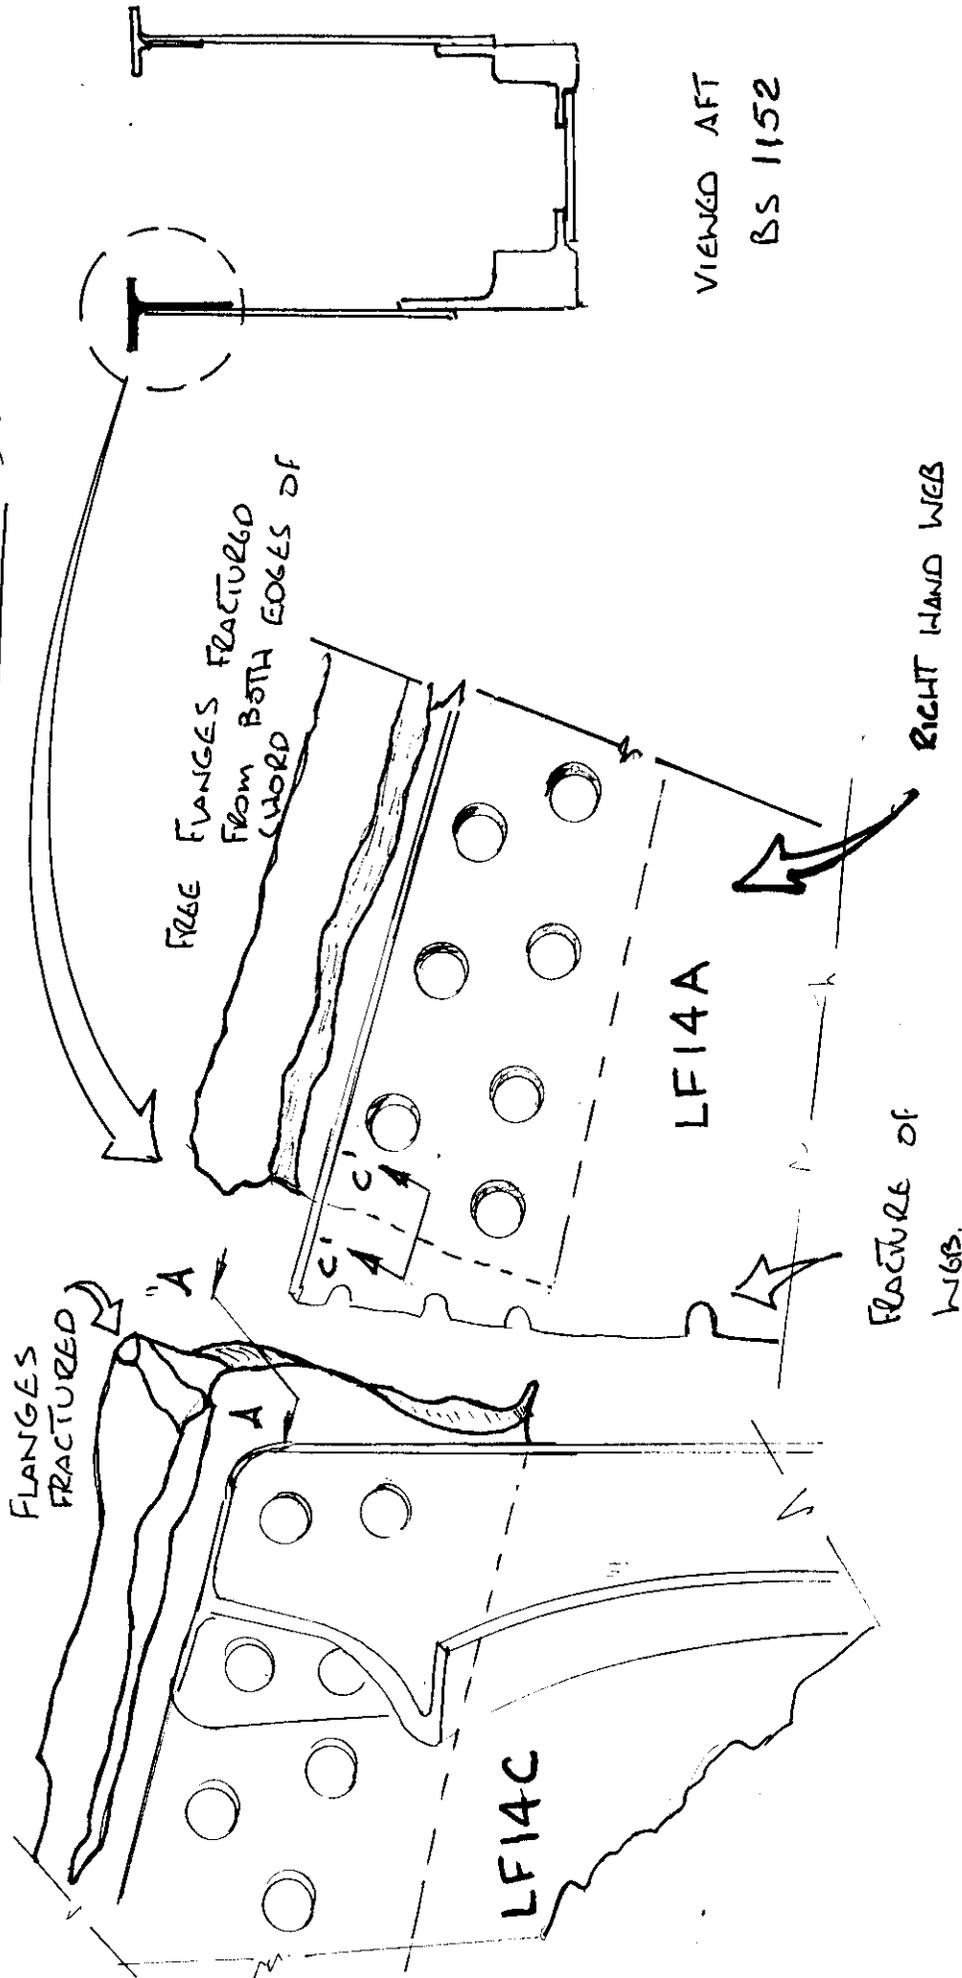
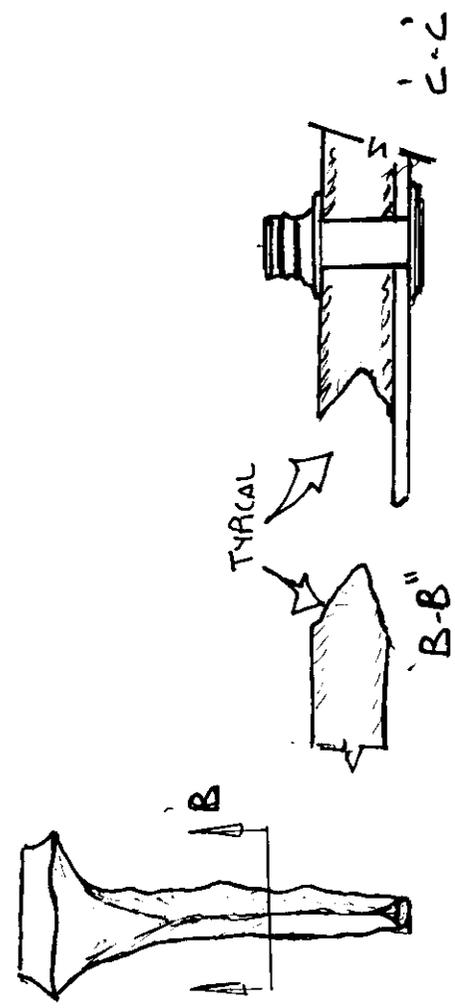
LF-14
FIG 2
KD 9-17-96
DEAN
 ∇ (LEFT UPPER CHORD)
SIMILAR

FRACTURE PLANE (UPPER RIGHT CHORD) ∇

KEEL BEAM (LEFT SIDE)
 LOWER CHORD FRACTURE LF-14

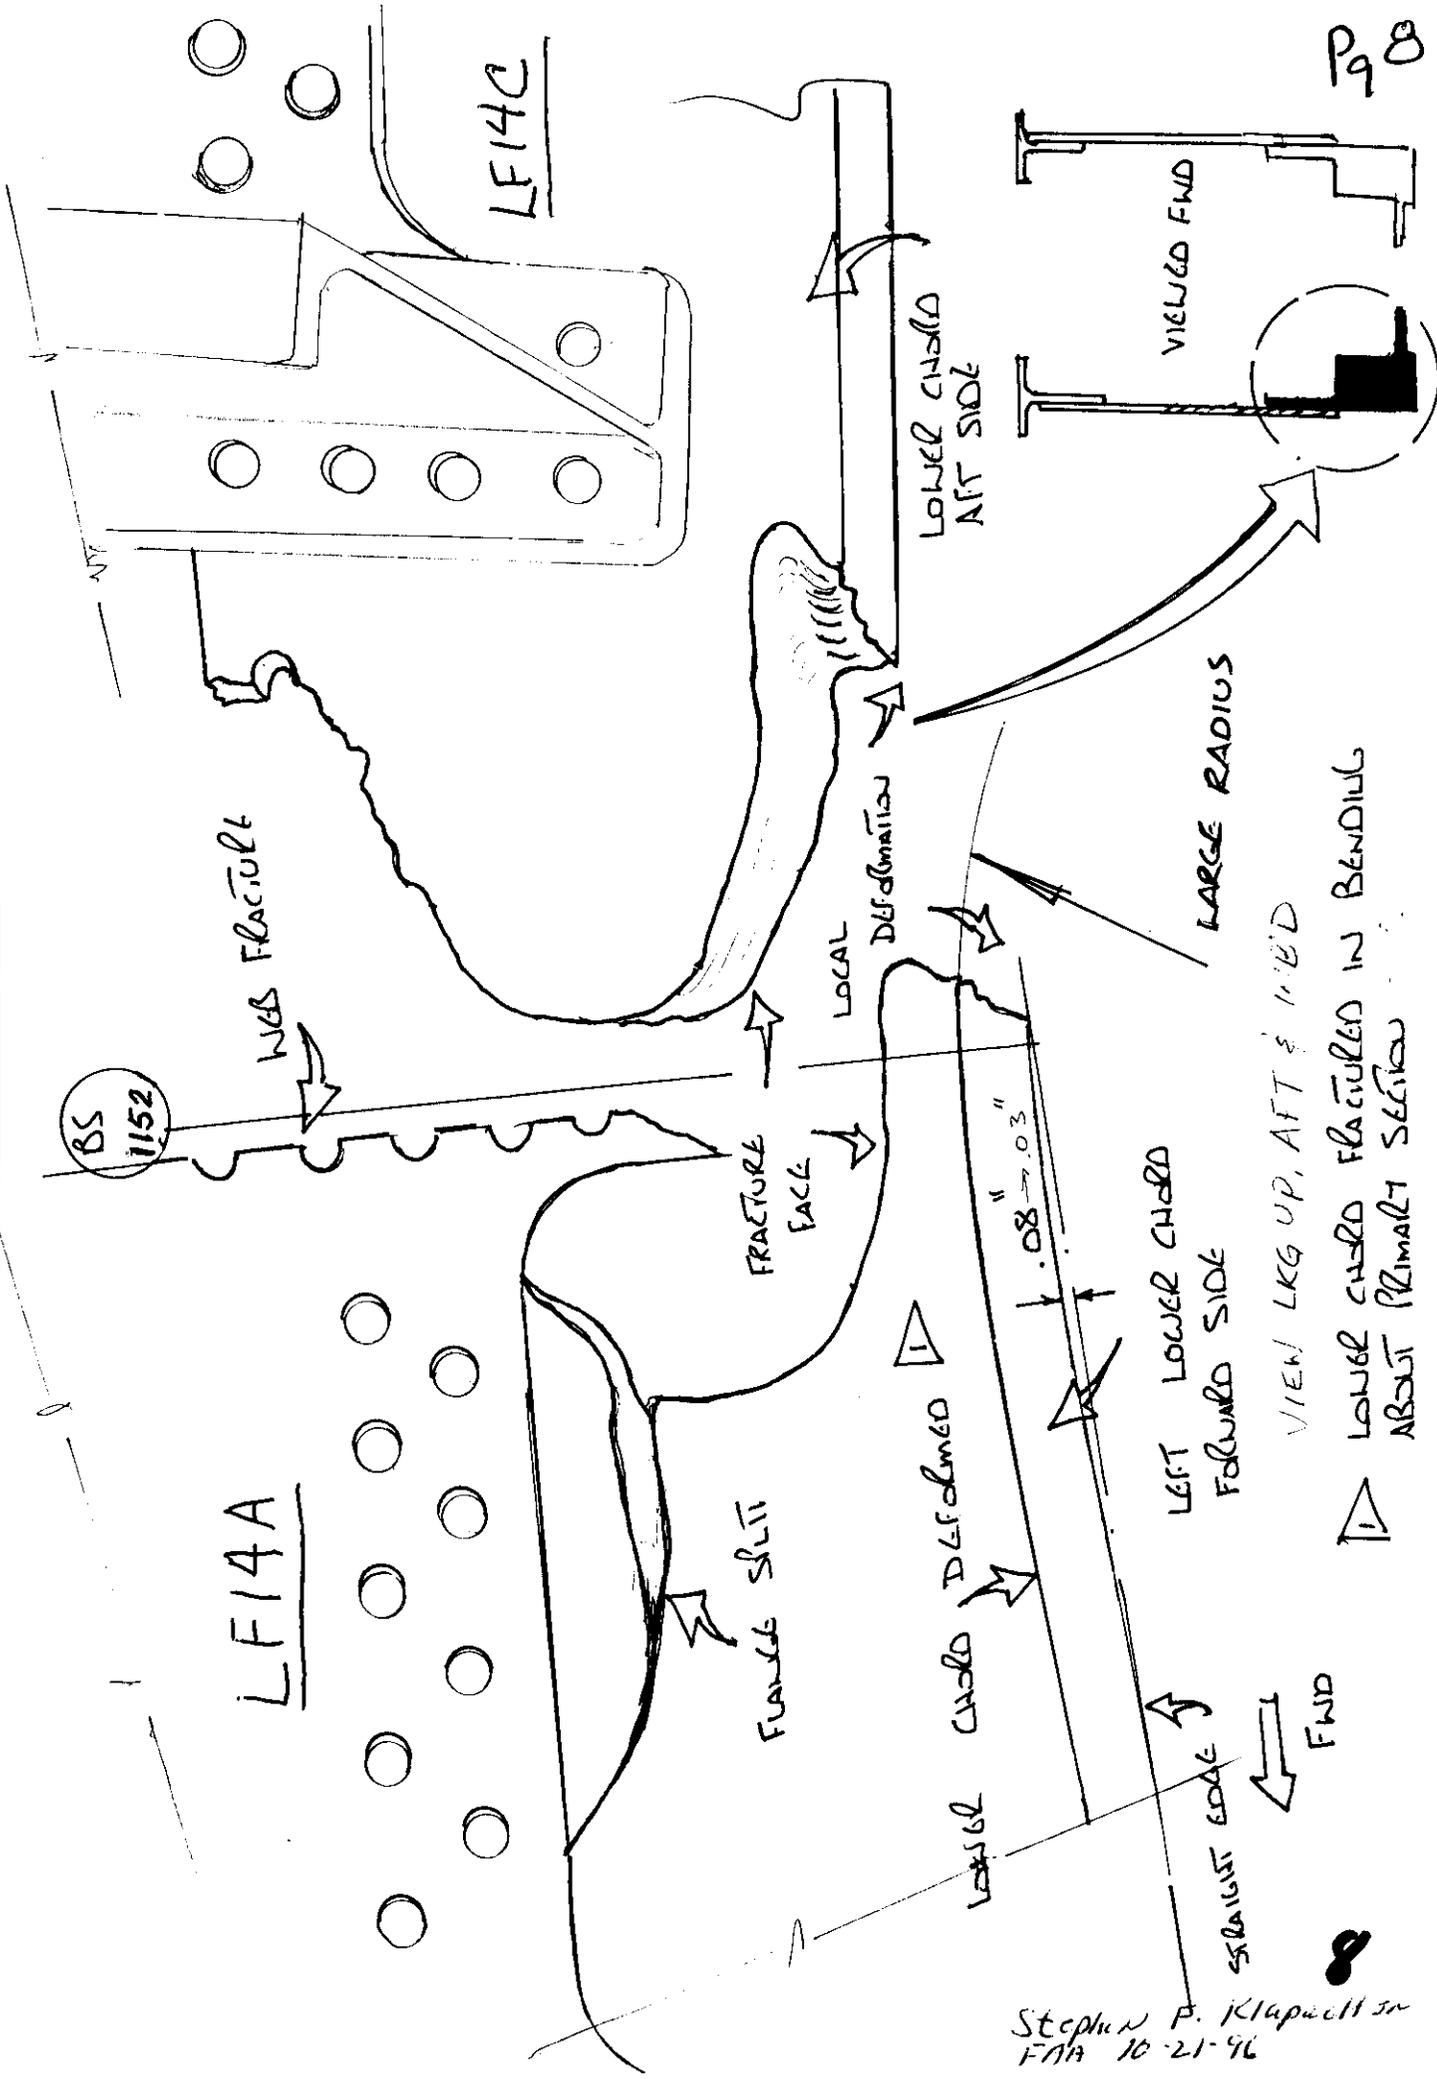
LF14A

LOWER CHORD AFT SIDE

LEFT LOWER CHORD FORWARD SIDE

LOWER CHORD FRACTURED IN BENDING ABOUT PRINCIPAL SECTION

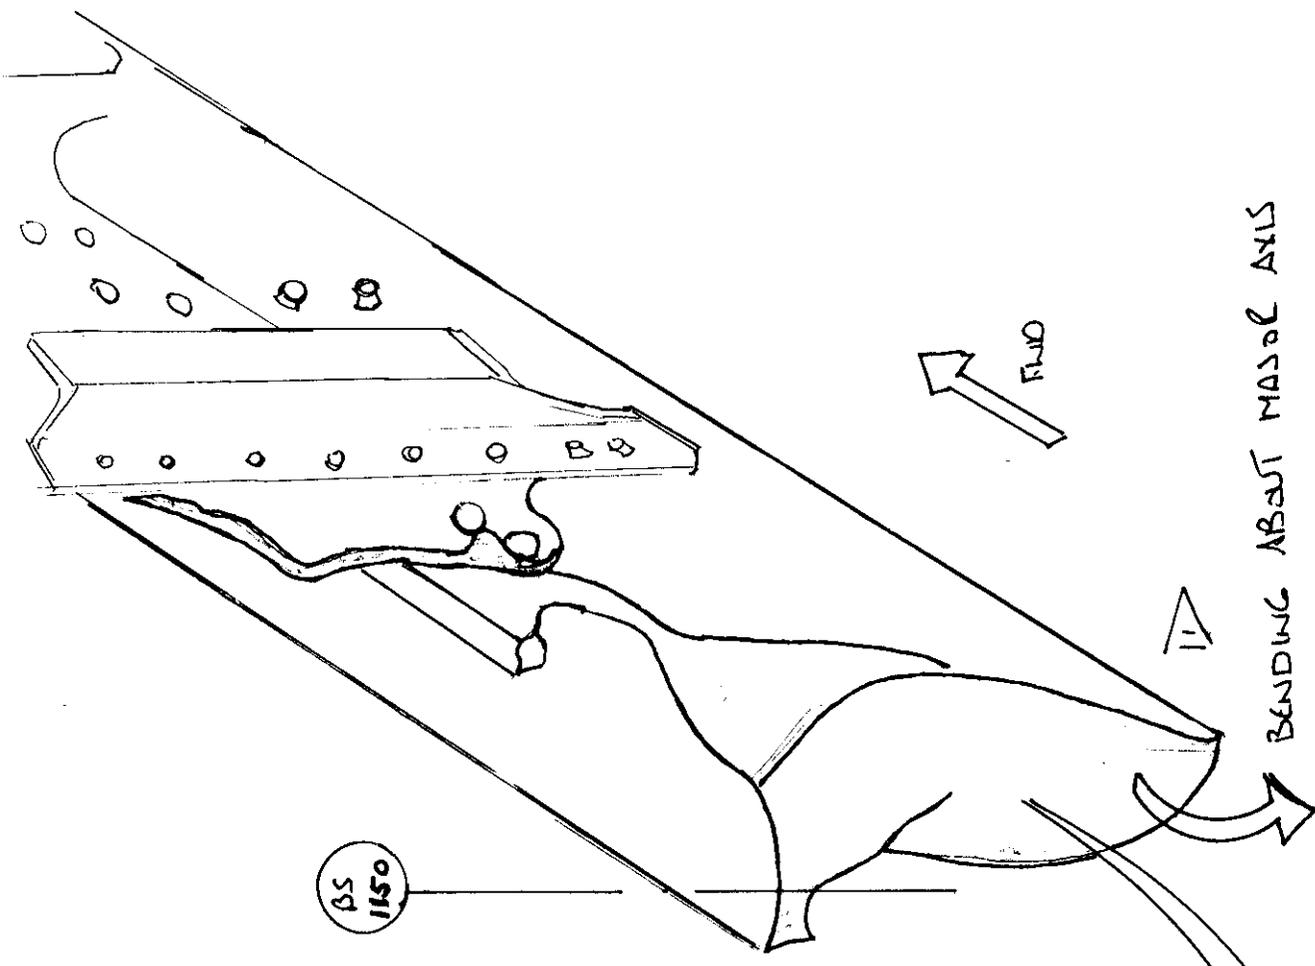
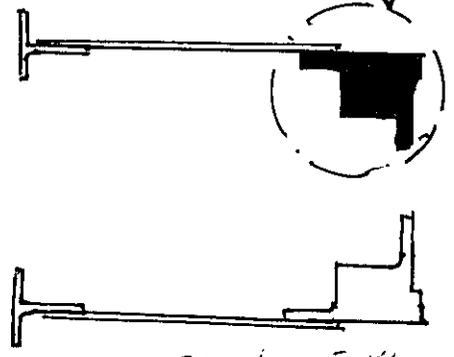
FIG 4.

BENDING ABOUT MASSAL AXIS

FRACTURE PLANE LF-14A
LOWER CHORD (RIGHT SIDE)

▷ SAME AS FIG 1 EXCEPT FRACTURE VIEWED FROM

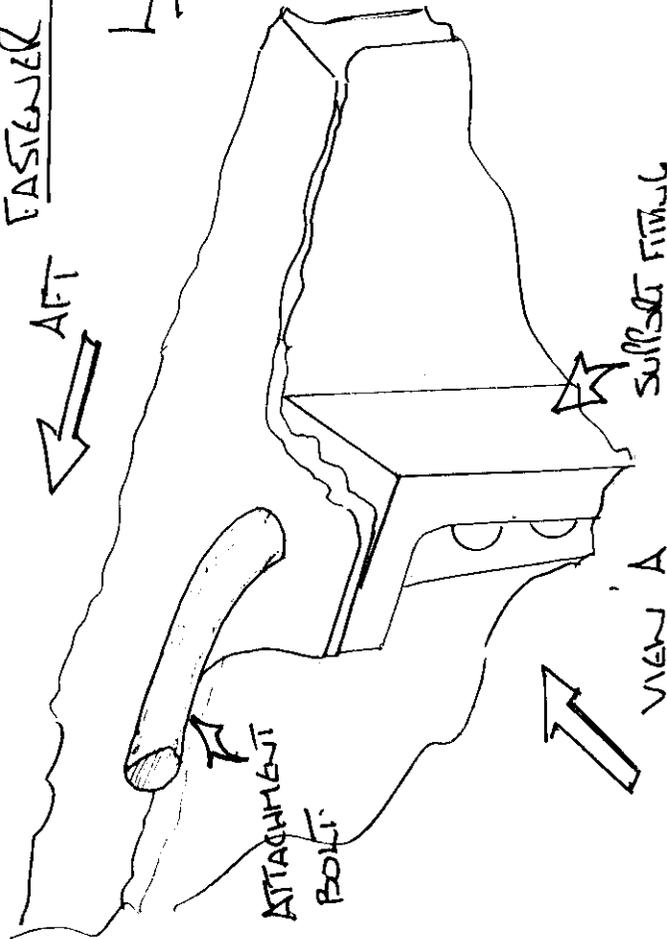
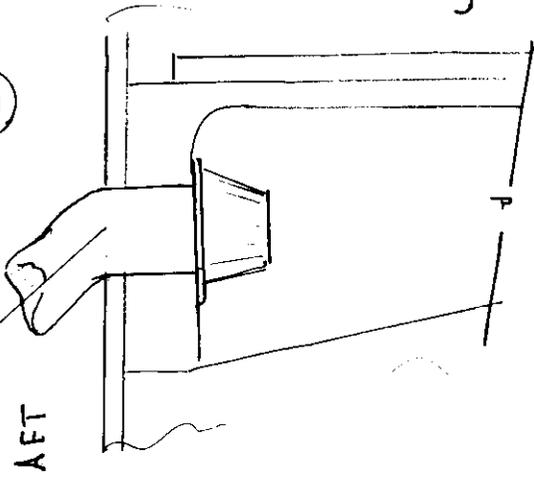
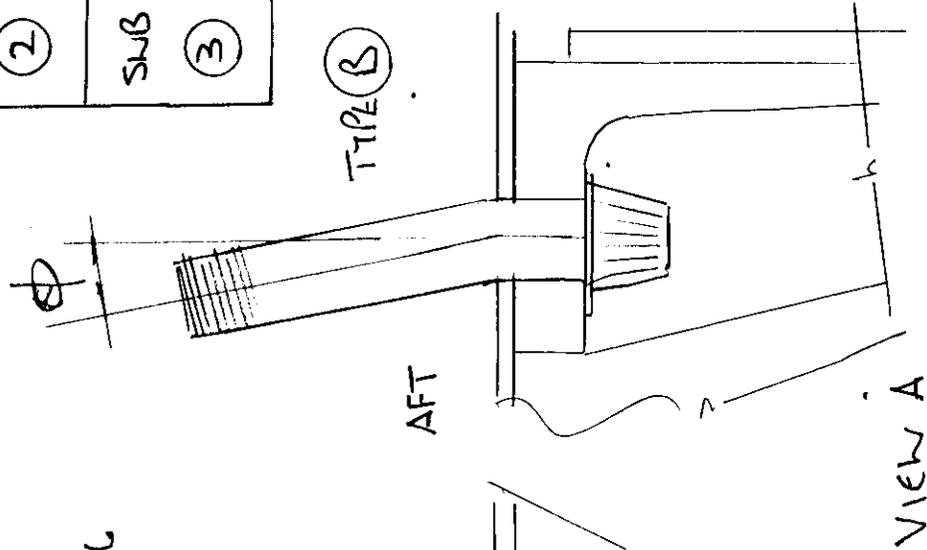
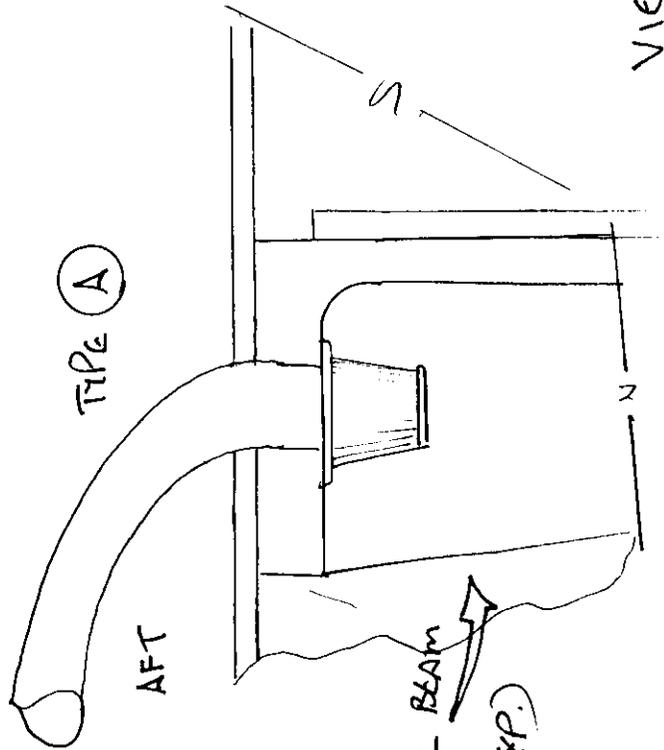
LF-14A

KEEL BEAM TO SPANWISE BEAM ATTACHMENT
EASIER CONDITION

STN	ATTACHMENT POSITION		BOLT CONDITION	
	LI	RI	TYPE	ϕ°
SNB ①	L1	R1	A	-
	LEFT	RIGHT	B	0
SNB ②	L2	R2	A	60
	LEFT	RIGHT	B	8
SNB ③	L3	R3	C	30
	LEFT	RIGHT	B	10

▷ BOLT FITTING MISSING.

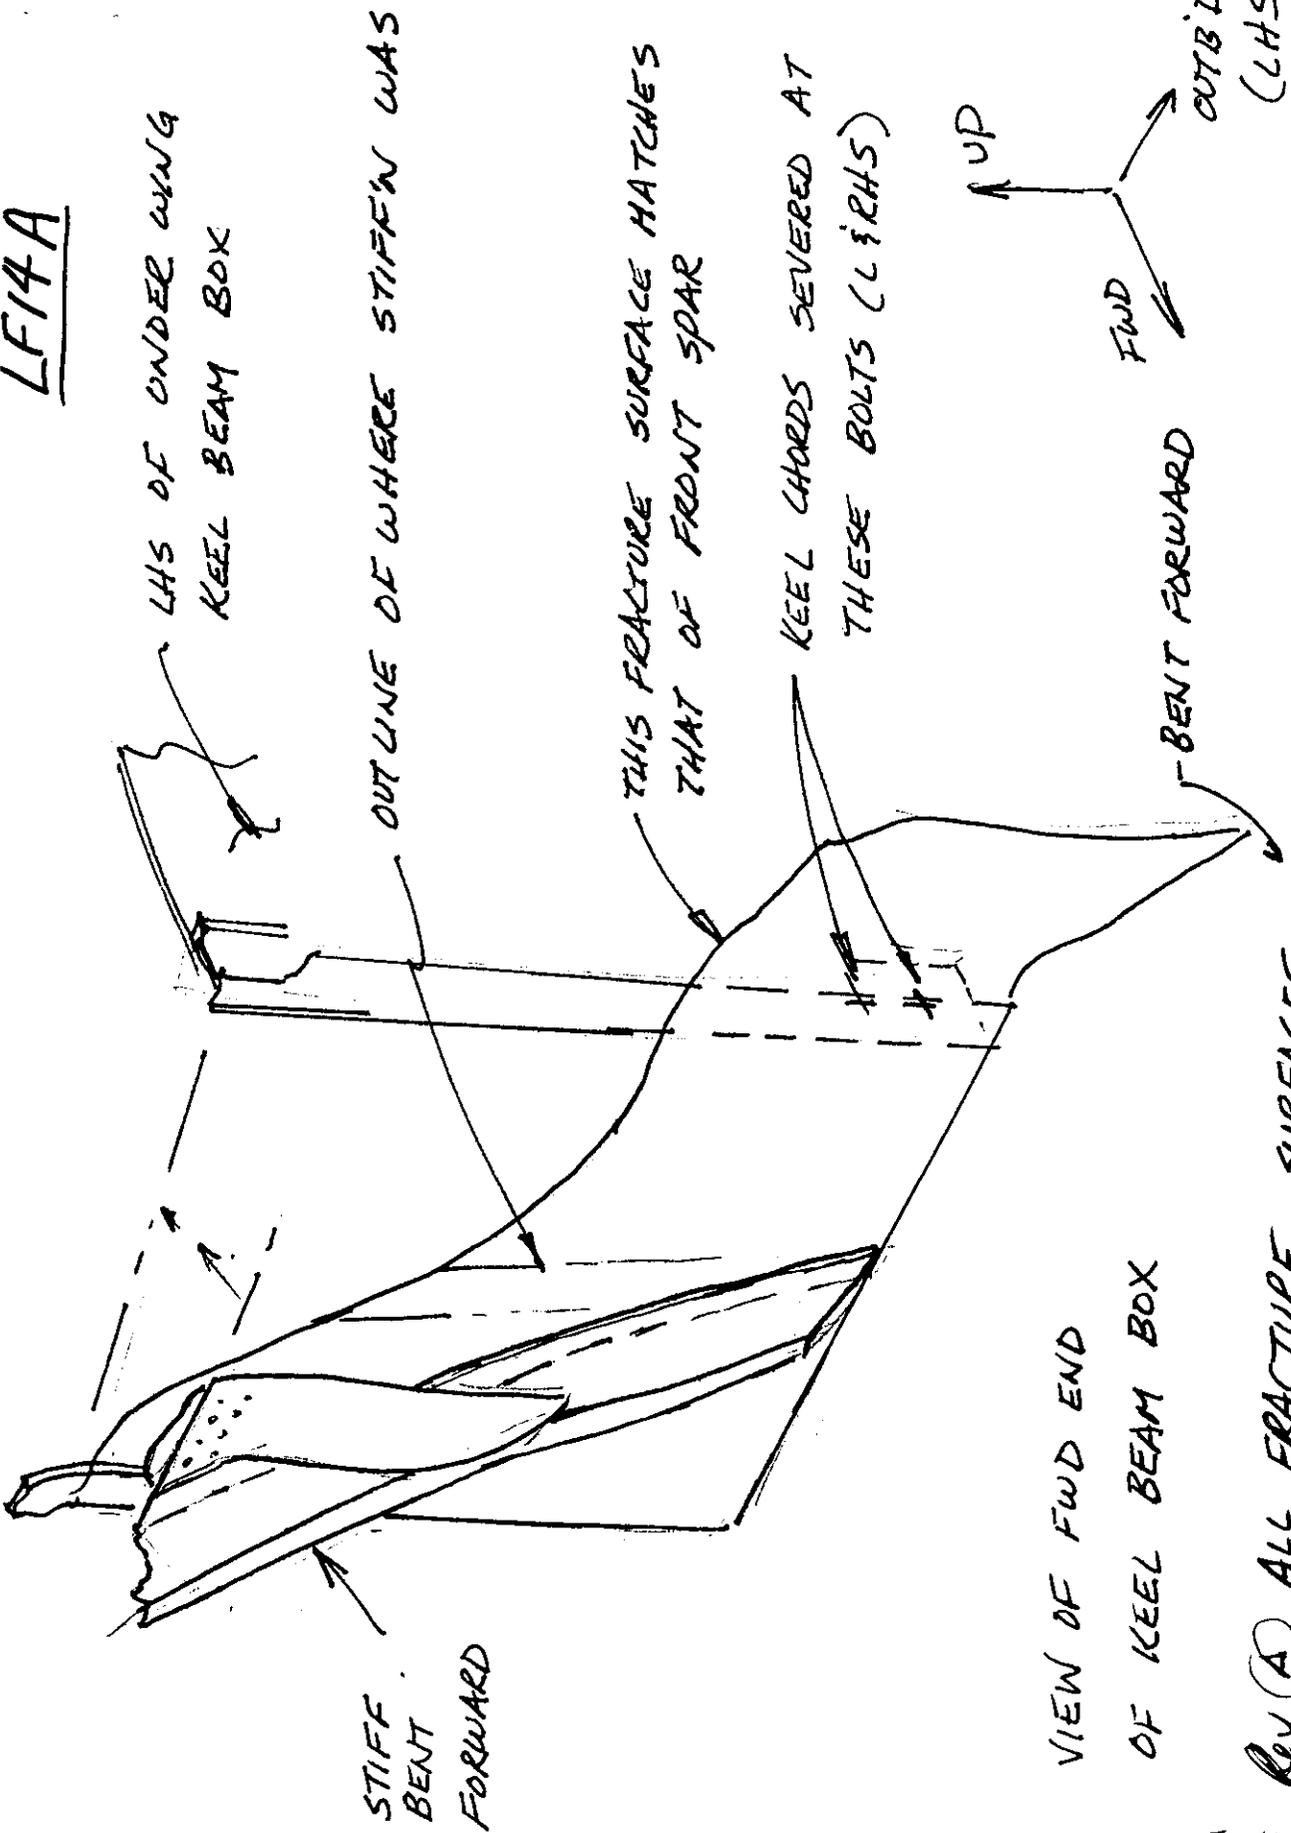
LF14A

VIEW OF FWD END OF KEEL BEAM BOX

REV (A) ALL FRACTURE SURFACES FREE OF SOOT

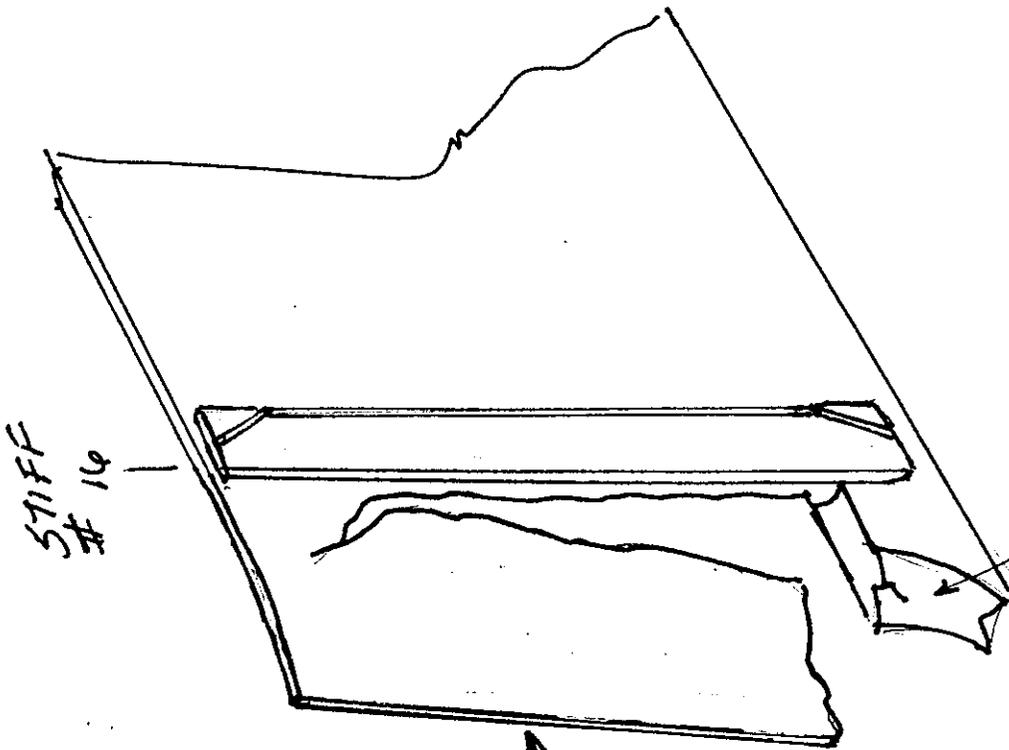
VIEW OF
RHS

KEEP BEAM
WEB BENT
BACK INTO
BOX

FRACTURE FACE OF
KEEP BEAM CHORD
TYP BOTH SIDES
BOTH SURFACES FREE
OF SOOT

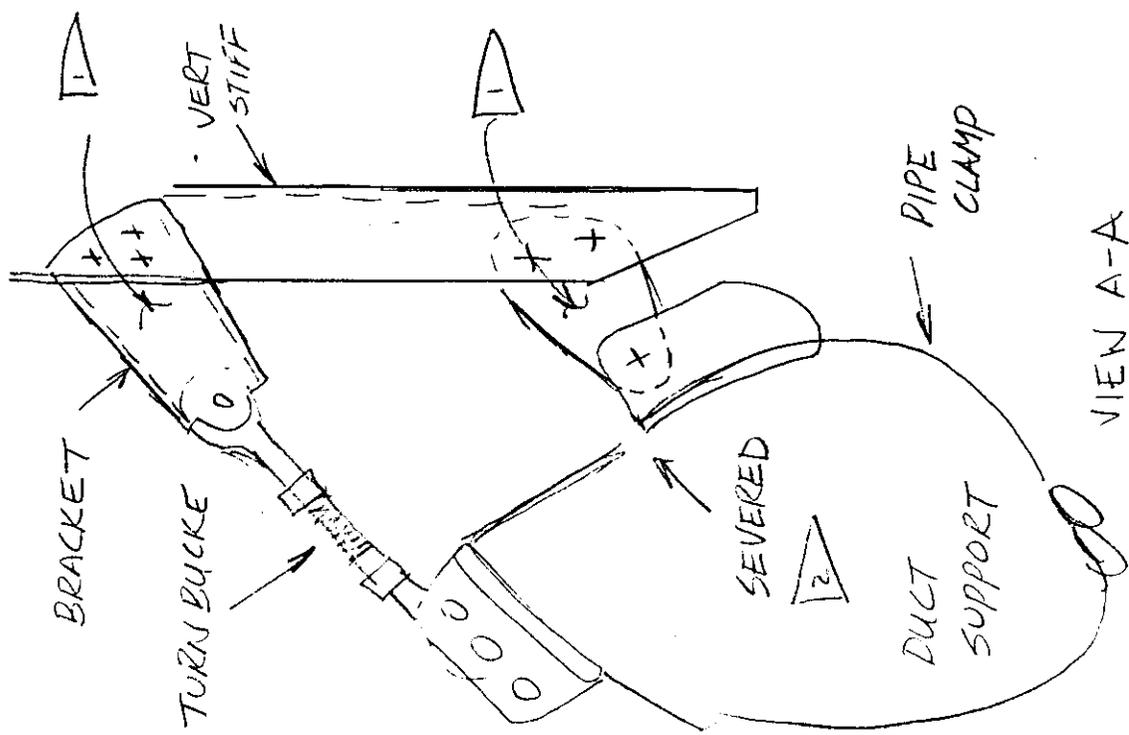
VIEW A-A

- 1 Pushed Fwd
- 2 LOOKS LIKE DUCT WAS PUSHED DOWN & FWD

A-A₁ HAS ONLY 1 UPR BRACKET WITH 2 TURN BUCKLES, UPR TURN BUCKLE IS SEVERED, LWR TURN BUCKLE IS STILL ATTACHED TO PIPE CLAMP. BRACKET ATTACHED TO STIFF HAS BEEN PUSHED FWD. PIPE CLAMP IS SEVERED

A-A₂ 1 UPR BRACKET w/ 1 TURNBUCKLE ATTACHED TO SEVERED PIPE CLAMP BRACKET PUSHED AFT

A-A₃ SIMILAR DESIGN TO A-A
 LWR BRACKET PUSHED FWD
 UPR BRACKET TWISTED ABOUT 10° CLOCKWISE

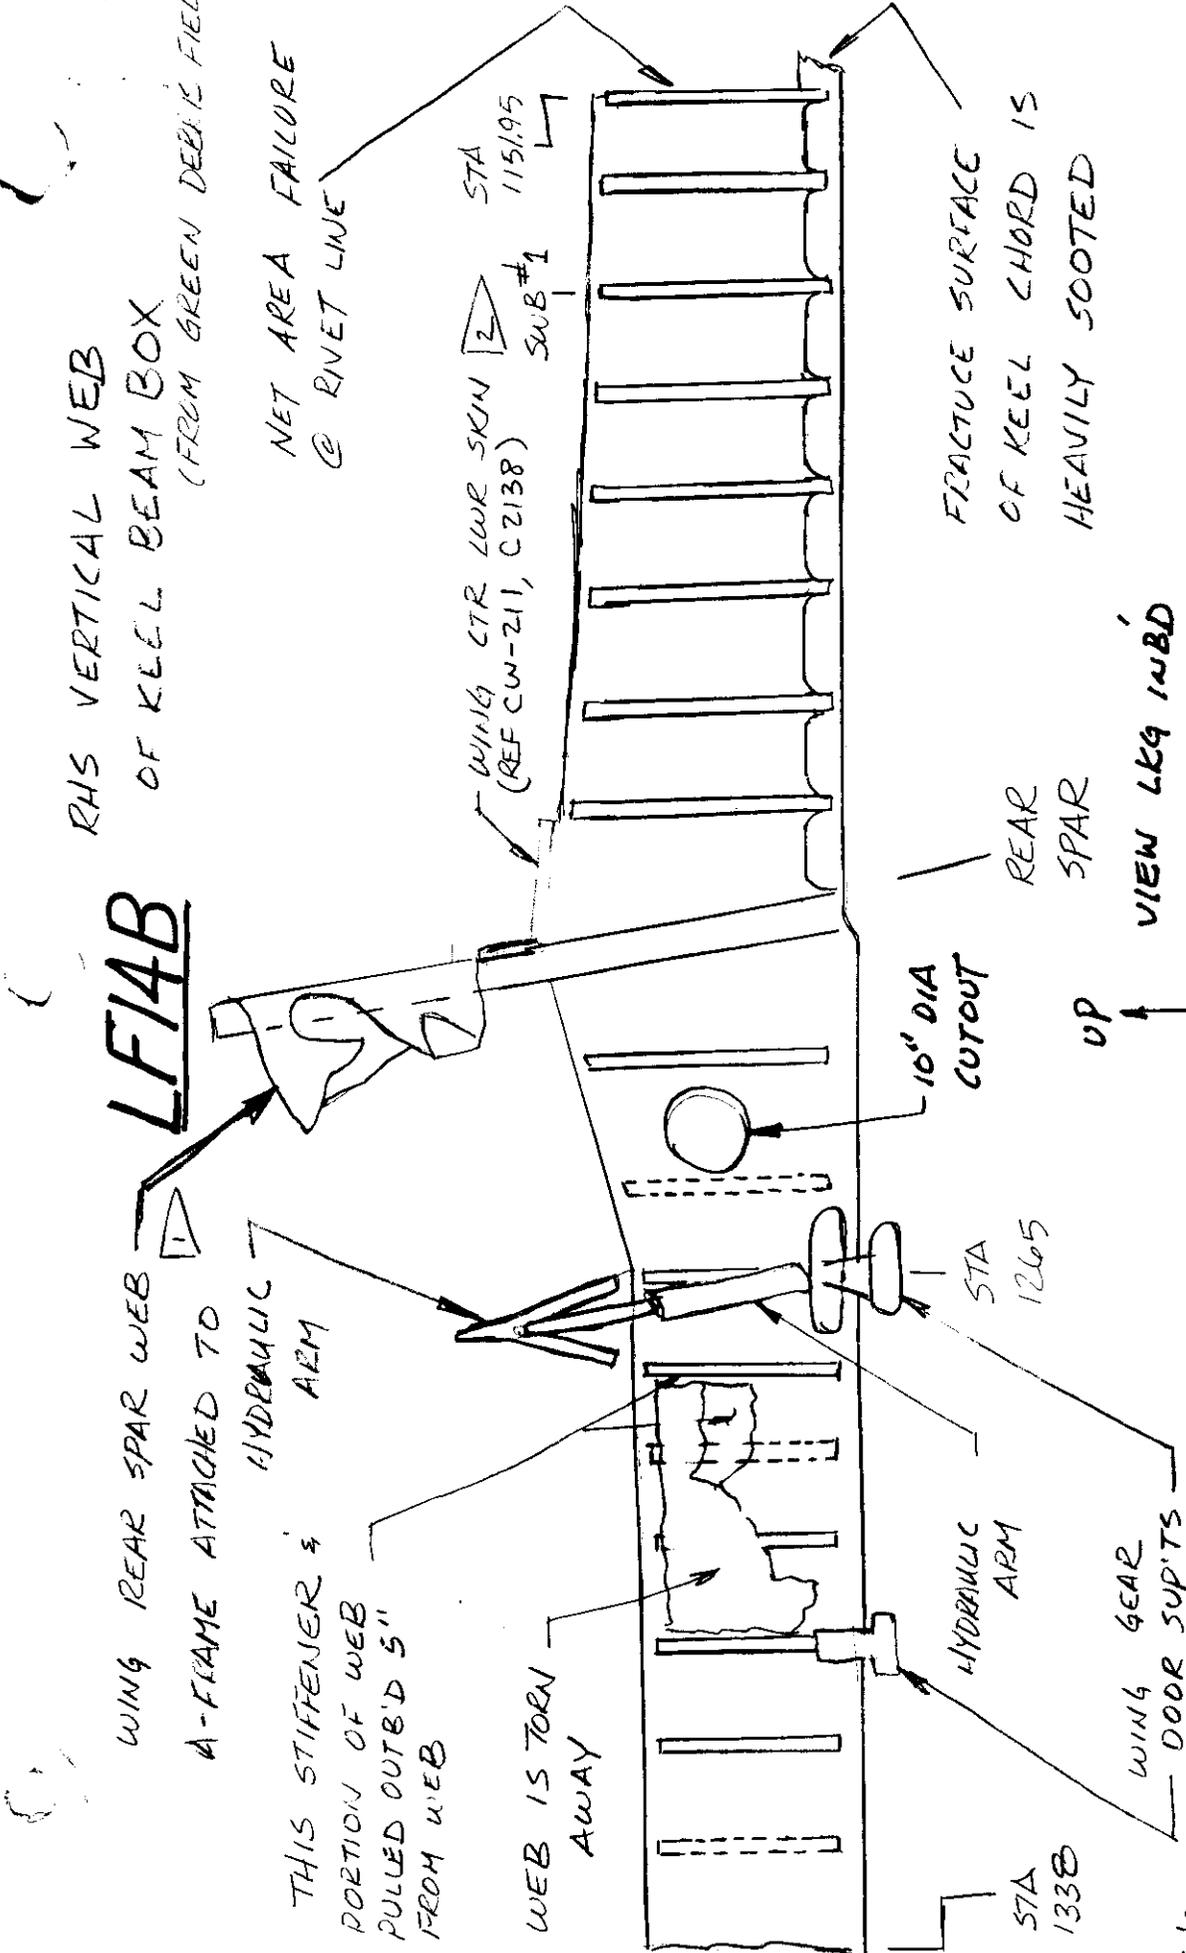
LF14B

RHS VERTICAL WEB
OF KEEL BEAM BOX
(FROM GREEN DEBRIS FIELD)

NET AREA FAILURE
@ RIVET LINE

FRACTURE SURFACE
OF KEEL CHORD IS
HEAVILY SOOTED

THIS STIFFENER &
PORTION OF WEB
PULLED OUT'D 5"
FROM WEB

WEB IS TORN
AWAY

RECEIVED THIS KEEL BEAM BOX IN 2 PIECES, RHS VERTICAL
WEB SHOWN ABOVE

- OUTB'D SURFACE OF KEEL BEAM BOX VERTICAL WEB IS HEAVILY SOOTED FROM REAR SPAR FWD, SOOTING FROM STA 1265 - R/S IS MEDIUM. SOOTING FROM STA 1265 AFT TO END OF PART IS LIGHT

1. FRACTURE SURFACE OF WEB IS SOOTED
2. FRACTURE SURFACE OF VERTICAL LEG OF R/S CHORD IS SOOTED AT LBL 7. FRACTURE SURFACE OF R/S CHORD AT RBL 9 CENTER BOX LWR SKIN IS NOT SOOTED

- THE INBD SURFACE OF THE KEEL BEAM BOX VERTICAL WEB EXHIBITS THE SAME SOOTING TREND AS OUT'D SURFACE BUT TO A LESSER DEGREE. NOTE, THAT FROM STA 1265 TO AFT END OF PART THERE IS ONLY SLIGHT SOOTING - THE GREEN PRIMER IS PREDOMINATE
- THE KEEL BEAM BOX INNER CROSS BRACING STRUCTURE AT STA 1265 & 1330 SEPARATED FROM THE LHS KEEL STRUCTURE.
