LOG # 1071045 SD's  
LF-16 REV A  
 TARGET # \_\_\_\_\_  
 COORD: LAT \_\_\_\_\_  
 LONG \_\_\_\_\_

DEBRIS FIELD GREEN \*

RELATED TO CWZ

LF-16

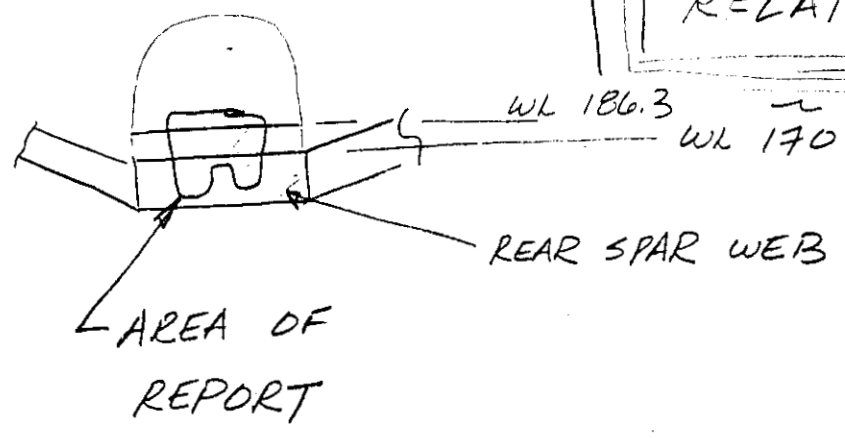
PARTS A & B  
 \* ASSOCIATED w/ DEBRIS FIELD  
 GREEN TAG # C-109

PART C ASSOCIATED w/ DEBRIS FIELD  
 GREEN TAG # C-224

CTR WING SKIN  
SECT'N NOT  
IN HANGER

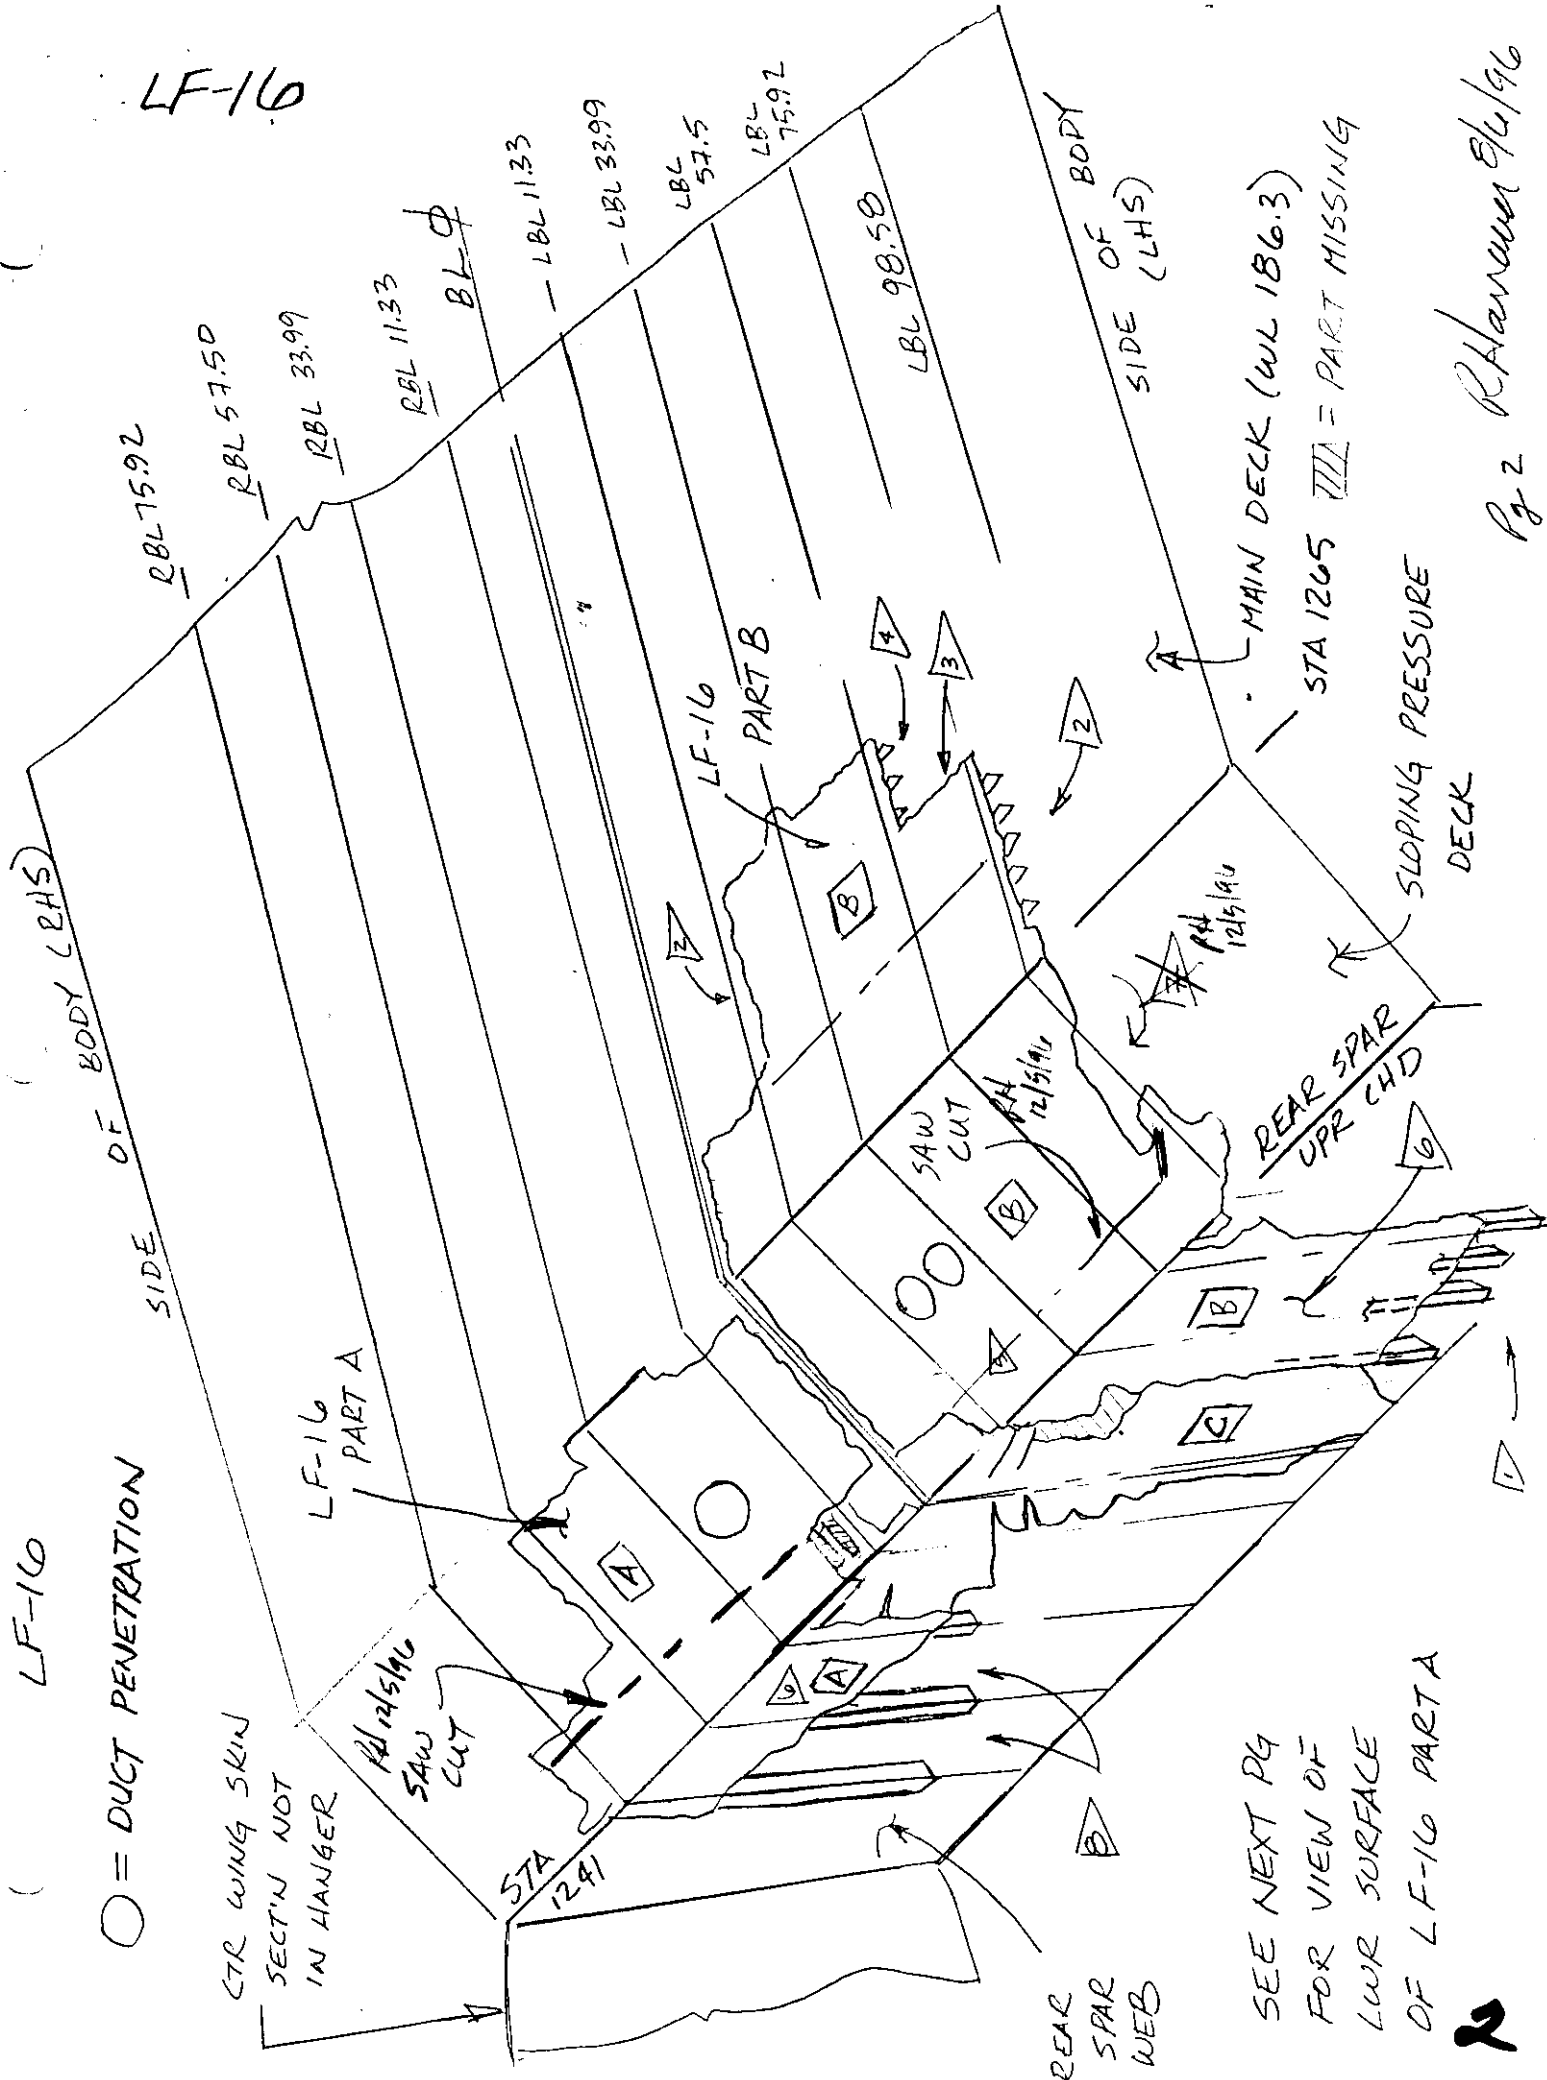
LF-16 PART A (RHS)

VIEW LOOKING UP @ SLOPING DECK

HEAVILY SOOTED  
PAINT PEELING  
OFF STIFFENER  
(BEFORE CUT)

*Left*  
DIRTY/SOOTED

9 THIS SIDE OF STIFF DIRTY/SOOTED NOT NEAR AS BAD AS BL 33 STIFF, OUTB'D SIDE OF STIFF CLEANER, BUT STILL SHOWS SIGN OF SOOT. THE STIFF AT BL 75 IS ABOUT THE SAME AS BL 57.5 STIFF

10 HORIZONTAL STIFF SEVERED @ RBL 70,

UP, ALSO BROKEN AT EXTRU. RADIUS FROM RBL 33 => 70

1 ▷ STIFFENERS @ LBL 21, 33.99, 45, 57.5  
INTACT DN TO LWR CHD / FASTENING FAILURE  
WITH LOWER CHD

2 ▷ 5 TRANSVERSE STIFFENERS SEVERED

3 ▷ NET AREA FAILURE @ RIVET LINE

4 ▷ 3 TRANSVERSE STIFFENERS SEVERED @ CLIP TO  
FLR BM ATTACHM'T

5 ▷ AREA BETWEEN DUCTS & R/S UPR CHORD SHOWS  
SIGN OF SOOT (~~WHICH COULD BE DUE TO SERVICE~~)  
REST OF SLOPING DECK / MAIN DECK DIRTY  
W/ LPS-3

6 ▷ FWD FACE OF REAR SPAR WEB EXTREMELY  
CLEAN - ~~ALSO TRUE FOR RAS~~ FOR PARTS A & B

7 ▷ UNDER SIDE OF SLOPING DECK, MAIN DECK  
LOOK AS CLEAN AS CAN BE EXPECTED  
AFTER 25 YEARS SERVICE FOR PARTS A & B

8 ▷ MISSING STIFFENERS (2 PLACES)

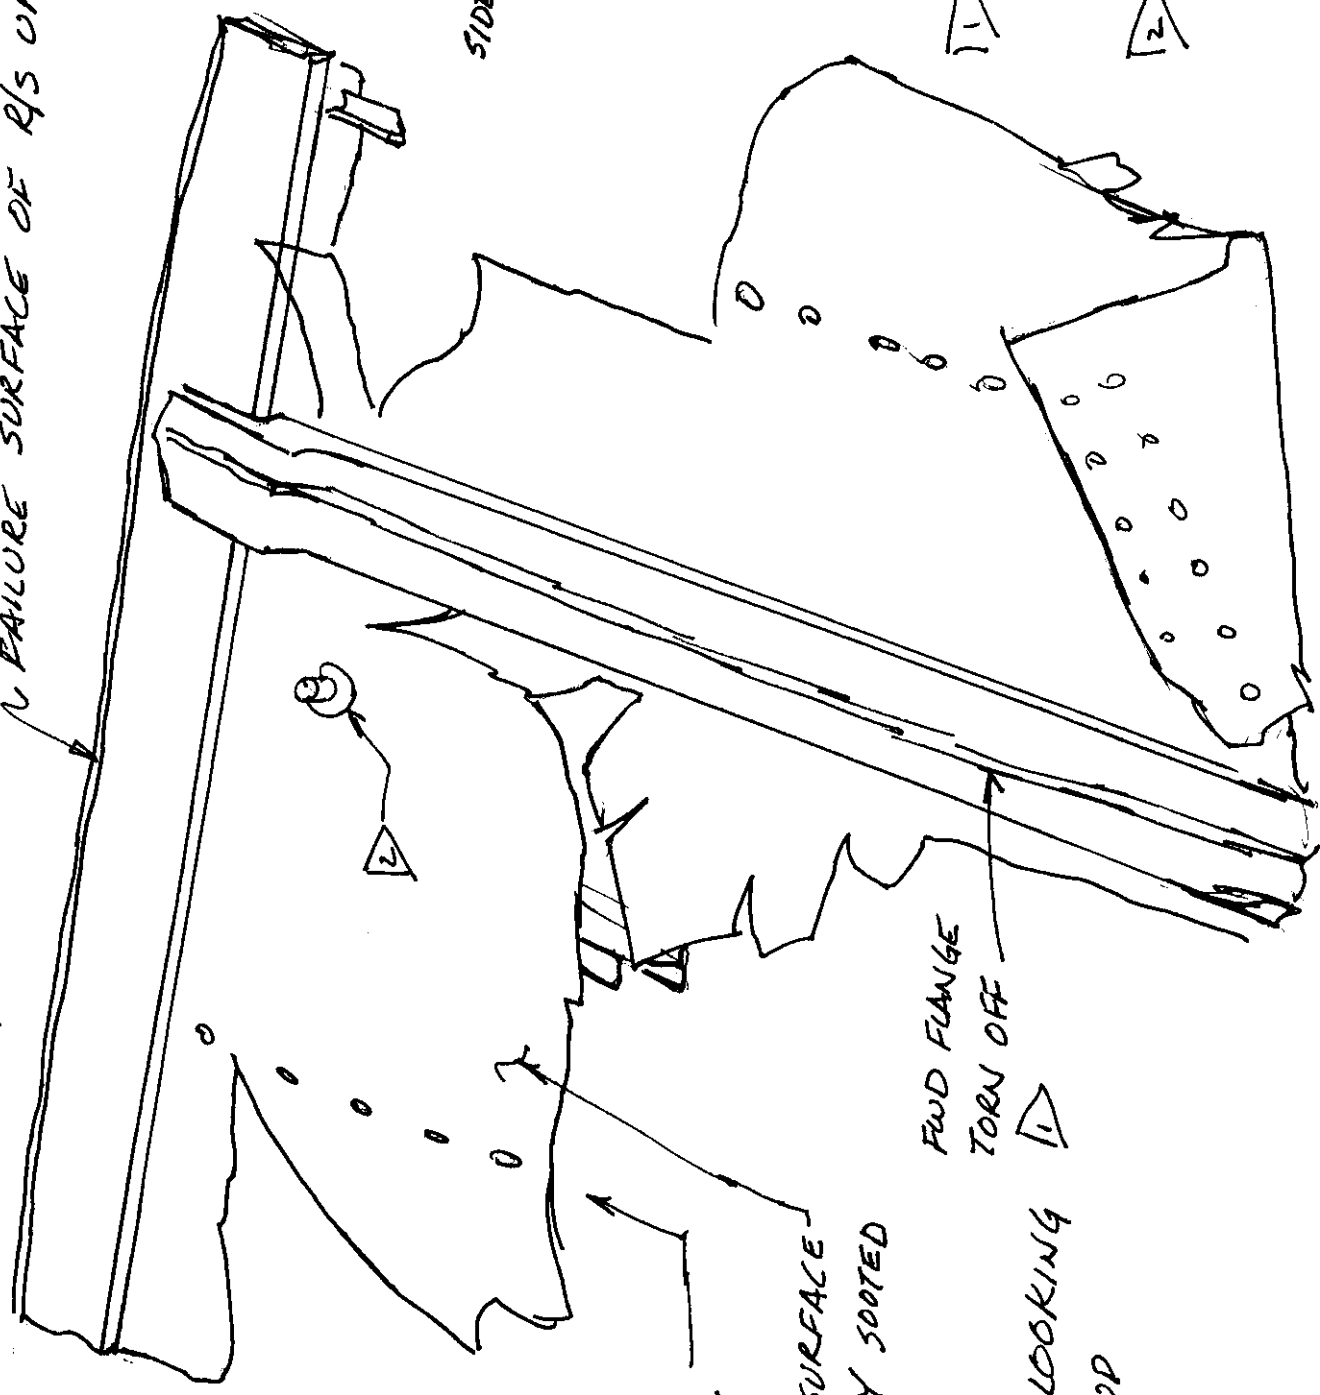
LF-16  
PART C

FAILURE SURFACE OF R/S UPR CHORD

1) SIGNS OF TENSION FAILURE  
 2) APU FUEL LINE

MISSING STIFF  
 ENTIRE SURFACE EXTREMELY SORTED

FWD FLANGE TORN OFF

VIEW LOOKING AFT & UP
