LOG # LF 17  
TARGET # C-109  
COORD: LAT \_\_\_\_\_  
LONG \_\_\_\_\_

DEBRIS FIELD GREEN

LOG# LF-17  
TAG: C-109 (GREEN)

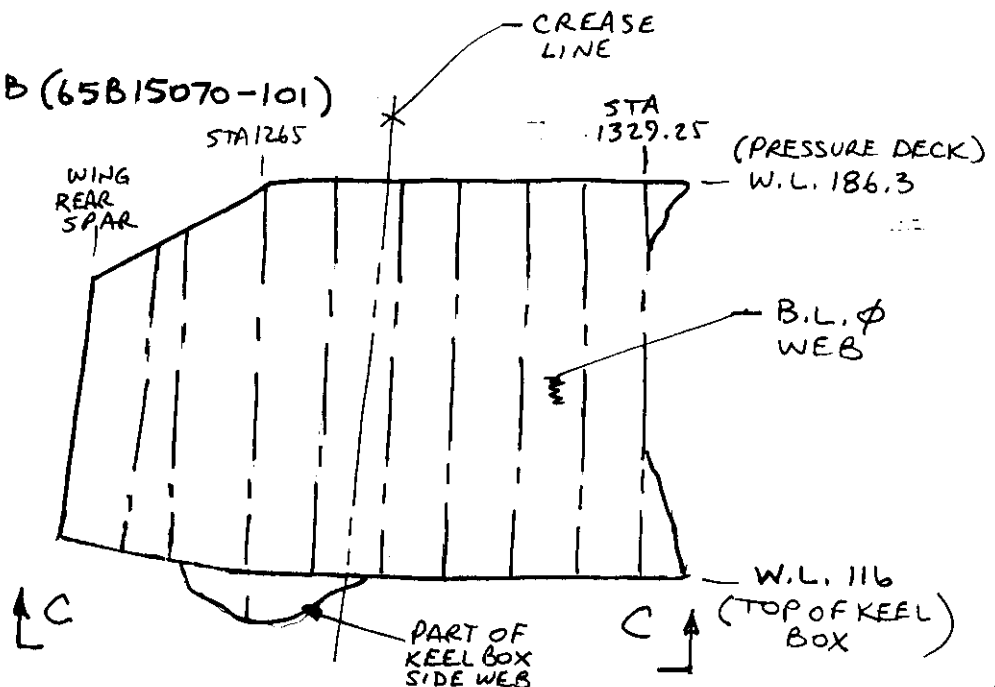
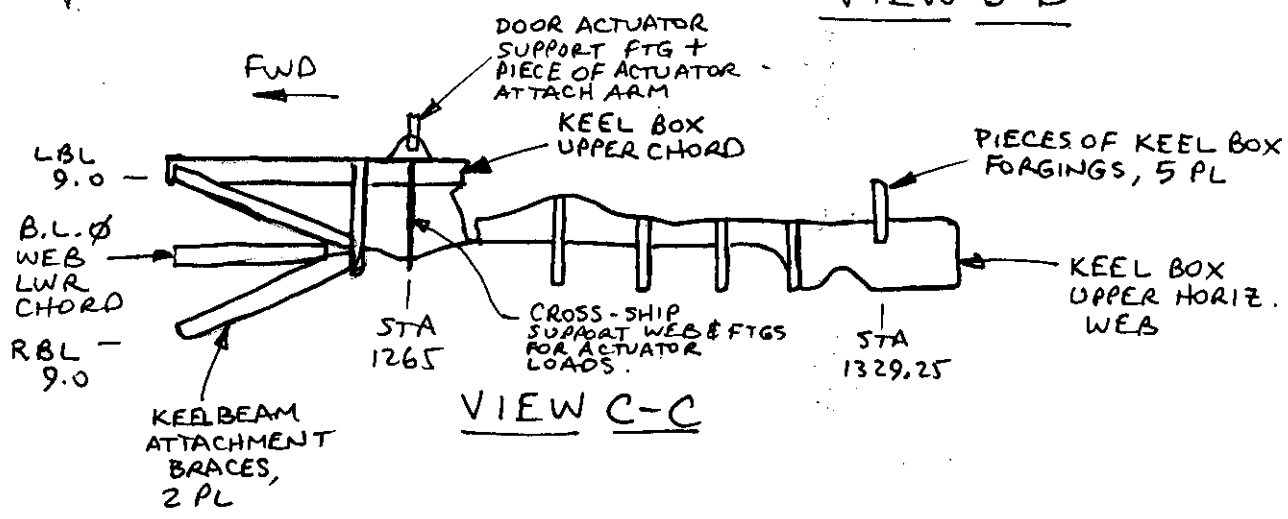
STRUCTURE IS PART OF THE B.L.  $\phi$  KEEL BEAM CENTER WEB EXTENDING FROM STA 1241 (REAR SPAR OF WING BOX) AFT TO STA  $\sim$ 1330, AND FROM THE PRESSURE DECK AT W.L. 186.3 DOWN TO W.L. 116 (TOP OF KEEL BEAM BOX). PARTS OF THE KEEL BOX UPPER SURFACE REMAIN ATTACHED, AS WELL, INCLUDING A PORTION OF THE BOX UPPER WEB, BOX VERTICAL WEB (LEFT SIDE, FROM STA  $\sim$ 1255 TO STA  $\sim$ 1277) WITH THE MAIN LANDING GEAR DOOR ACTUATOR SUPPORT FTG (LHS) AT STA 1265, WITH A PORTION OF ITS BACK-UP INTERCOSTAL AND FITTINGS. A PIECE OF ACTUATOR SUPPORT ARM REMAINS ATTACHED TO THE SUPPORT FITTING. REMNANTS OF KEEL BOX UPPER FORGINGS REMAIN ATTACHED IMMEDIATELY BELOW THE BOX UPPER WEB AT STATIONS  $\sim$ 1287,  $\sim$ 1301,  $\sim$ 1307,  $\sim$ 1319 AND  $\sim$ 1329. A PORTION OF THE KEEL BOX UPPER CHORD, LBL 9.0, REMAINS FROM  $\sim$ STA 1235 TO  $\sim$ 1277. FROM STA  $\sim$ 1235 TO STA  $\sim$ 1255, ON THE ~~KEEL~~ KEEL BOX SLOPING UPPER SURFACE, REMAIN THE TWO KEEL BEAM ATTACHMENT BRACES (SEE SKETCH) AND THE B.L.  $\phi$  LWR CHORD.

THE B.L.  $\phi$  WEB ASSEMBLY IS BENT AS SHOWN IN THE SKETCH ALONG A LINE RUNNING FROM STA  $\sim$ 1283 AT THE TOP (W.L. 186.3) TO STA  $\sim$ 1281 AT THE BOTTOM (W.L. 116). THE BEND IS APPROXIMATELY 110°, WITH THE AFT PART OF THE WEB ASSY BENT OUTBOARD TO THE LEFT.

A PIECE OF TOILET DRAIN TUBE REMAINS ATTACHED TO THE WEB ASSY AT STA 1265, W.L.  $\sim$ 174, BY A DUCT CLAMP. THE DUCT REMNANT IS ABOUT EIGHT FEET LONG AND IS ATTACHED TO THE RIGHT HAND SIDE.

A LENGTH OF APU PNEUMATIC DUCT REMAINS ATTACHED TO THE WEB ASSY ON THE LEFTHAND SIDE AT STA 1265, W.L.  $\sim$ 146. ITS LENGTH IS ABOUT EIGHT FEET AND THE DUCT IS CRUSHED AND ALMOST BROKEN IN TWO AT ABOUT THREE FEET FROM ONE END.

A CONSIDERABLE AMOUNT OF HYDRAULIC TUBING REMAINS ATTACHED TO THE WEB ASSY, THE MAJORITY OF IT BEING LOCATED ON THE RIGHT HAND SIDE OF THE WEB. IN ADDITION, THE AIRPLANE'S LATERAL CONTROL MECHANISMS REMAIN ENTANGLED WITH THE B.L.  $\phi$  WEB ASSY, HELD BY CONTROL CABLES, <sup>LINKAGE</sup> AND HYDRAULIC TUBING WHICH'S PASSES THROUGH THE WEB AT VARIOUS ~~PENETRATION~~ PROVISIONS LOCATIONS.
