STA 1350 LHS  
LANDING GEAR BEAM

LOG # LF181

Pg 1 of 3

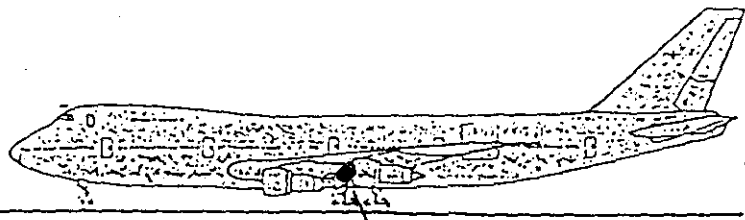
ONLY THESE TWO PARTS CAME INTO THE HANGER STILL ATTACHED TO ONE ANOTHER

- HORIZONTAL BEAM ON FWD SIDE OF BULKHEAD IS ATTACHED TO LBL 70, WEB IS TORN INB'D OF LBL 98 APPROX.
- WING GEAR SIDE STRUT SUPPORT FT4 & 3' LONG STRUT ARE ATTACHED.
- LOWER CHORD OF LANDING GEAR BEAM IS BROKEN OFF FOR 16" OUTB'D OF LBL 75 SPLICE.
- SPLICE PLATE FOR LOWER LONGERON CHORD IS ATTACHED & BENT UPWARDS
- STARTING AT THE CUTOUT FOR THE WING LANDING GEAR TRUNION, THE WEB IS TORN FROM OUTB'D EDGE OF CUTOUT TO 18" OUTB'D APPROX.
- VIRTUALLY ALL VERTICAL STIFFENERS ARE BUCKLED

- A 'V' SHAPED TEAR THRU THE BEAM AT LBL 105 APPROX  
- SEE SKETCH
- WEB OF BEAM IS TORN JUST BELOW UPR CHORD FROM LBL 103 TO LBL 130, WHERE THE TEAR GOES DOWN DIAGONALLY THEN DOWN VERTICALLY AT LBL 127 TERMINATING AT 4" ABOVE LWR CHD
- ALL VERTICAL STIFFENERS ARE BUCKLED

- AT 62" OUTB'D OF WING LANDING GEAR TRUNION SUPPORT CUTOUT THERE IS MAJOR DAMAGE TO BOTH B&D PARTS. DAMAGE APPEARS AS IF SUPERMAN THREW A BASKETBALL THRU BOTH BEAMS IN THE AFT DIRECTION. AREA THE SIZE OF A VOLLEY BALL IS MISSING FROM THE LF181B PART. THE MATERIAL ON THE AFT PART (LF181D) IS SPLAYED AFT WITH A TEAR RUNNING INB'D FOR 23". STILL MISSING MATERIAL FROM AFT PIECE ABOUT 1/2 THE SIZE OF PIECE MISSING FROM FWD BEAM.
- ALL VERTICAL STIFFENERS ARE BUCKLED. ON LF181D, THE WEBS ARE PILLOWED OUT OF PLANE.
