RIGHT ~~LEFT~~ FORWARD NOSE  
LANDING GEAR DOOR  
DOOR ACTUATION ROD

LF192

A-731  
(RED)

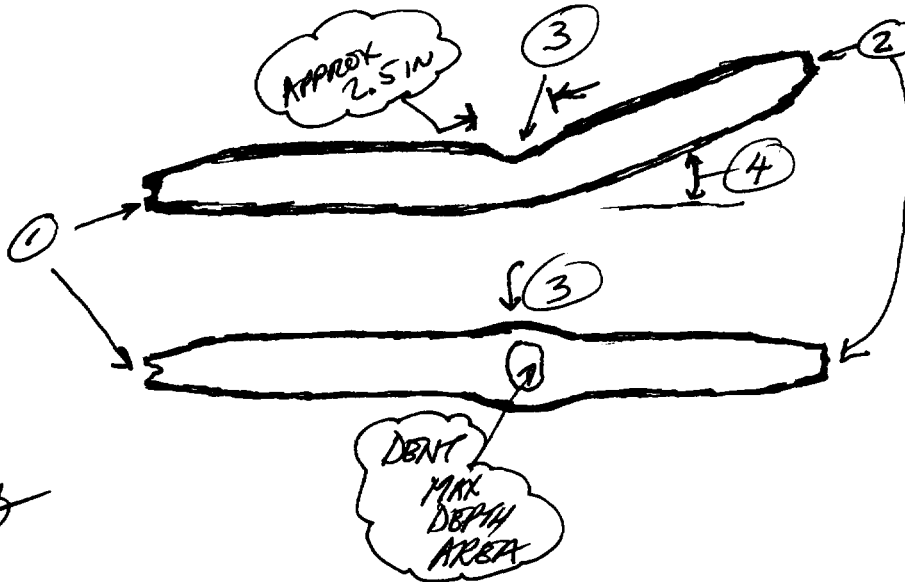
- ROD FRACTURED AT EACH END
- ① - UPPER END FRACTURED CIRCUMFERENTIALLY THROUGH EACH OF FOUR HOLES FOR END FITTING. FRACTURE INDICATES PRIMARILY A TENSION FAILURE.
- ② - LOWER END FRACTURED CIRCUMFERENTIALLY ADJACENT TO THREADED AREA. FRACTURE INDICATES PRIMARILY TENSION FAILURE WITH SOME BENDING.
- ③ - ROD HAS A DENT LOCATED 16.5 IN BELOW UPPER END. MAXIMUM DEPTH OF DENT IS APPROXIMATELY .6 IN. IMPACT MARKS ARE LOCATED IN THE DENT AREA.
- ④ - ROD IS BENT ABOUT THE DENT AREA APPROXIMATELY 15°.
