LOG # LF-20 ⁵⁰⁶ _{275 10-7-96}

DEBRIS FIELD #2

Aft 41 and Fwd 42 Belly Skins

STA 440 → 580, S-42L → 37R

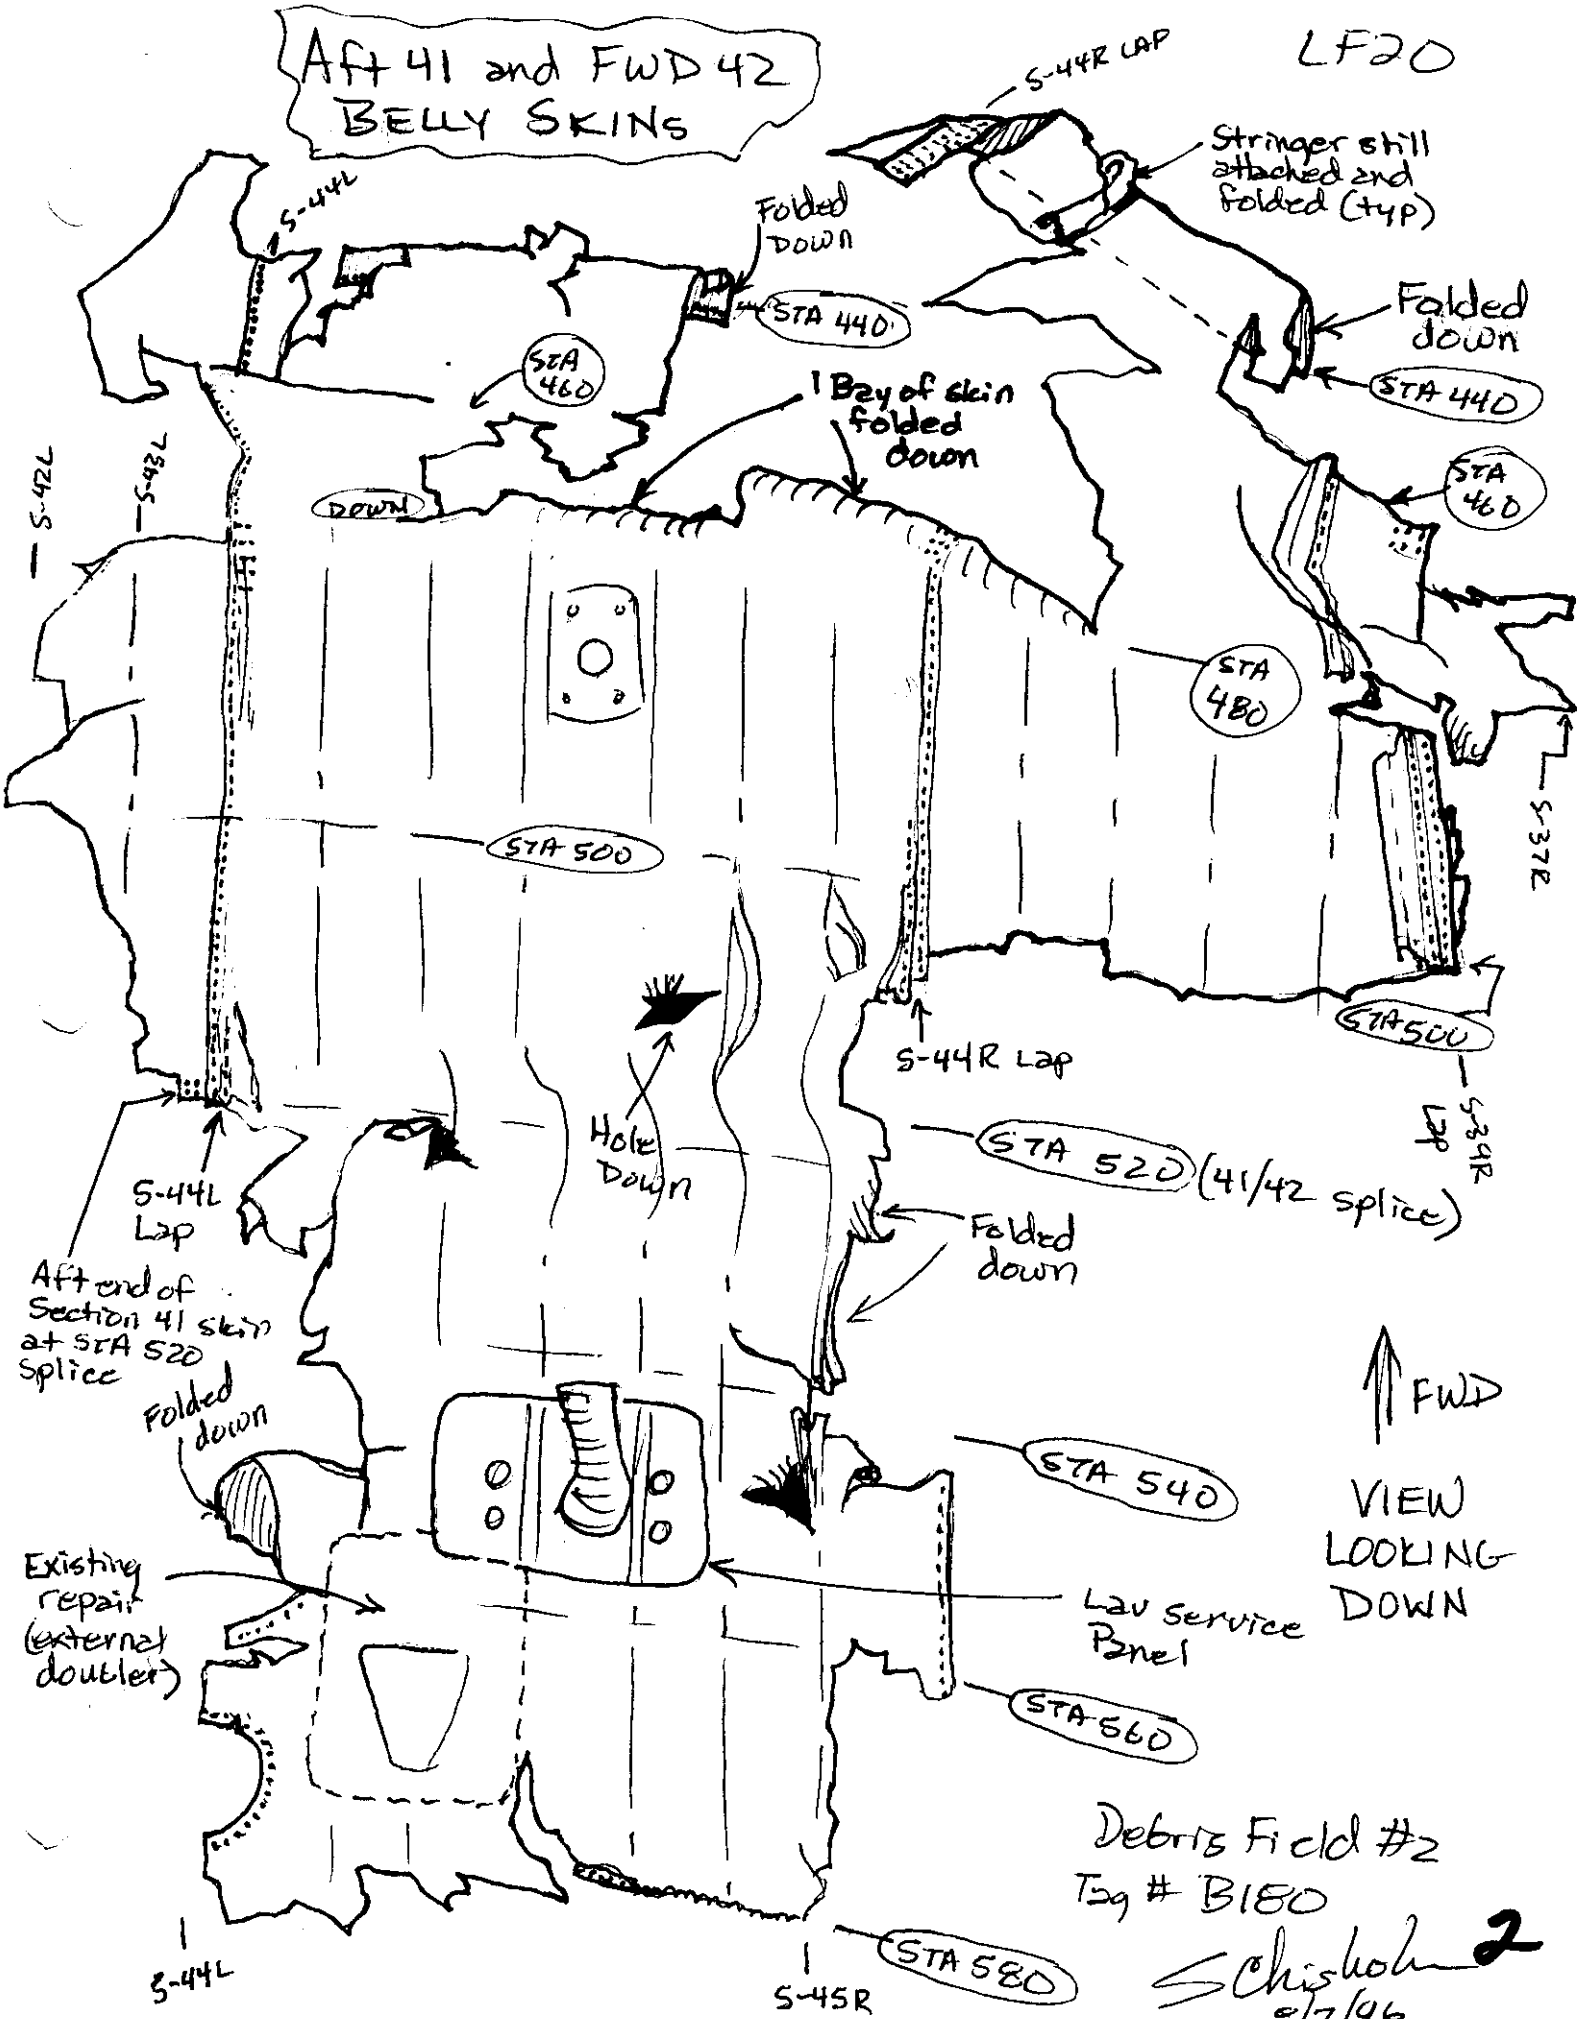
LF20

Skin panel very deformed.

See next sheet for plan view of skin Assy. Most

stringers are still attached and

somewhat flattened against the skin.

No frame segments remain attached. Most edges on

segment are bent downward. The lav service panel between STA 540/560 is still in place. The panel outer skin is pushed upward into the service panel.

Large portion of cargo container (R1) recovered in same load. No evidence of burn damage.
