LOG # LF 126
 TAG TARGET # Z 3205
 COORD: LAT _____
 LONG _____

LBL 75.92 LONGITUDINAL FLOOR BEAM
 FROM STA 1290 TO STA 1318

DEBRIS FIELD GREEN

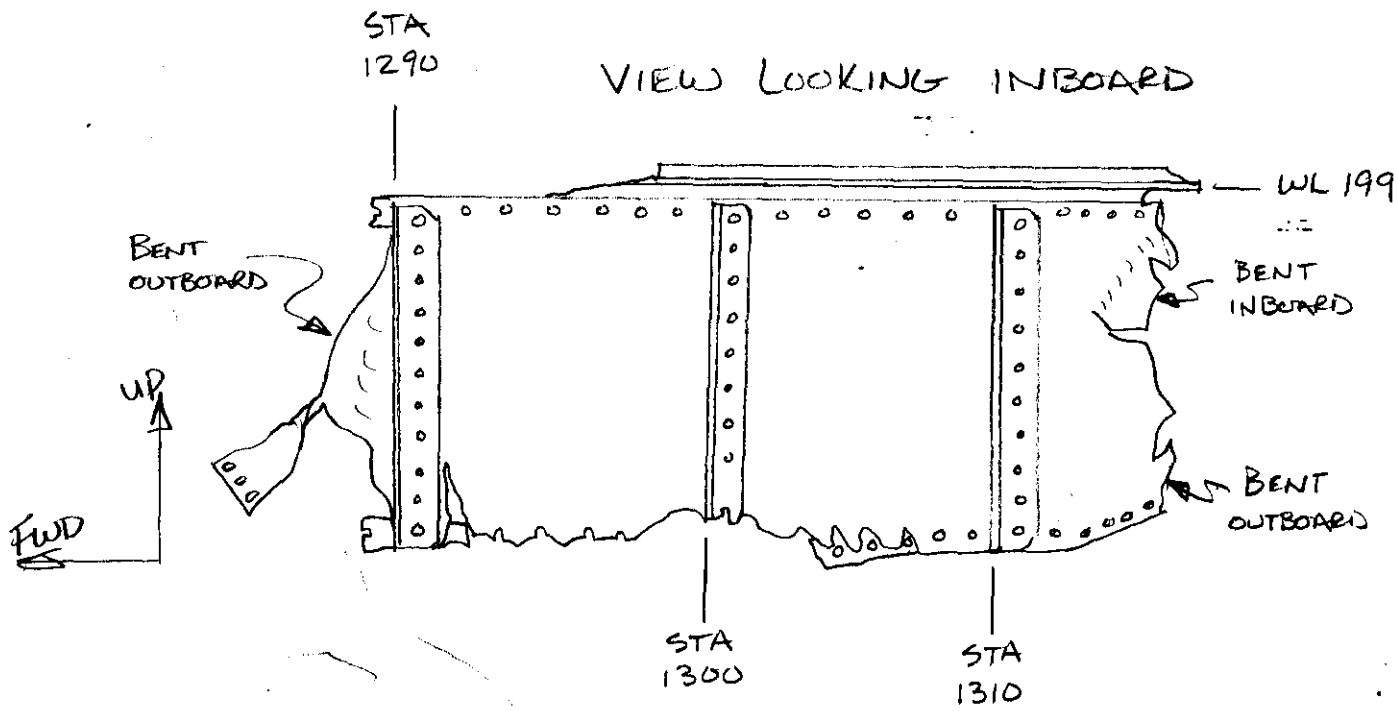
- * THERE ARE INDICATIONS OF MEDIUM TO HEAVY SOOTING ON BOTH INBOARD AND OUTBOARD SIDES.
- * LOWER CHORD HORIZONTAL FLANGE IS MISSING
- * LOWER CHORD VERTICAL FLANGE PULLED OUT OF WEB AND SEPERATED FROM REMAINING LOWER CHORD FROM STA 1290 TO STA 1305.
- * THERE ARE NO INDICATION OF PENETRATIONS IN WEB.
- * THERE IS A TAR LIKE SUBSTANCE ON THE LOWER SURFACE OF THE REMAINING UPPER CHORD HORIZONTAL FLANGE AND THE UPPER EDGE OF THE WEB ON THE OUTBOARD SIDE ONLY.
- * THERE ARE DARK SPLATER MARKS ON THE OUTBOARD WEB SECTION FORWARD OF STA 1290
- * THE FORWARD SIDE OF THE VERTICAL STIFFENERS HAVE A THICK BLACK SUBSTANCE FROM THE UPPER CHORD TO THE LOWER CHORD.
