LOG # LF27

DEBRIS FIELD

LOG # LF27G

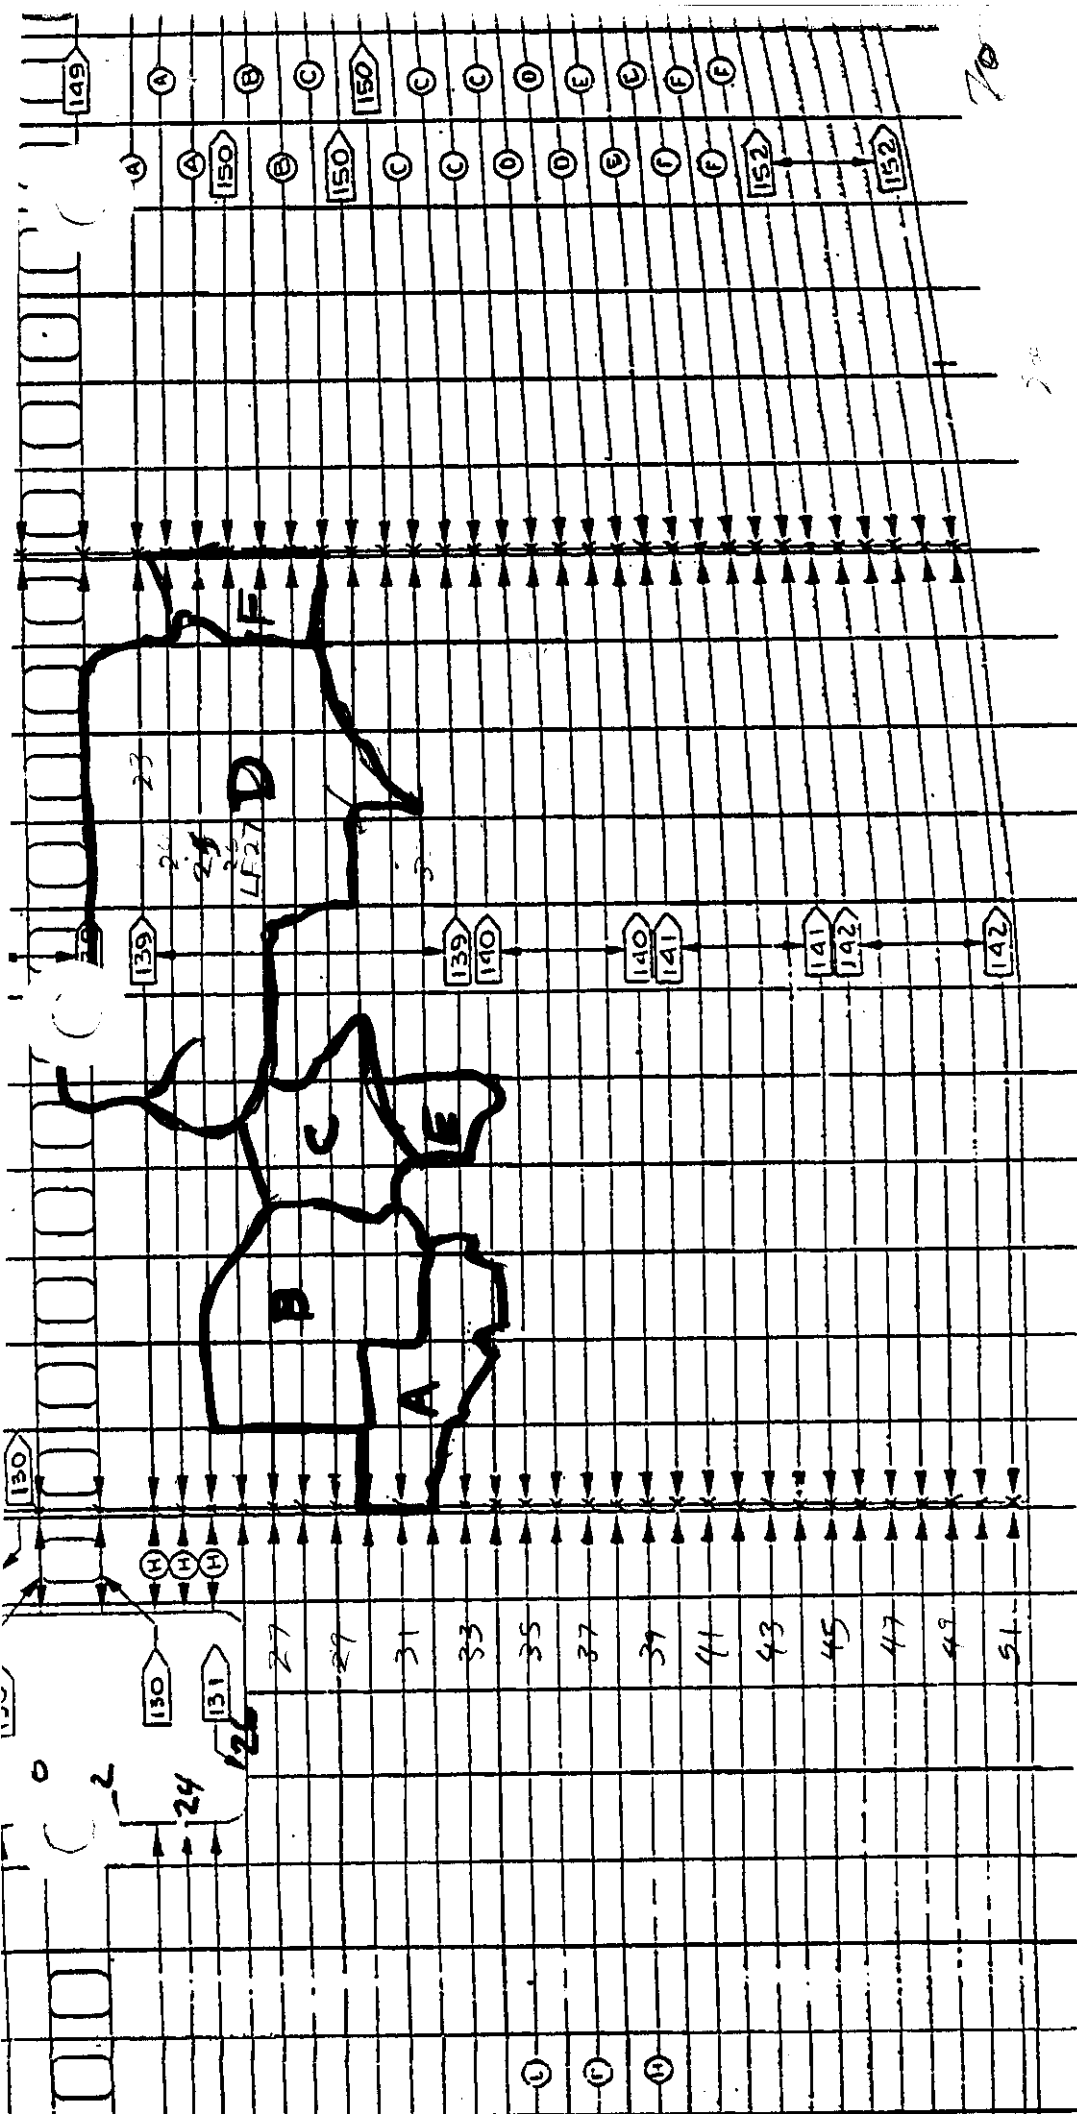
LF27

SECTION LF27A MEASURES APPROX $5\frac{1}{2}' \times 3\frac{1}{2}'$ AND ENCOMPASSES FRAMES 1740 THRU 1800 AND STRINGERS S30L THRU S34L. ALL FRAMES MISSING AND ALL STRINGERS FRACTURED, ALSO S33L + S34L MISSING. FUSELAGE SKIN IS IRREGULAR IN SHAPE AND ALL EDGES SHEARED AND TORN AT RIVET HOLES. NO EVIDENCE OF FIRE/SMOKE DAMAGE.

SECTION LF27B MEASURES $5' \times 5'$ AND ENCOMPASSES FRAMES 1760 THRU 1800, AND STRINGER LOCATION S25L THRU S31L. ALL FRAMES MISSING, AND ALL STRINGERS FRACTURED, ALSO STRINGERS S25L, S26L, & S27L MISSING. FUSELAGE SKIN IS IRREGULAR IN SHAPE AND ALL EDGES SHEARED AND TORN. THIS SECTION MATCHES UP TO LF3 AND LF27A NO EVIDENCE OF FIRE/SMOKE DAMAGE.

SECTION LF27C MEASURES APPROX $3\frac{1}{2}' \times 3\frac{1}{2}'$ AND ENCOMPASSES FRAMES STA 1820 THRU 1840, AND STRINGER LOCATIONS S27L THRU S31L. ALL FRAMES MISSING, STRINGERS S29 + 30 FRACTURED AND PULLED FROM FUSELAGE SKIN/RIVETS, ALL OTHERS MISSING. FUSELAGE SKIN IS IRREGULAR IN SHAPE AND ALL EDGES ARE EITHER SHEARED OR TORN. THIS SECTION MATCHES UP TO LF27B, LF3 AND LF27D NO EVIDENCE OF FIRE OR SMOKE DAMAGE.

SECTION LF27D MEASURES APPROX $12' \times 6\frac{1}{2}'$
AND ENCOMPASSES FRAMES 1840 THRU 1940 AND STRINGER
LOCATIONS S22L THRU S30L. ALL FRAMES ARE MISSING
SO ARE STRINGERS S22L, S24L, S25L, S26L, S29L & S30L.
REMAINING STRINGERS S23L AND S27L ARE FRACTURED.
FUSELAGE SKIN IS BENT AND EDGES ARE SHEARED, TORN & IRREGULAR.
TWO PARTIAL WINDOW OPENINGS ABOVE AND BETWEEN
FRAMES 1840 TO 1860 AND 1860 TO 1880. THIS
SECTION MATCHES UP WITH LF3 AND LF27E.
NO EVIDENCE OF FIRE OR SMOKE DAMAGE.

SECTION LF27E MEASURES APPROX $2' \times 1\frac{1}{2}'$
AND ENCOMPASSES FRAME STATIONS 1820 + 1840, AND STRINGERS
S31L THRU S34L. NO STRINGERS OR FRAMES ARE ATTACHED.
FUSELAGE SKIN IS JAGGERED AND TORN. THIS SECTION MATCHES
TO LF27C, LF27B, AND LF27A. NO EVIDENCE OF FIRE
OR SMOKE DAMAGE.

SECTION LF27F MEASURES APPROX $2\frac{1}{2}' \times 1\frac{1}{2}'$ AND
ENCOMPASSES FRAME STATIONS 1940 THRU 1960 AND STRINGERS
S24L THRU S29L. NO STRINGERS OR FRAMES ATTACHED.
FUSELAGE SKIN IS JAGGERED AND TORN. THIS SECTION MATCHES
TO LF27D, LF3 AND LF28A. NO EVIDENCE OF FIRE
OR SMOKE DAMAGE.

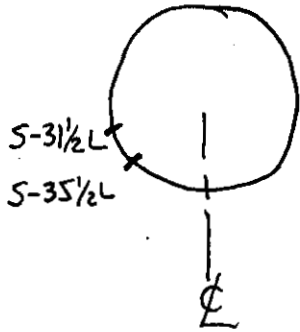
VIEW A-A

SKIN SEGMENT, STA 1920 TO 1940,
STG 31 1/2 L TO STG 35 1/2 L.

SKIN IS ACCORDIONED DRAMATICALLY WITH SHARP BENDS AT STG 33L, STG 33 3/4 L, STG 34 1/2 L. IT IS TORN ALMOST THROUGH LONGITUDINALLY AT STG. 33L — ONLY 2" REMAIN BEFORE COMPLETE SEPARATION.

- 1) STG. 34L REMAINS ATTACHED BETWEEN STA. 1920 TO 1940.
- 2) STG 35L REMAINS ATTACHED BETWEEN STA 1920 TO 1940.

- 1) A STABILIZATION INTERCOSTAL REMAINS ATTACHED ALONG THE UPPER SIDE WALL OF STG 35L.
- 2) THERE IS LIGHT SOOTING / DIRT ALONG THE INBOARD SURFACE OF THE PANEL.
- 3) FRACTURE SURFACES APPEAR TO BE ~~BE~~ DUCTILE FAILURES.
