LOG # LF-3

DEBRIS FIELD #1

FUSELAGE SKIN AND STRINGERS
STA 1720 - 2018, STR 27L-3R

LF-3 FUSELAGE SKIN

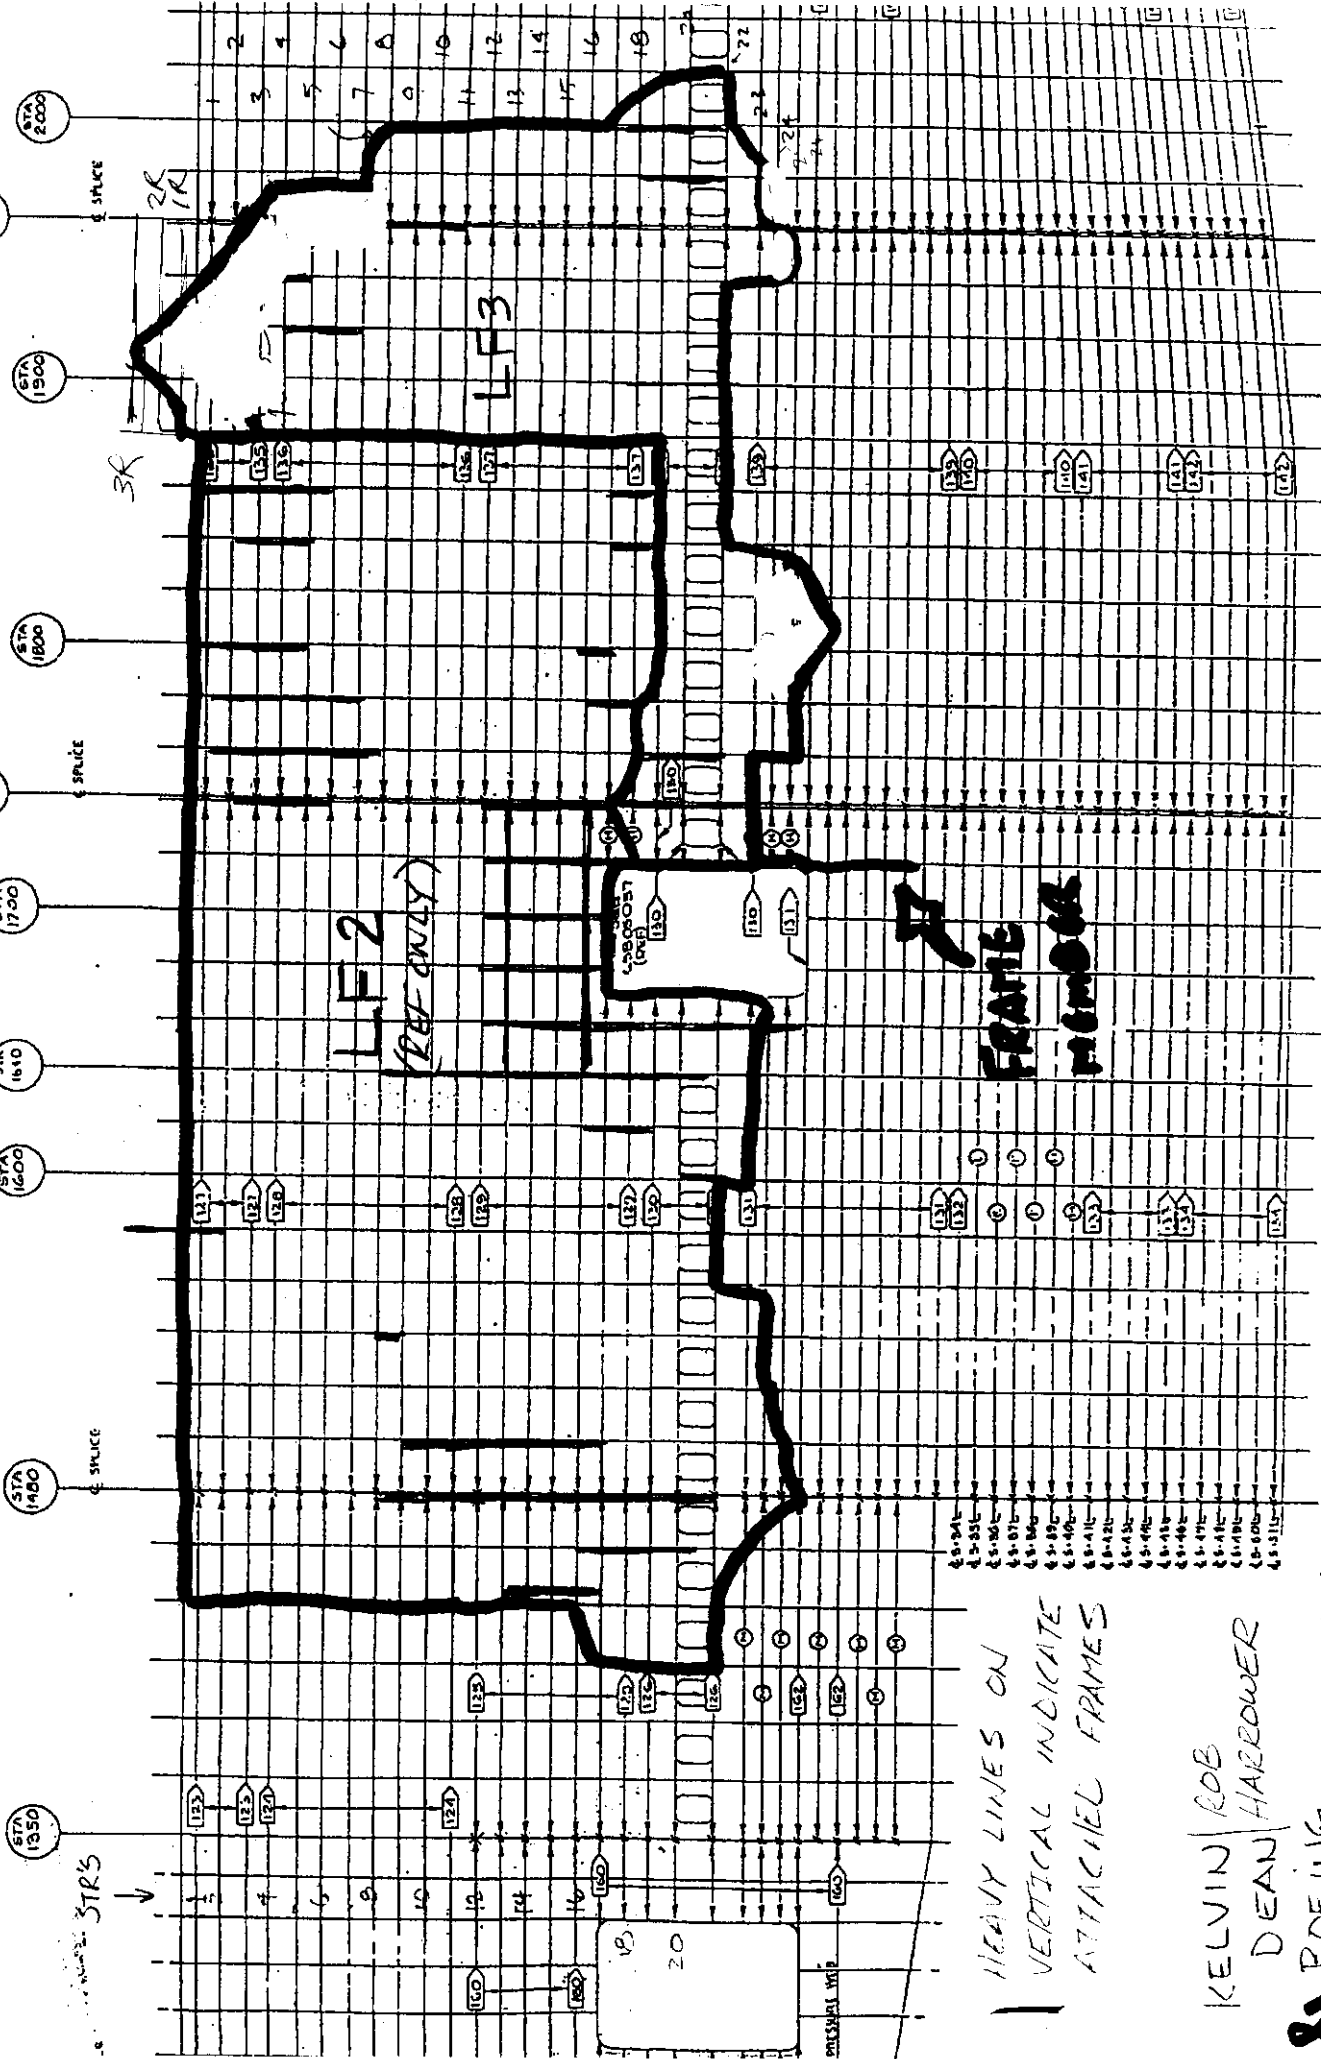
BOEING
10/14/96
DEVELOPED VIEW -
LEFT SIDE
SCALE: 1/4" = 1'-0"

HEAVY LINES ON
VERTICAL INDICATE
ATTACHED FRAMES

PANEL IS CLEAN AND FREE OF SOOT/ASH

SKIN IS FREE OF SHEAR WRINKLES

UNIT HAS 15 WINDOWS, ONE HAS GLASS

DOOR # 4L AFT EDGE FRAME IS SEVERED JUST ABOVE
STOP # 9 AND JUST BELOW STOP # 1

NO PUNCTURES TO REPORT

A crease runs diagonally up and aft beginning at FS 1880, stringer 18L. The crease turns more upward at FS 1940, stringer 15L. This location has a ^{12"} skin tear that crosses the crease line and has been displaced by the crease. The crease continues from this location to FS 2000, S-13L. The fracture sites at S 18L, 16L, 15L, 14L and 13L lie at or very near this crease.
