LOG # LF 32

TARGET # A 145

Body STA 940 Tension Tie STR  
W/L 338.5 str 8L 65B09631-102

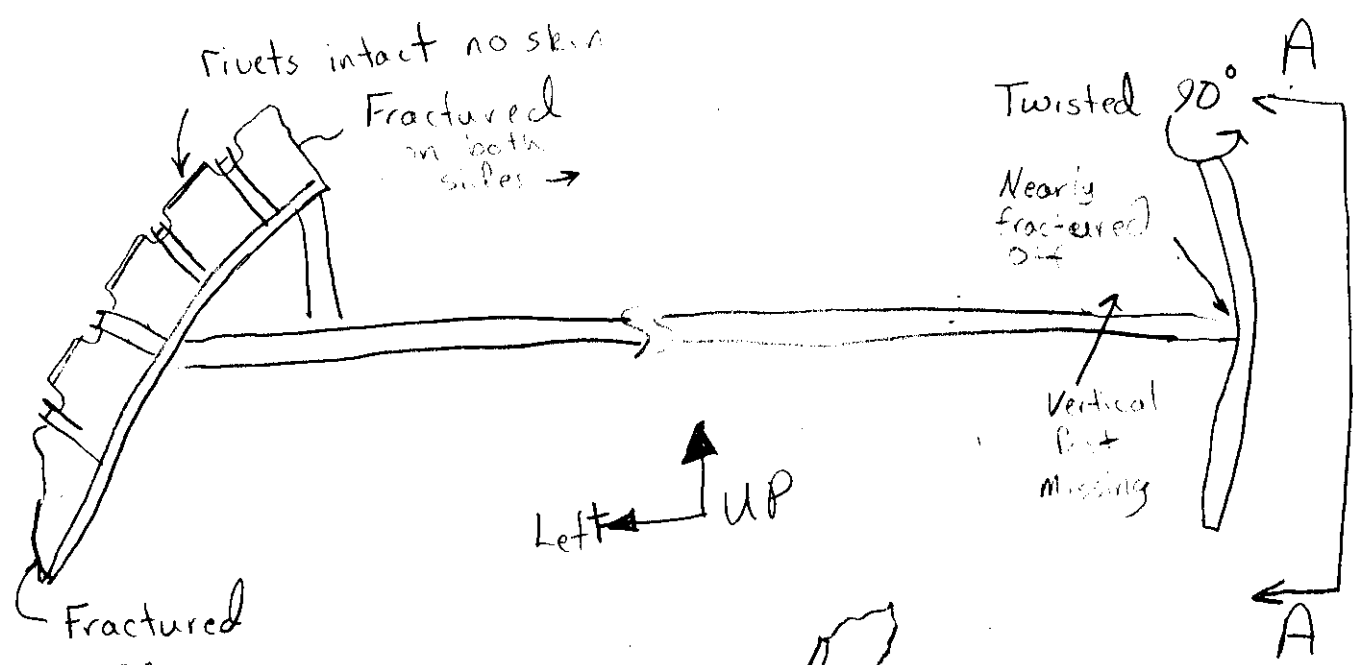
- Tension Tie includes Frame Segments on both sides
- ~~No Fatigue Surfaces~~ 12/5/96

Fractured on both sides

AFT TENSION TIE IS BOWED IN THE FORWARD DIRECTION WITH RESPECT TO ITS ENDS.

~~FWD AFT FLANGES OF THE BUILT UP CROSS SECTION ARE WARPED SLIGHTLY OUT OF PLANE DUE TO BUCKLING. DEFLECTION OF CENTER WRT ENDS IS ABOUT 1/2 IN.~~  
SUPPORT FITTINGS ON THE LOWER SURFACE OF THE TENSION TIE REMAIN ATTACHED AT FOUR LOCATIONS. THE FITTING AT RBL 34 HAS ITS VERTICAL FLANGE BROKEN OFF

IN ADDITION TO THE OUT OF PARALLEL CONDITION OF THE FRONT CHANNELS, THERE ARE CRACKS AT THE FOLLOWING LOCATIONS 1) 10 INCHES LEFT OF CENTER ON THE FWD UPPER CHANNEL 2) 13 INCHES RIGHT OF CENTER ON THE FWD LOWER CHANNEL 3) 44.5 INCHES RIGHT OF CENTER ON THE UPPER FORWARD CHANNEL.

AT RBL 13, THERE IS A LOCAL BUCKLE AT LWR FWD LIP OF CHANNEL

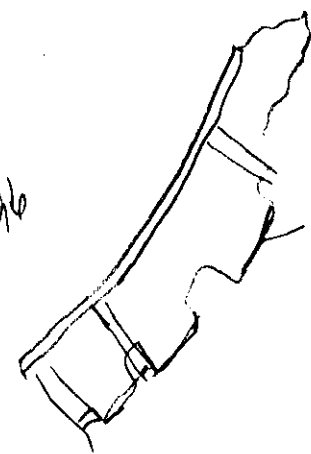
A-A

rivets intact
