LOG # LF 33 SOG RTS 10-7-96 A-B

DEBRIS FIELD

SKIN STRINGER, FRAME AND DOOR # 5

LF 33A

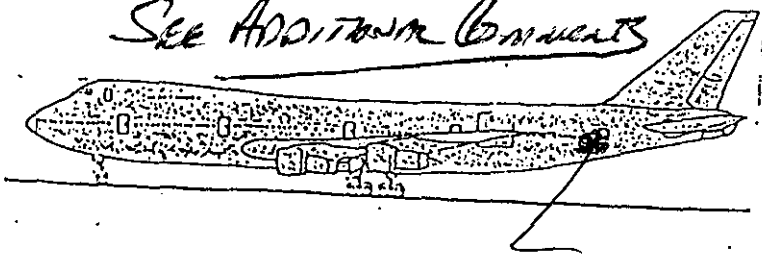
L This section of fuselage measures approximately 14' x 9' and encompasses stations 2140 thru 2280, and stringer locations S11L thru S24L. 60% of the L5 entry door is attached to this structure. Fuselage skin is rolled over, crushed, and twisted throughout. Skin edges are jagged, and contain 2 window openings.

All stringers are fractured and pulled loose from skin along various stations. Stringer S11L missing.

All frames are fractured. Frame section at stations 2140, 2160, and 2180 ^① missing. Small sections of remaining frames are attached at:

No evidence of fire or smoke damage.
