LOG # LF36 ^{SOS}
TARGET #
COORD: LAT
LONG

STA 980 Lower Frame Segment

LF36

LF 36
SUPPLEMENTAL
PAGE

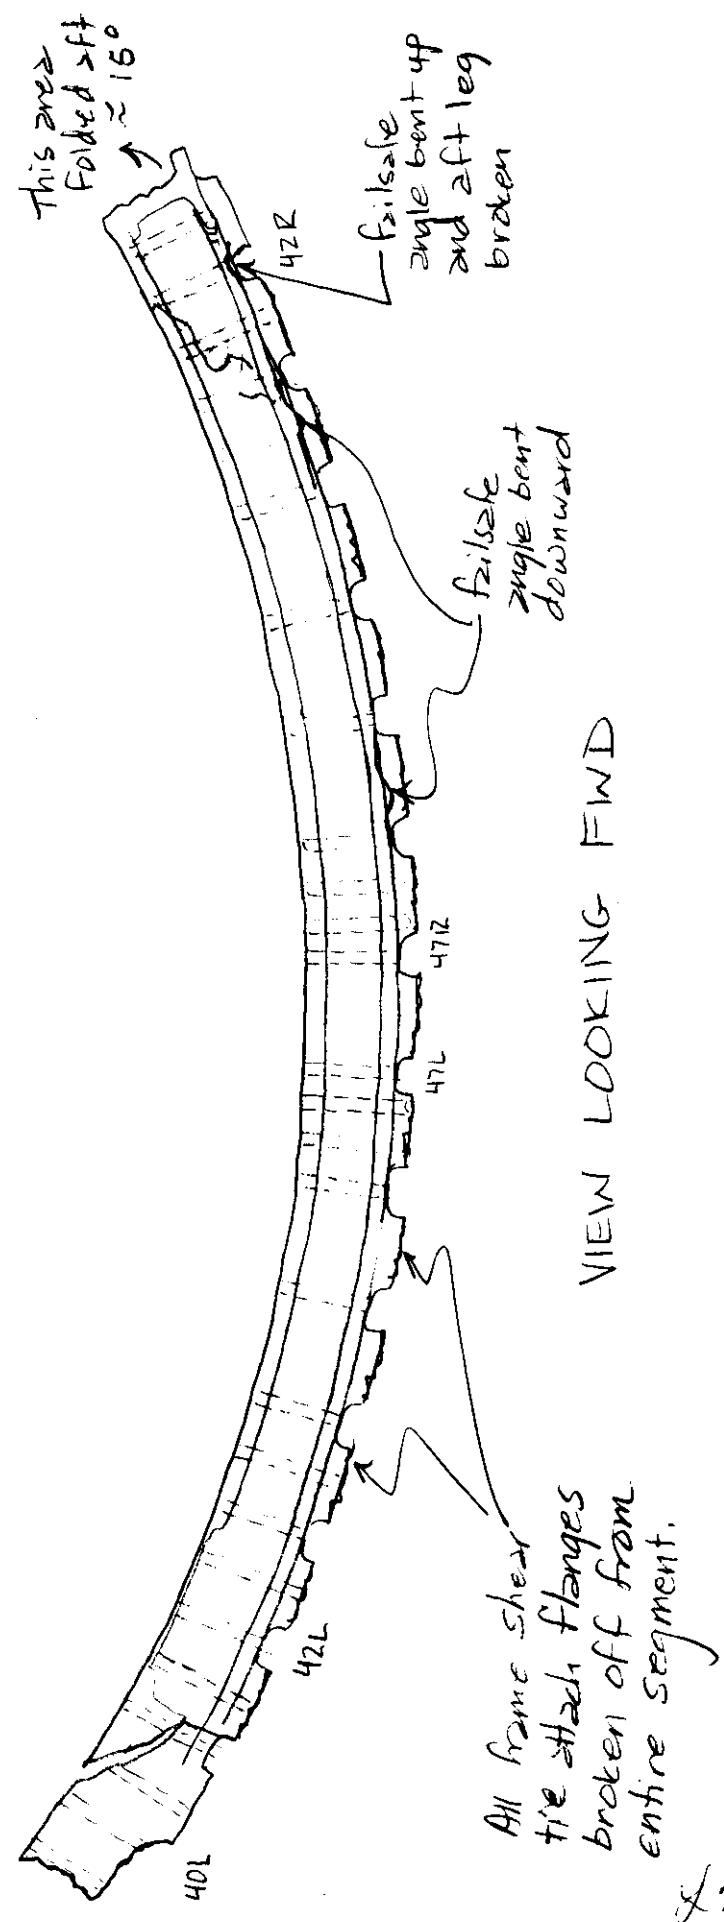
STA 980
FRAME SEGMENT

This is the first frame segment forward of the front Spar Bulkhead. Frame retains original contour. All skin attach flanges are broken free. The failsafe angle is bent at three location, however there are no other signs of impact damage. There is no evidence of fire damage or sooting.

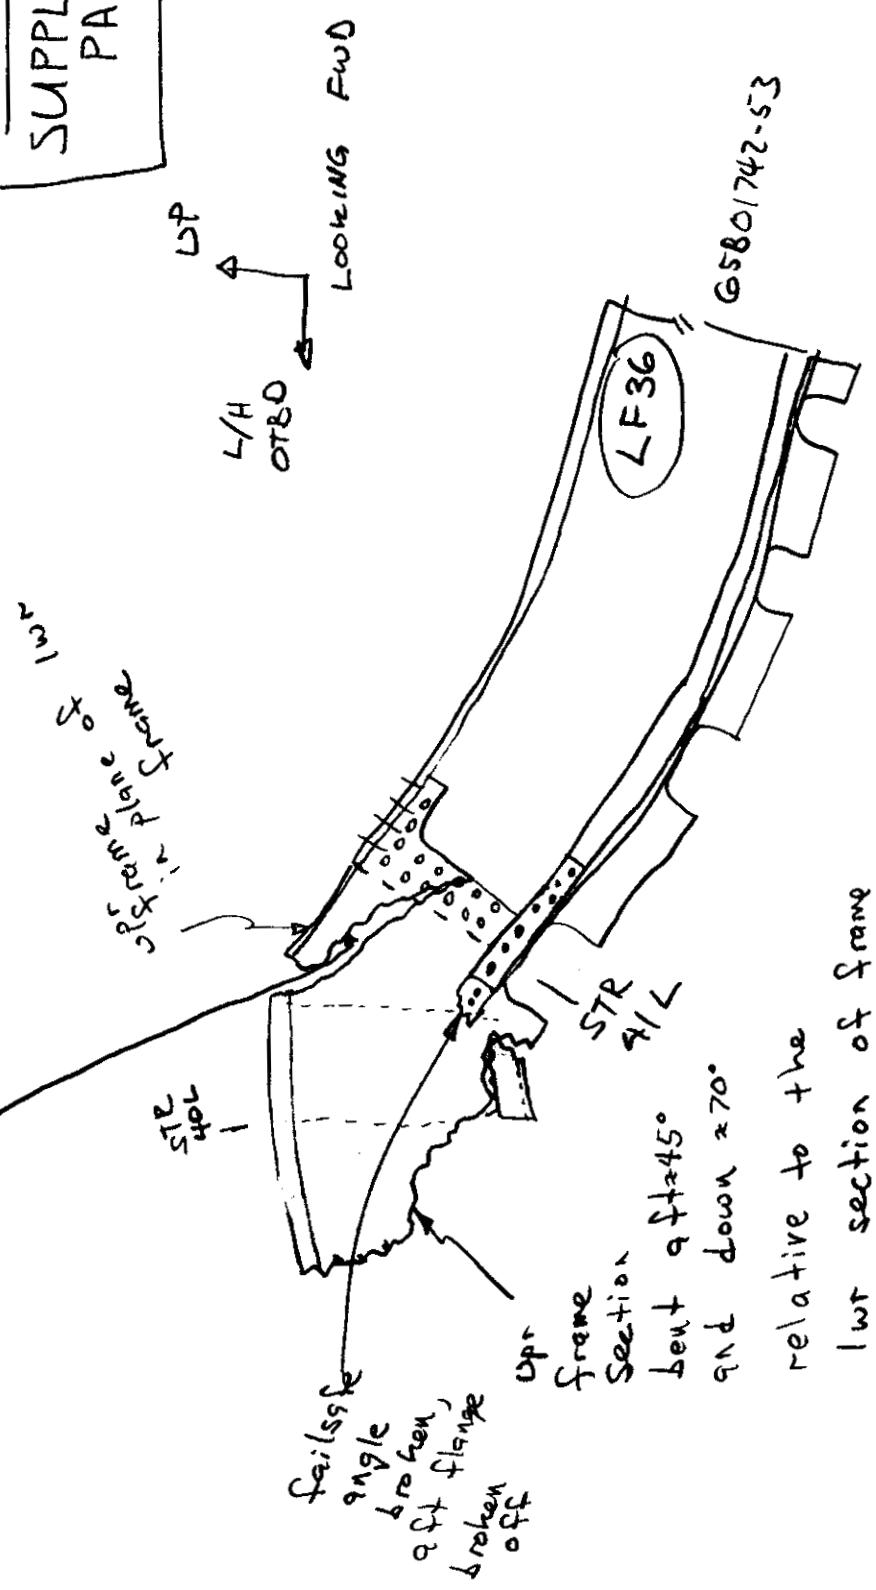
STA 980
FRAME

Tower Reduces
Frame 3-27-97
