LOG # LF38

LHS Upper Fuselage skin from STA 900 to STA 1350, S-412 to S-29L.

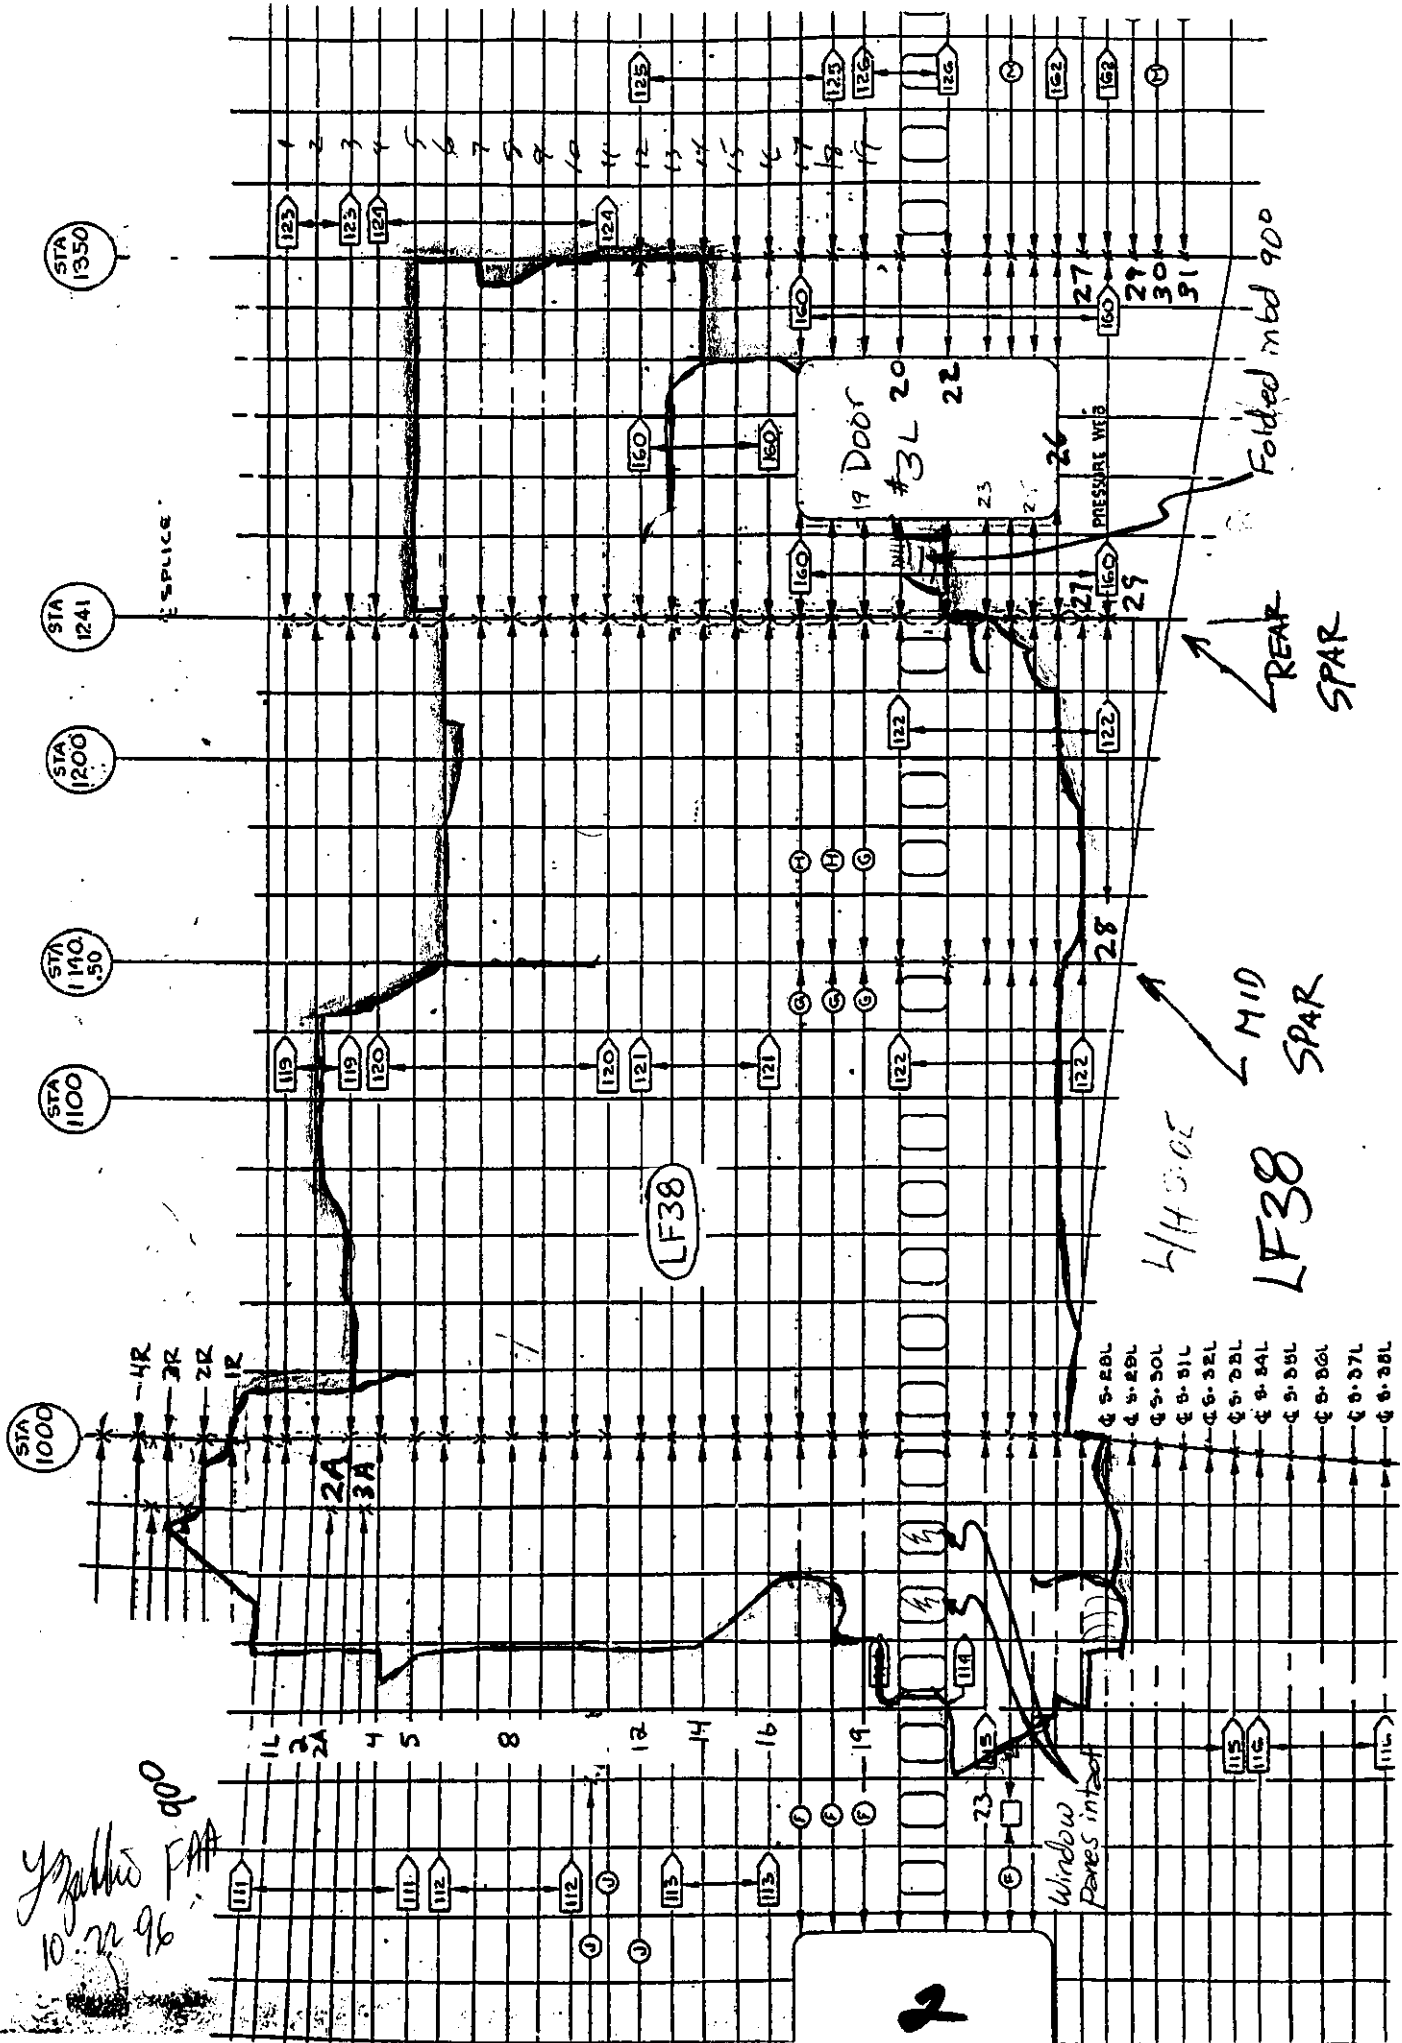
LF 38

Major portions of frames remain attached to the skin from STA 1000 forward. Between 1000 and 1140, only the segments near the window belt remain attached. The STA 1241 frame is attached below S-14. The Door 3L forward edge frame is intact for upper stops #6 through #9. The sill structure remains attached.

The two window panes centered at STA 950 and STA 970 remain in place. Both the inside and outside surfaces are smooth and show no obvious signs of heat damage. There is no obvious heat damage to remaining portions of Wing to Body fairing between STA 920 and 1000 at the lower edge of the segment.

The panel itself does not show any obvious signs of fire damage or sooting.

- ① FRONT SPAR BLKHD ALSO ATTACHED, ALONG WITH PIECE OF WING BOX FRONT SPAR WEB, UPPER SPAR CHORD VERTICAL FLANGE & INTERNAL STIFFENER. BLKHD REMAINS ATTACHED UP TO APPROXIMATELY STG $7\frac{1}{2}$, HOWEVER INBOARD CHORD & WEB HAVE FRACTURED AT STG $\sim 18\frac{1}{2}$ L AND AT STG 14 TO STG 16L.
- ② MID SPAR BLKHD ~~ATTACHED~~ ^{PRESENT} FROM STG 9L DOWN TO STG 26L. UPPER PART FROM STG 9L DOWN TO STG 16L IS SEPARATED FROM SKIN.

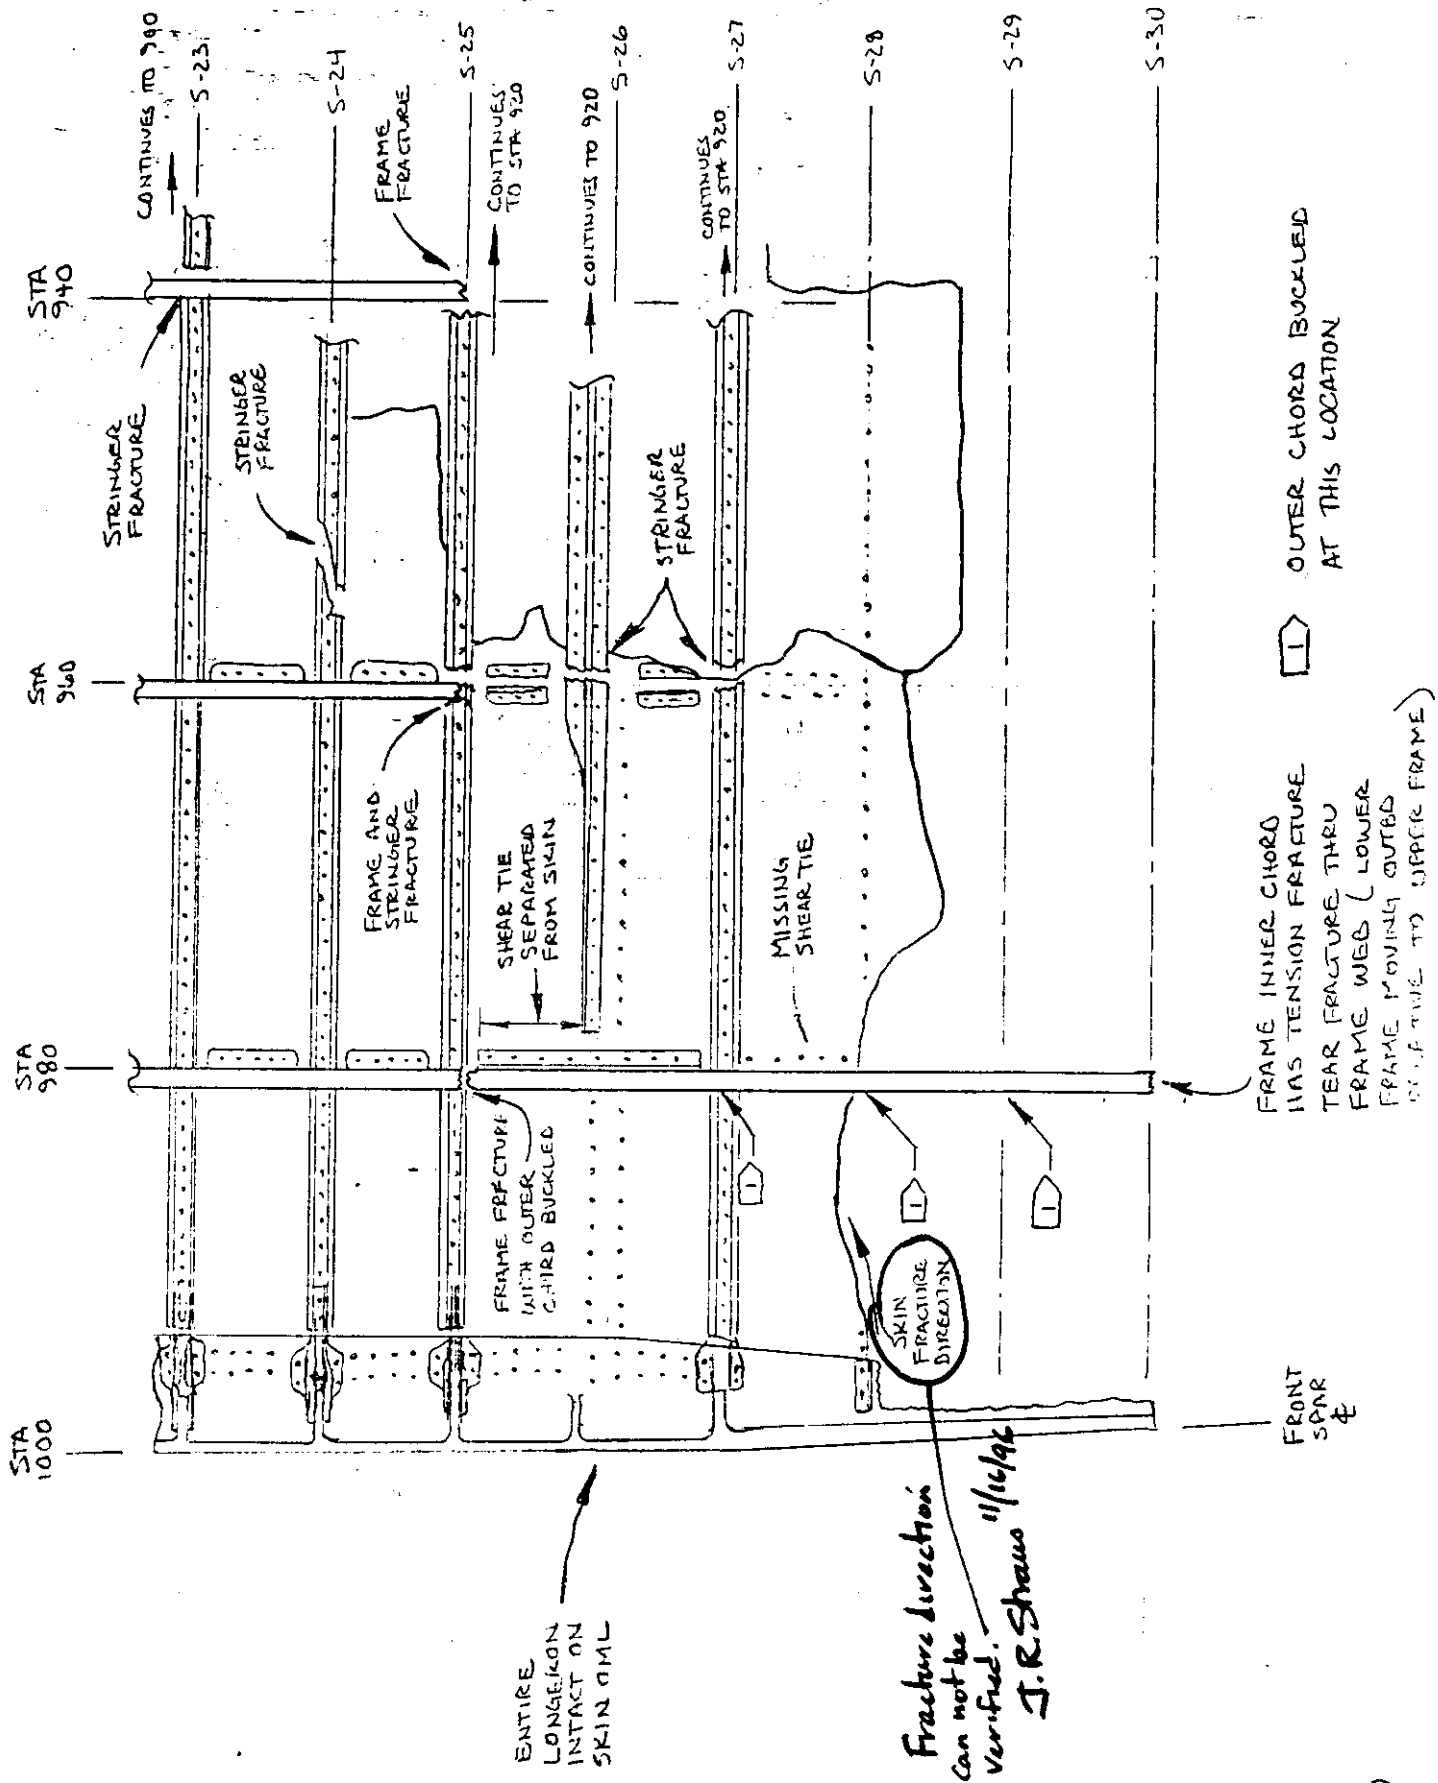
ENTIRE LONGEON INTACT ON SKIN OML

Fracture direction can not be verified.
J.R. Strauss 11/16/96

FRAME INNER CHORD HAS TENSION FRACTURE TEAR FRACTURE THRU FRAME WEB (LOWER FRAME MOVING OUTBOARD DUE TO UPPER FRAME)

OUTER CHORD BUCKLED AT THIS LOCATION

STRINGER FRACTURE

FRAME FRACTURE

FRAME FRACTURE WITH OUTER CHORD BUCKLED

SHEAR TIE SEPARATED FROM SKIN

MISSING SHEAR TIE
