LOG # LF39
 TARGET # _____
 COORD: LAT _____
 LONG _____

DEBRIS FIELD # 1 green
 (far)

Green Tag # C860 LF39A

LHS Skin Panel, STA 1319 to STA 1440,
 S-5L to S-23L.

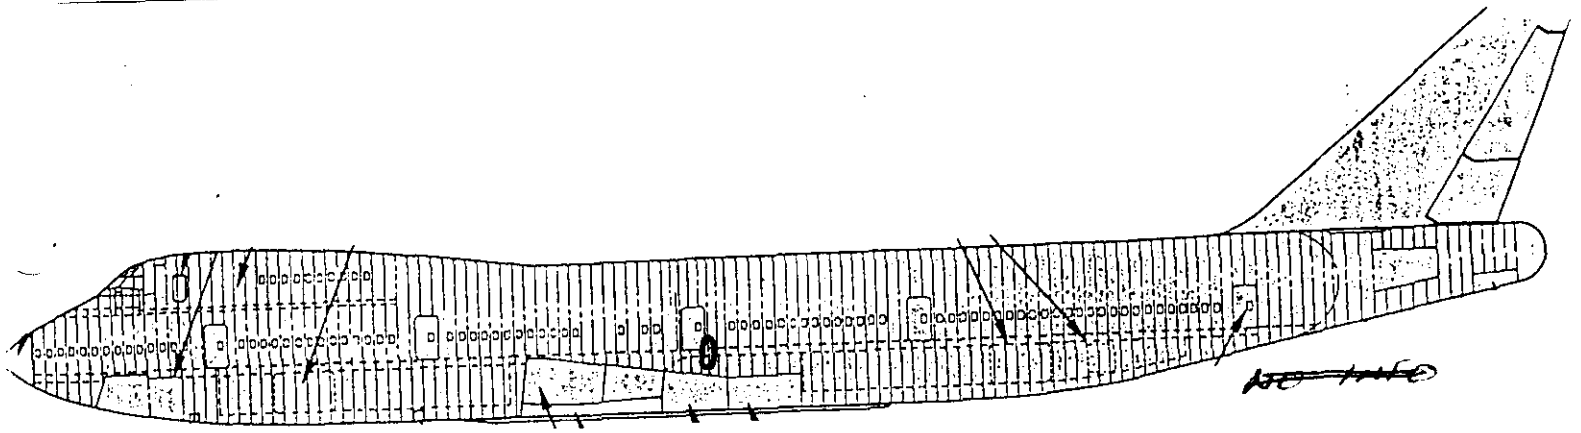
LF 39 B

DESCRIPTION: STATION 1350 FRAME JUST ABOVE BULKHEAD

PART MEASURES 70" LONG X 16" WIDE AT GREATEST POINT. FRAME IS FRACTURED AT FACTORY SPLICE BETWEEN S20L AND S22L DOWN TOWARD S22L WHERE IT IS SEPARATED FROM OUTER SKIN FOR THE REMAINDER OF ITS LENGTH

THE FRACTURE SURFACES OF THE FRAME AT THE SPLICE ARE HEAVILY SOOTED. ALL SURFACES OF THE FRAME EXHIBIT LIGHT TO MODERATE SOOTING. THE BOTTOM FRACTURE SURFACES OF THE FRAME EXHIBIT MODERATE TO HEAVY SOOTING. ATTACHMENTS FOR STRINGERS S22L, S24L, S25L, AND S26L ARE STILL ATTACHED ON FRONT FACE.
