LOG # LF4 ^{RHS 5083} 10-1-96

DEBRIS FIELD #1

YELLOW TAG B103

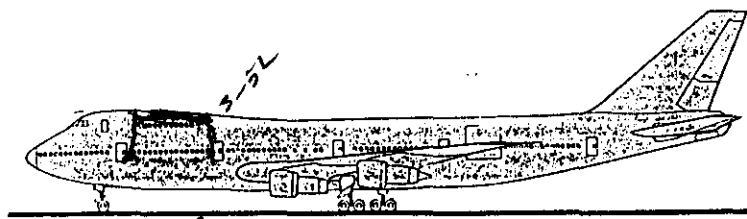
S-23L
NTSB CUT LINE

S-20L WINDOW
S-22L

S-23L

REFER METALLURGY GROUP NOTES

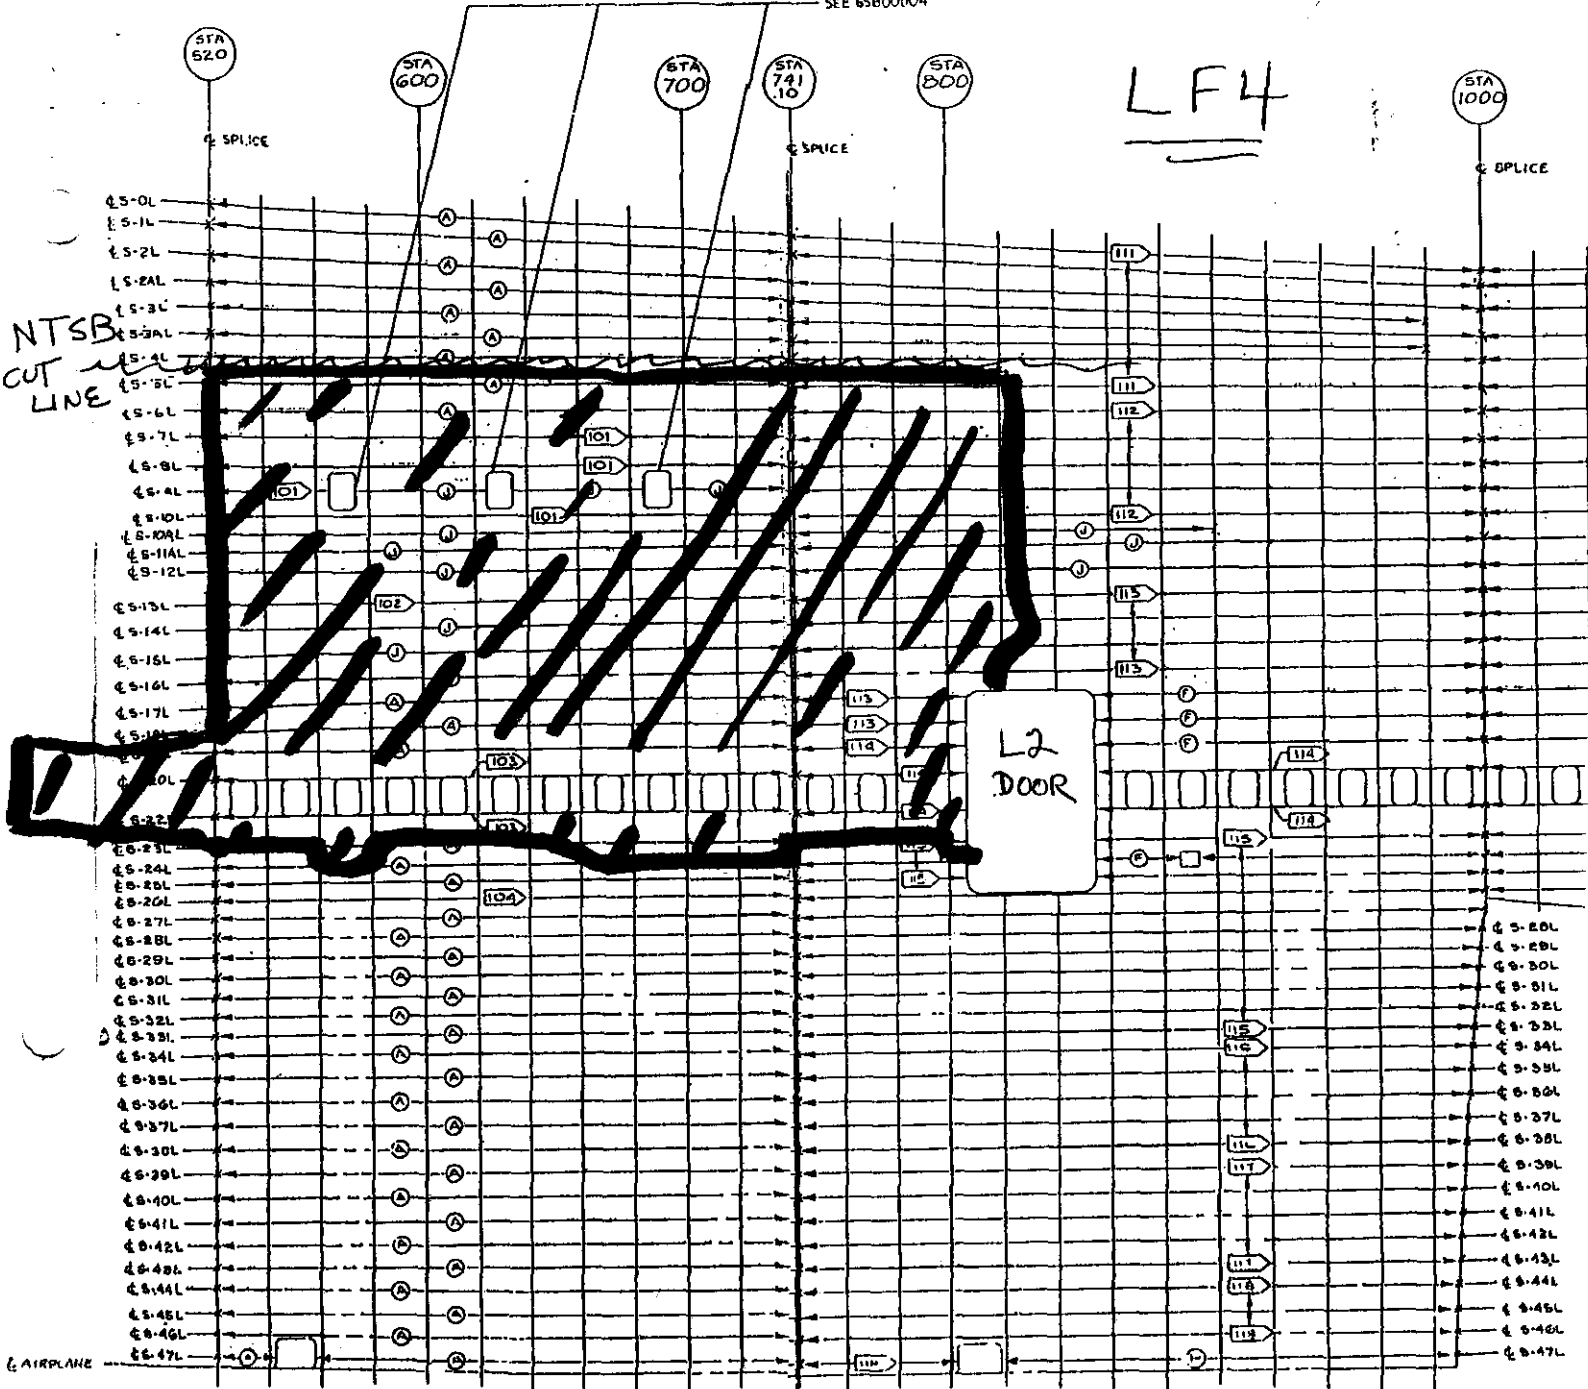
LF4

↳ 12" FWD OF STATION 500 @ STRINGER 22L; TEAR RUNS APT AND ALONG STRINGER 22L TO A POINT 3" PRIOR TO STATION 500 TEAR GOES DOWN APPROX 2" DIAGONALLY APT TO A POINT 2" APT OF STATION 500 AND FOLLOWS WINDOW FRAME DOUBLER TO 5" FWD OF STATION 520; THEN VERTICALLY DOWN TO STRINGER 23L TEAR RUNS APT AND ALONG STRINGER 23L TO STA. 560. AND VERTICALLY DOWN STATION 560 FOR 5" APT TO STA 580. TEAR RETURNS TO STRINGER 23 AND CONTINUES APT ALONG STRINGER 23L TO A POINT 4" FWD OF STA. 660. TEAR RUNS DIAGONALLY DOWN & APT TO A POINT 6" BELOW STRINGER 23L AND 5" APT OF STA 660. THE TEAR RUNS APT AND ALONG RIVET LINE 6" BELOW S23L TO STA 740. TEARS TURNS VERTICALLY UP TO S23L (6") APT ALONG RIVET HOLES AT MISSING S23L STRINGER TO STA 780 AND THEN VERTICALLY DOWN 4" AND APT (HORIZONTALLY) TO FWD EDGE OF THE L2 DOOR FRAME.

TEAR RESUMES AT TOP FWD EDGE OF L2 DOOR FRAME TO A POINT 16" APT OF STATION 800 AND 3" BELOW STRINGER S16L
 ↳ TEAR RUNS VERTICALLY 2 1/2" ABOVE S16L AND RUNS DIAGONALLY UP AND APT TO A POINT 10" APT OF STA 820 AT S14L
 STRINGERS S15L, S14L, S13L ARE BROKEN FWD OF STATION 820
 & S12L ALSO B.H. 10/23/96 M&P Pouchon TWA 9/29/96

TEAR CONTINUES VERTICALLY UP 10" APT OF STA 820, S14L TO A POINT THAT IS 5 INCHES APT OF STA 820 @ S12L, TEAR CONTINUES VERTICALLY UP 5" APT OF STA 820, TO S8L, IT CONTINUES 2" APT OF STA 820 @ S8L TO THE NTSB CUT LINE ABOVE S5L.

PROCEED FROM A POINT ^{9"} APT OF STA 820 AND 4" ABOVE S5L ALONG AND FWD OF THE NTSB CUT LINE TO STA 520.

TEAR LINE RUNS ALONG STA 520 (VERTICALLY DOWN) TO STRINGER S18L. TEAR PROCEEDS DOWN AND FWD TO A POINT 2" APT OF STA 500, AND 1" ABOVE S19L, TEAR PROCEEDS DIAGONALLY UP TO A POINT .7" ABOVE S19L, THEN CONTINUES DIAGONALLY DOWN 5" ABOVE S19L AND TERMINATES AT L1 DOOR FRAME DOWN TO STARTING POINT OF PAGE #1

ALL FUSELAGE FRAMES ^{FROM STA.} 1520 THRU ~~740~~ ⁸⁰⁰ ALONG STRINGER S17L ARE FRACTURED (EXTERIOR SKIN REMAINS ATTACHED). FRACTURE LINE DOES NOT INCLUDE THE L2 DOOR FRAME ~~AND STA 800~~ ^{B.H. 10/23/96}. CABIN CEILING/UPPER FLOOR STRUCTURE APPROX 22" FROM FUSELAGE TO TEAR POINT AND RUNS ALONG (APT) SPICE TO STA 740. ~~NO~~ INTERIOR TRIM MISSING.
