GREEN C101

LOG # LF 41 RB

TARGET # 2

DEBRIS FIELD 7

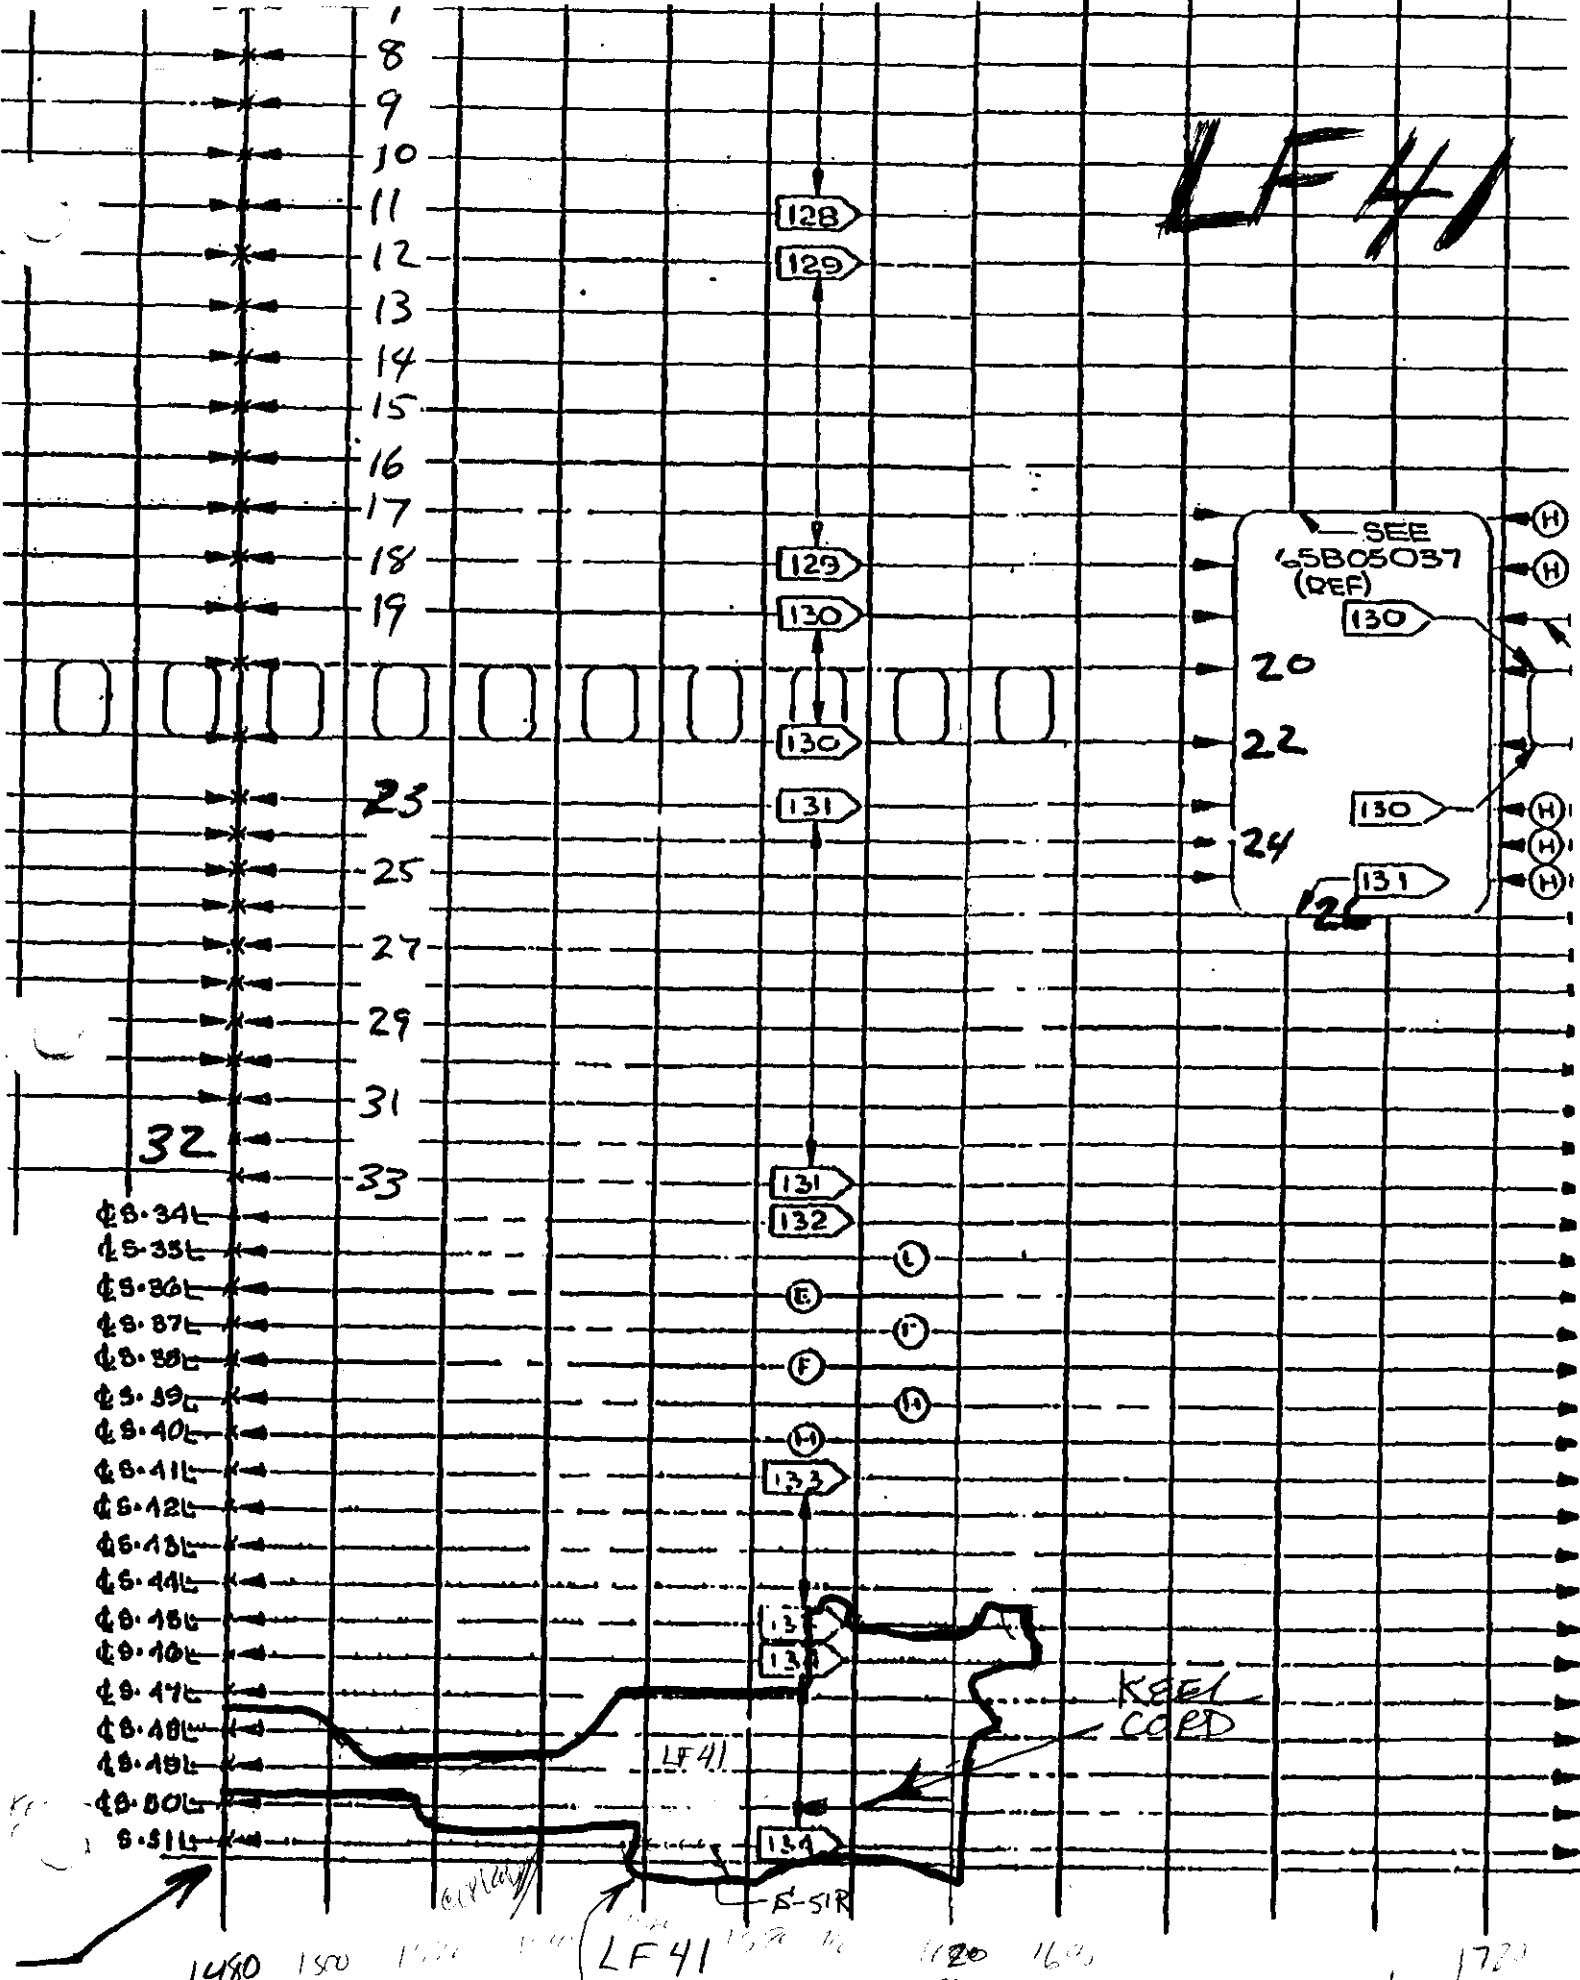
This section of fuselage measures approx 12' x 4' and encompasses station locations 1480 to 1620, and stringer location S51R, E, S51L (S50L KEEL CHORD) S49L, S48L, S47L, S46L

- a) PORTION OF S46L FRACTURED FROM STA 1620 TO 1560. REMAINING PORTION OF STRINGER (WITH FUSELAGE SKIN) MISSING FROM STA 1560 TO 1480
- b) PORTION OF S47L FRACTURED FROM STA 1620 TO 1560. REMAINING PORTION OF STRINGER (WITH FUSELAGE SKIN) MISSING FROM STA 1560 TO 1480
- c) PORTION OF S48L FRACTURED FROM STA 1620 1580 (FUSELAGE SKIN MISSING FWD STA 1560 - DOWN TO S49L.

d) S49L MISSING STA 1620 thru 1600. REMAINDER OF STRINGER TO STA 1480 FRACTURED AND CRACKED THROUGH AT STA 1540

e) S50L FRACTURED AT STA 1620 TO 1600, REMAINDER OF STRINGER MISSING

f) S51L NOT SECURED FROM STA 1620 TO 1560 (RIVETS PULLED) AND REMAINDER OF STRINGER MISSING TO STA 1480.

g) KEEL CHORD FRACTURED AT STA 1540 AND REMAINING SECTION MISSING TO STA 1480.

h) Support casting AT STA 1480 FRACTURED.

FUSELAGE SKIN JAGGERED, EDGES BENT INWARD AND OUTWARD AT VARIOUS LOCATIONS. ENTIRE SKIN PANEL BENT 90° INWARD AT STA 1540.

SOME EVIDENCE OF SMOKE/SOOT RESIDUE.

CENTER OF PANEL BAYS BULGE INWARD B.H.

LF41 FOLDED INWARD 90°
