LOG # LF42 ^{1/23}
 TARGET # 2
 COORD: LAT 7
 LONG 11
 DEBRIS FIELD 1

LF 42A

DEBRIS FIELD #1

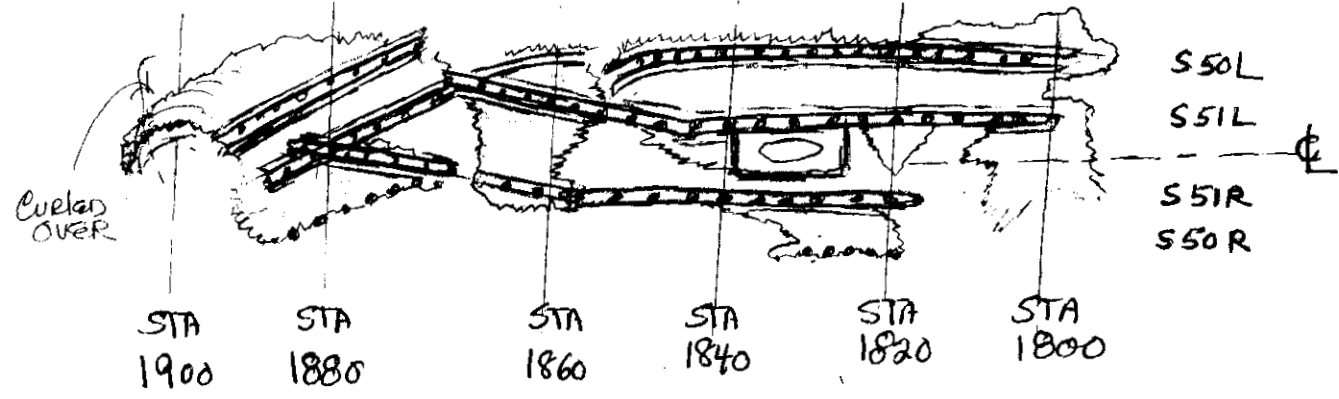
This section of fuselage measures approx 9' x 2' and encompasses station location 1800 thru 1900, and stringer locations S50L, S51L, (⊕) S51R and S50R. NO FRAMES ATTACHED TO STRUCTURE, WHICH IS TWISTED AND CURLED OVER.

- a) STRINGER S50R MISSING
- b) " S51R TWISTED AND FRACTURED AT STA 1860, REMAINING SECTION FROM STA 1820 TO 1800 MISSING
- c) STRINGER S51L TWISTED AND FRACTURED AT STA 1860
- d) " S50L " " " " " 1860

SPIN PUNCTURES OUTWARD	between	S51R + S51L,	STA	1900 - 1880
" PUNCTURES/TEARS	"	S51R + S51L,	STA	1880 - 1860
"	"	S51R + S51L	"	1860 - 1820
"	"	S51R + S51L	"	1820 - 1800

NO EVIDENCE OF FIRE OR SMOKE DAMAGE

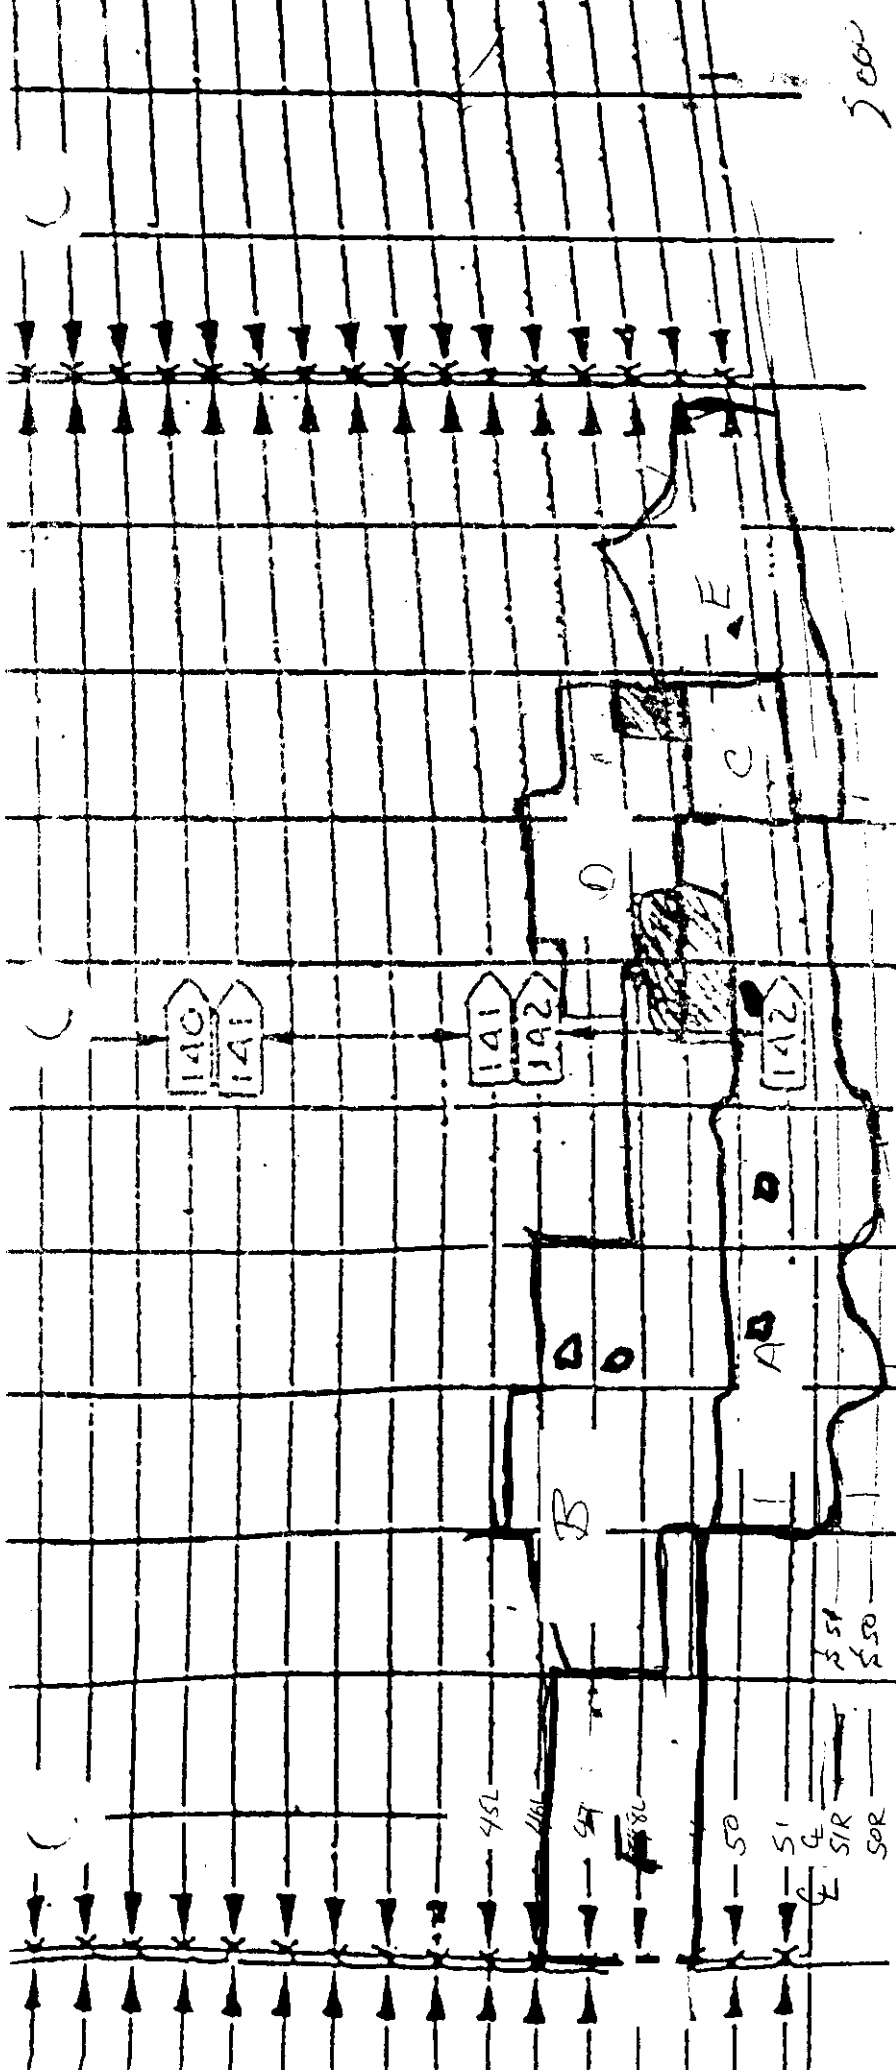
LF 42

THIS SECTION OF FUSELAGE IS APPROX 20" X 20" and ENCOMPASSES STRINGERS 50L AND 51L. THE SKIN SECTION ENDS SHY OF STANGERS 51R AND 49L. THE SKIN IS BENT INWARDS AND IS TORN OR RIPPED. THERE IS NO SIGN OF BURNING OR SMOKE DAMAGE. SKIN STARTS AT STATION 1900 AND ENDS AT 1920.

THIS SECTION OF FUSELAGE IS APPROX 15" X 45" and ENCOMPASSES STRINGERS 47L AND 48L FROM STATION 1875 TO 1920. THIS SECTION OF SKIN ALSO CONTAINS A 4" SECTION OF S49 AT STATION 1900. THE SKIN ALSO HAVE RIVETS THAT WOULD BE ATTACHED TO S46L FROM STATION 1880 TO 1900. THIS SECTION IS TORN AND SLIGHTLY BENT. THERE IS NO SIGN OF BURNING OR SMOKE DAMAGE

THIS SECTION OF FUSELAGE has an overall size of approx 60" long X 30" wide. ENCOMPASSES 551R FROM STA 1900 thru 1960, 551L FROM 1920 thru 1960, 550L FROM STA 1920 thru 1960 AND S49L FROM 1920 thru 1940. THIS SECTION IS TORN AND Bent with NO signs of burning or smoke damage.

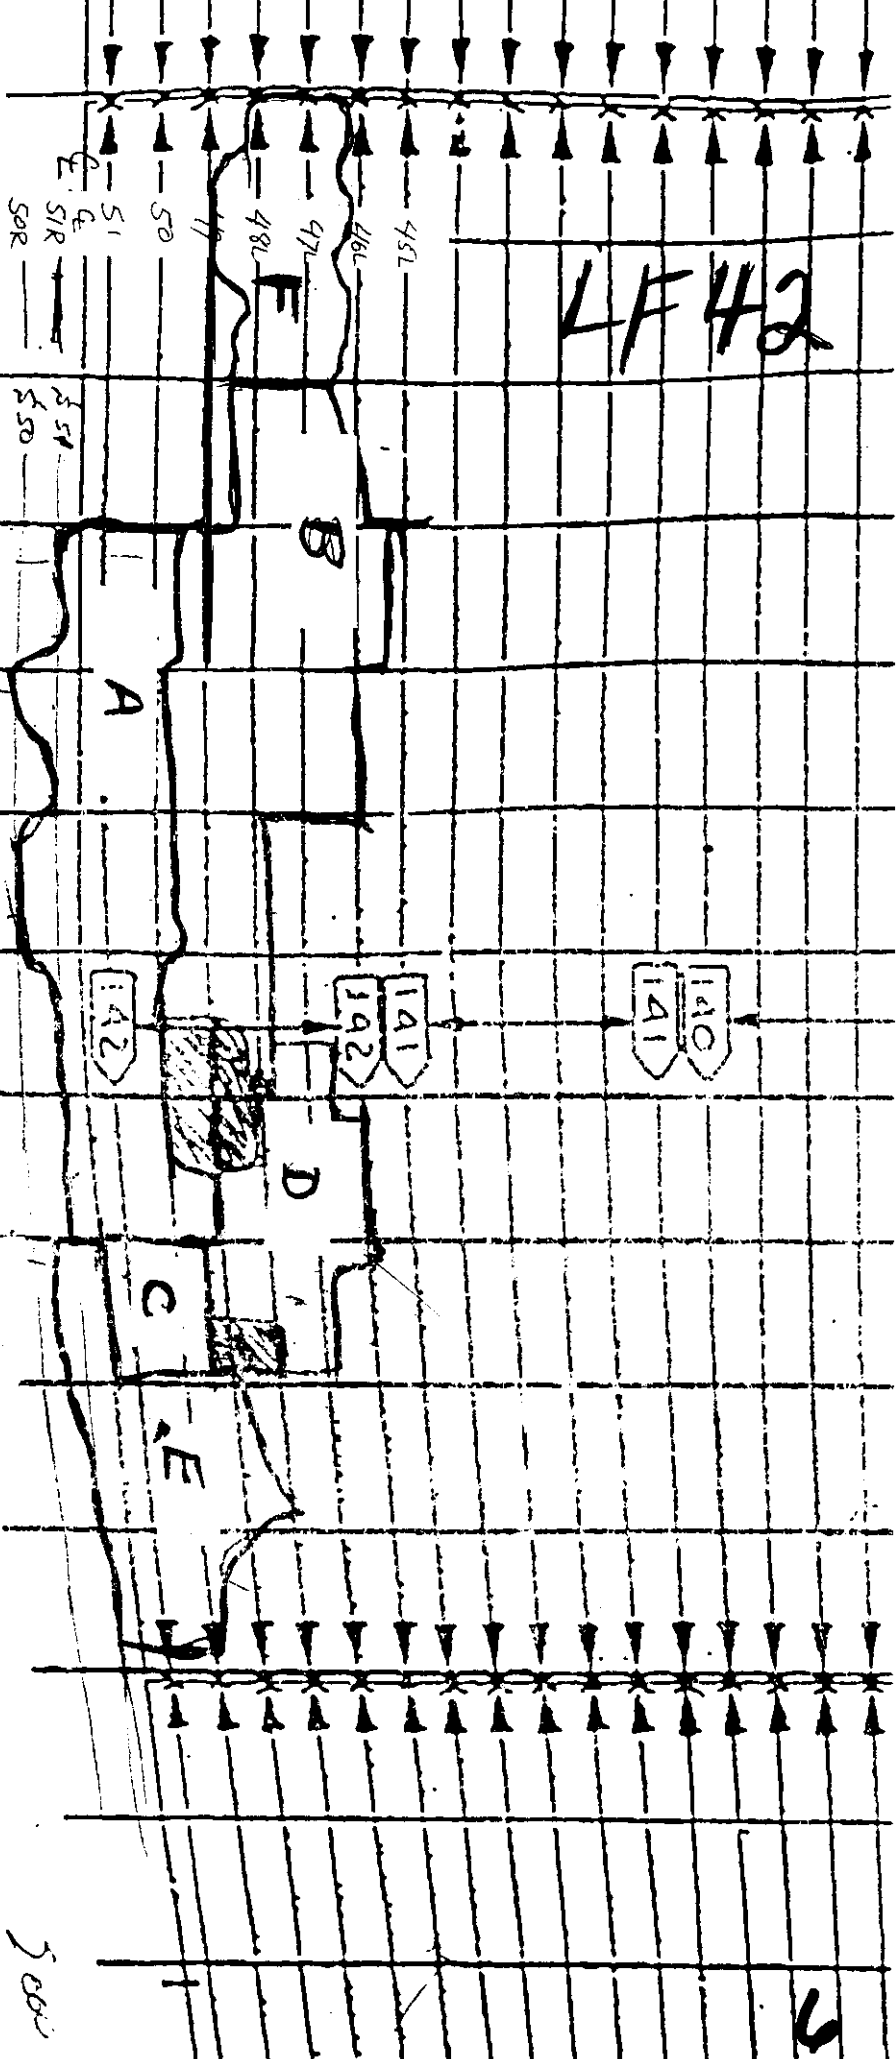
LF 42

This SECTION OF FUSELAGE MEASURES APPROXIMATELY 2 1/2' x 2' (WITH APPROX 6 1/2' OF STRINGER S 49L ATTACHED).

THIS SECTION ENCOMPASSES FRAME STATION 1780 THRU STA 1741 (BUTT LINE), AND STRINGERS ^{LOCATION} S 46L THRU S 49L

- a) STRINGER S 46L MISSING
- b) STRINGERS S 47L, S 48L, + S 49L FRACTURED AND BENT.

FUSELAGE SKIN JAGGERED AND BENT OUTWARD ALONG S 47L, AND AT OTHER LOCATIONS ALONG EDGES.

FUSELAGE SKIN PUNCTURE (OUTWARD) AT STATION 1760 BETWEEN STRINGERS S 48L + S 47L.

NO EVIDENCE OF FIRE OR SMOKE DAMAGE

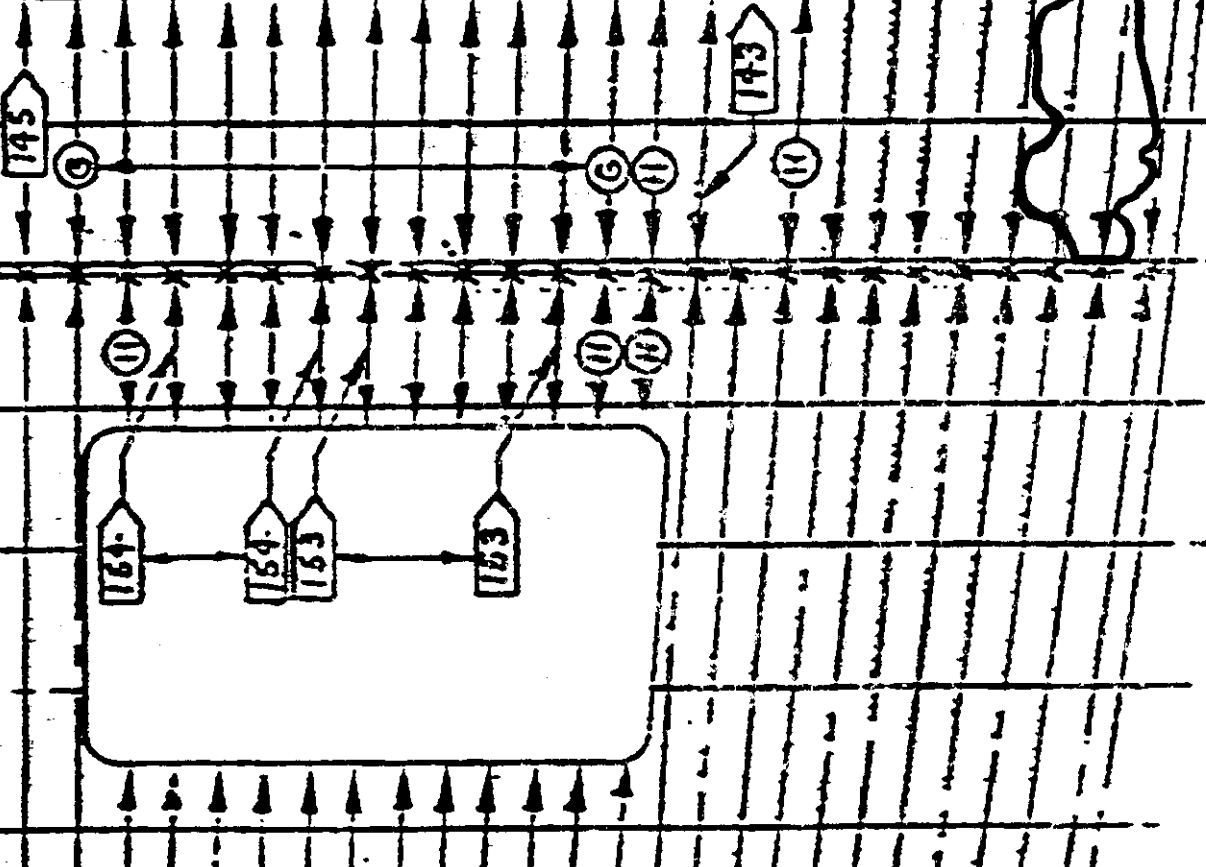
LOG # LF42G

SKIN SEGMENT, STA 1961.10 TO STA ~1916,
STG 48R TO STG 51R.

- 1) THE SKIN GAGE APPEARS TO BE APPROXIMATELY .07 TO .08 INCH THICK
- 2) THE FWD END OF THE PANEL, STA ~1916 TO ~STA 1921 APPEARS TO BE BENT INBOARD AND AFTWARD.
- 3) IT APPEARS THAT ITEMS OF MASS MAY HAVE EXITED THE AIRPLANE AT THE FOLLOWING LOCATIONS: STA 1926, STG 48R TO STG 49R; STA ~1942, STG 48R TO STG 49R. EDGES CURL O/B.
- 4) THE SKIN PANEL APPEARS TO BULGE INWARDLY BETWEEN EACH ~~STRINGER~~ ADJACENT STRINGERS.

- 1) STG 49R REMAINS ATTACHED FROM STA ~1920 TO ~1952.
- 2) STG 50R REMAINS ATTACHED TO THE PANEL FROM STA ~1920 TO STA ~1960.
- 3) HALF OF A STRINGER SPLICE FTG REMAINS ATTACHED AT STG 50R FROM STA 1954 1/2 TO STA 1960.

- 1) FRAME SHEAR TIE PORTIONS (LEG AGAINST SKIN PANEL) REMAIN ATTACHED AT STA 1940, STG 5-50R TO 5-51R, AND AT STA 1960, STR 49R TO 50R AND STR 50R TO 51R.
- 2) OUTBOARD SURFACE OF THE SKIN PANEL APPEARS TO BE MODERATELY SOOTED.
- 3) FRACTURE SURFACES APPEAR TO BE DUCTILE FAILURE.

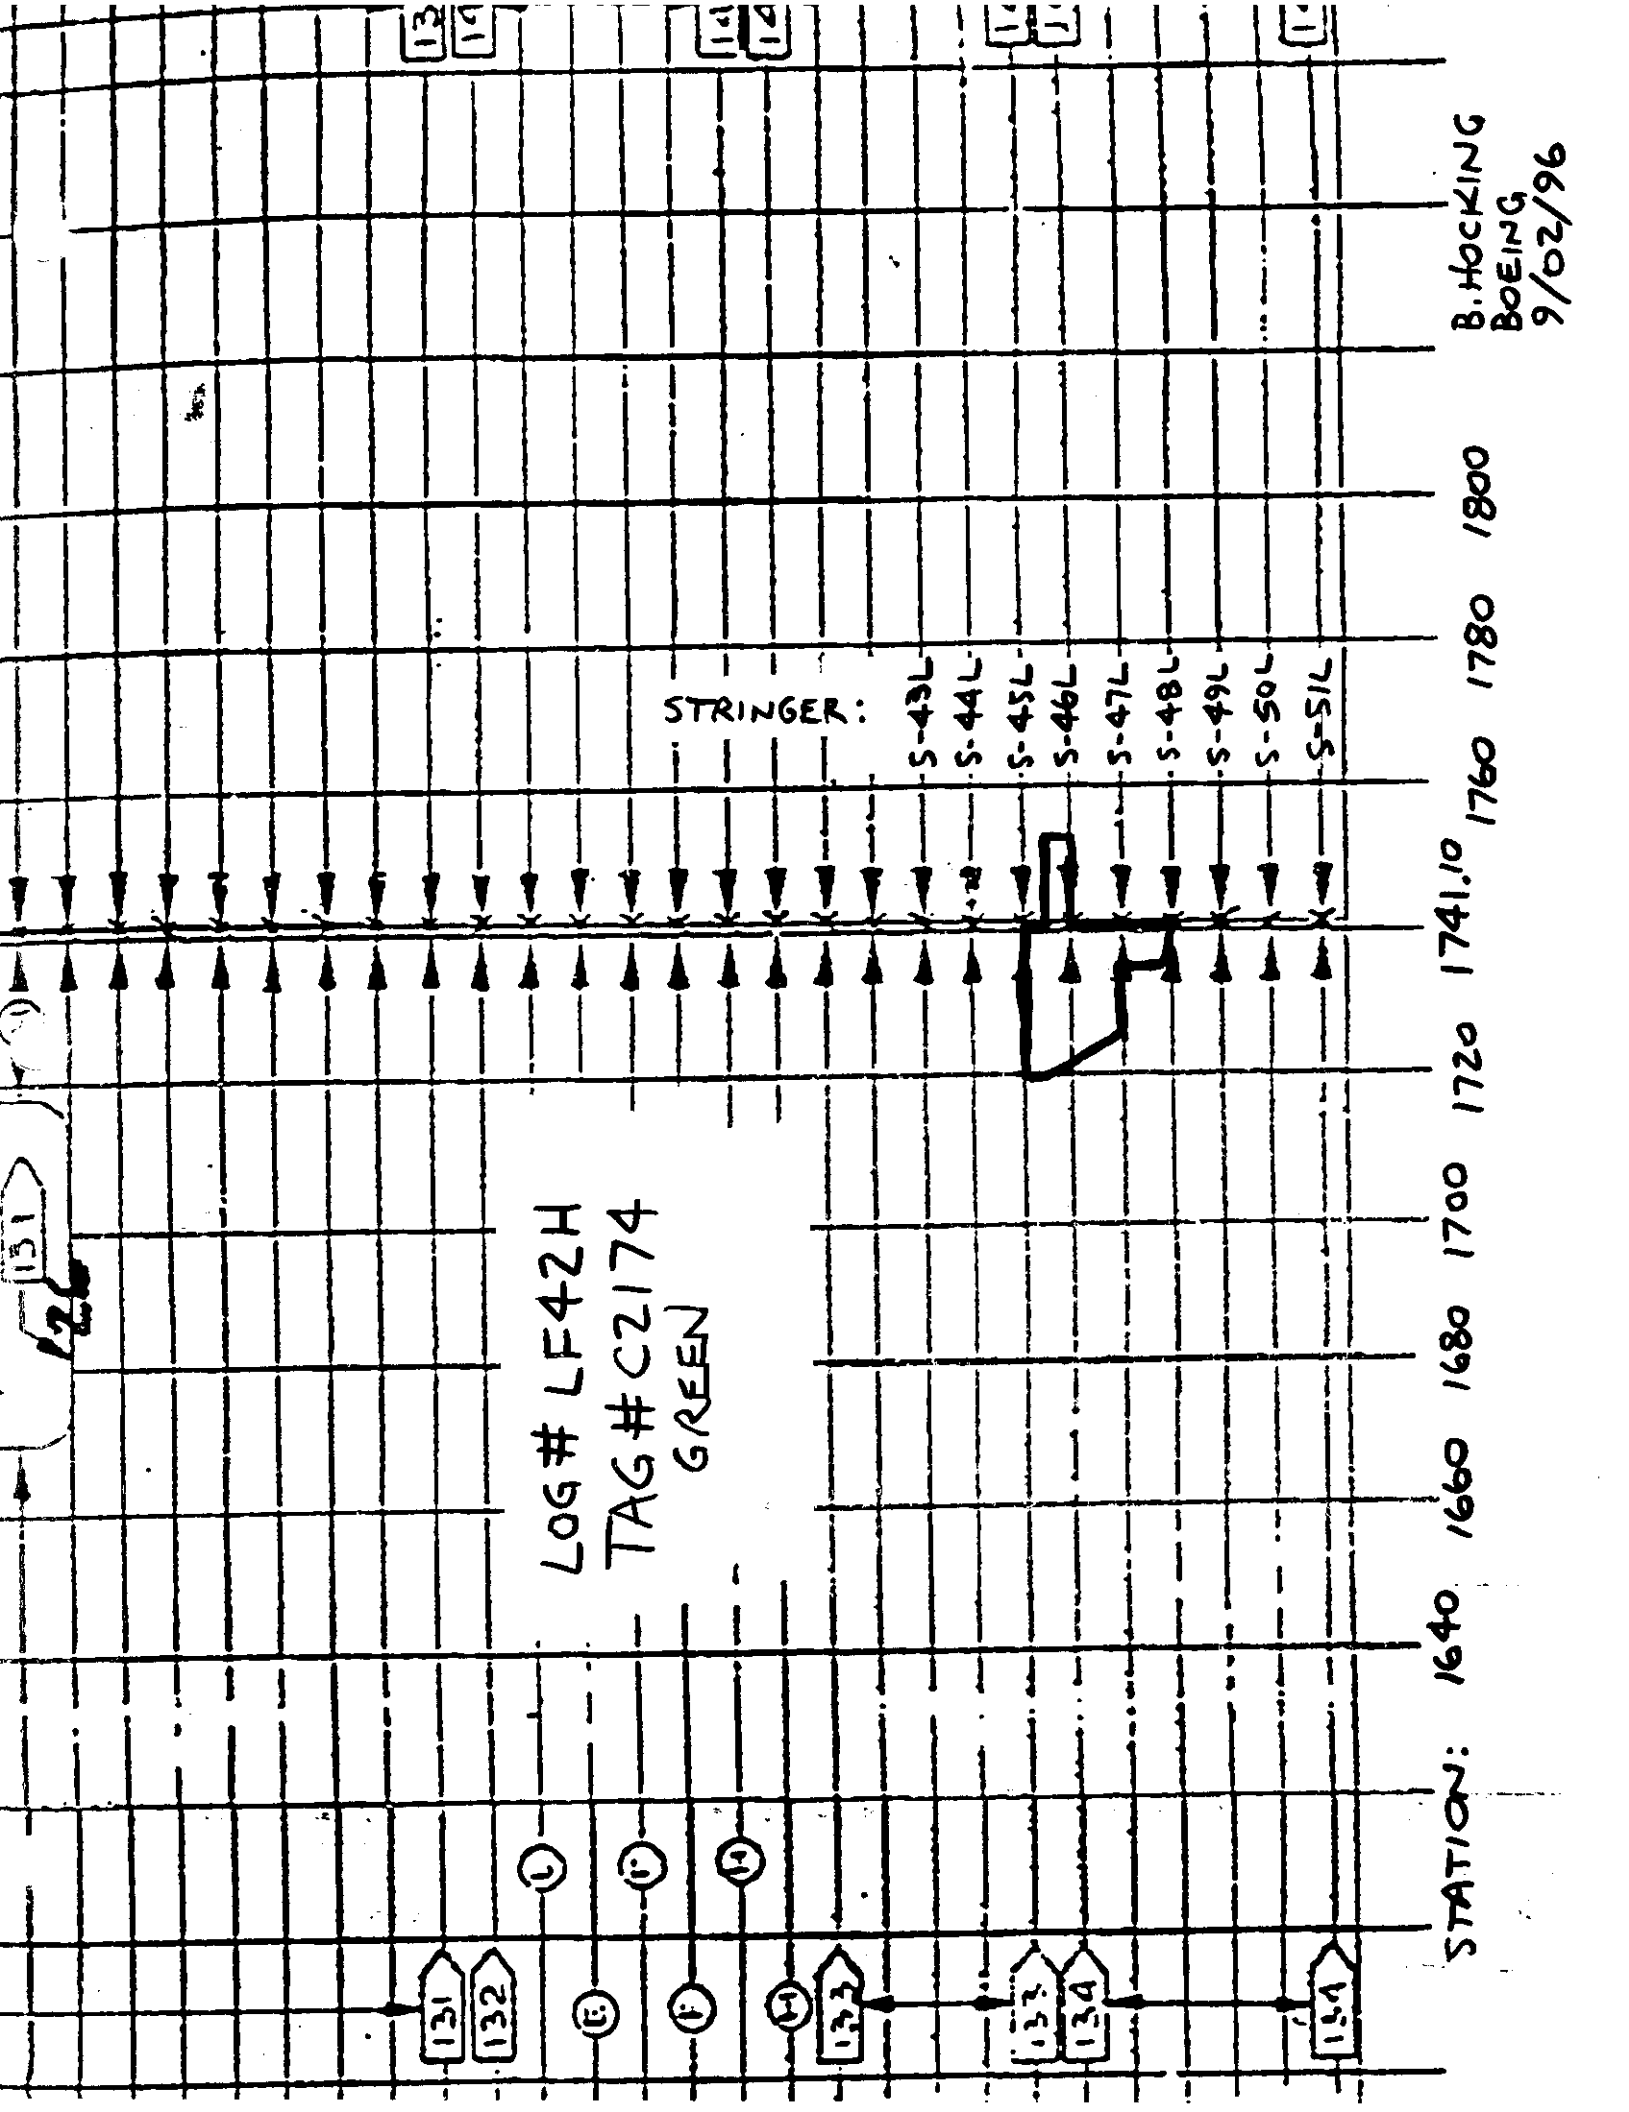
LOG # LF42H

PANEL SEGMENT, STA 1720 TO 1750,
STG 45L TO 48L

- 1) REGION INCLUDES THE INTERSECTION OF TWO SKIN SPLICES. THE CIRCUMFERENTIAL SPLICE AT STA 1741.10 IS REPRESENTED FROM STG. 45L TO 48L. THE LONGITUDINAL SPLICE AT STG 46L IS REPRESENTED FROM STA 1720 TO 1750.
- 2) THE SKIN IS OF HEAVY GAGE, ~0.160 TO 0.180 INCH, HOWEVER IT APPEARS THAT SOMETHING OF MASS EXITING THE AIRPLANE THRU IT CENTERED AT ABOUT STA 1730, STG 48L. TAKEN AS A WHOLE, WITH PANEL, LOG # LF53, IN THIS VICINITY, THE SKINS BEND OUTBOARD NOTICEABLE WITH A CENTRALIZED PORTION ATTACHED TO LF42H BENT OUTBOARD SIGNIFICANTLY.
- 3) AN EXTERNAL SKIN REPAIR APPEARS TO EXIST IN THE REGION STA ~1722 TO ~1734, STG 45 1/4 L TO 46L.

- 1) STG 45L REMAINS ATTACHED FROM STA ~1723 TO STA 1740
- 2) STG 46L REMAINS ATTACHED FROM STA ~1721 TO STA ~~1732~~ ~1752
- 3) STG 47L IS MISSING
- 4) STG 48L REMAINS ATTACHED FROM STA ~1732 TO STA ~1740
- 5) STRINGER CLIPS ARE PRESENT AT STA 1740 FOR STRINGERS 45L AND 46L.
- 6) STRINGER SPLICE FITTINGS (OR A PORTION OF ONE) EXIST AT STA 1740 FOR STRINGERS 45L, 46L AND 48L.

- 1) A SMALL PORTION OF THE STA 1740 FRAME REMAINS ATTACHED AT STG 46L.
- 2) THERE IS NO APPARENT SOOTING.
- 3) FRACTURE FACES APPEAR TO BE DUCTILE FAILURE.
