# LF45D

LOG # LF67 D,E

DEBRIS FIELD GREEN

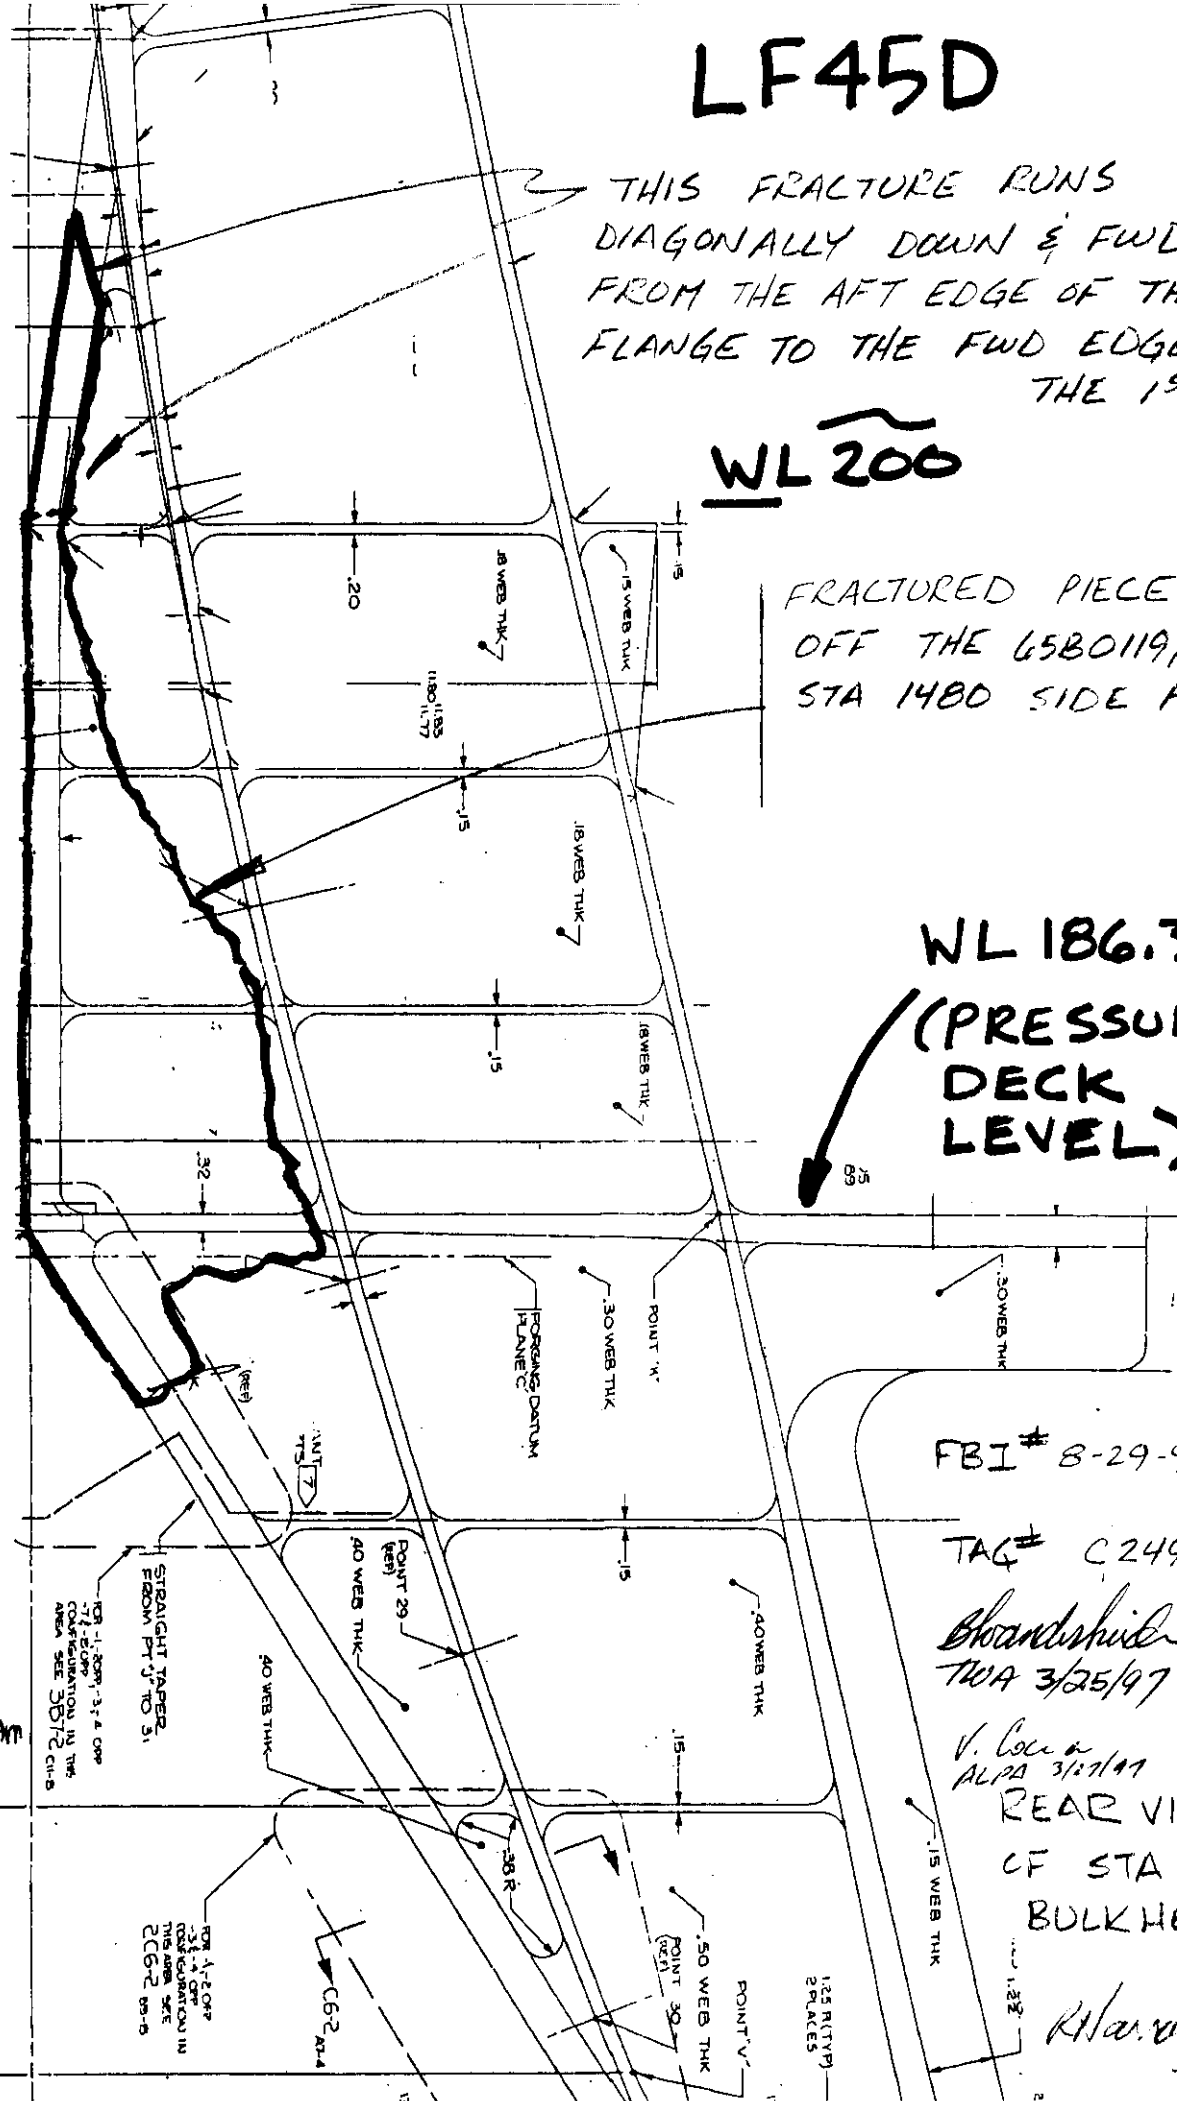
THIS FRACTURE RUNS  
DIAGONALLY DOWN & FWD  
FROM THE AFT EDGE OF THE  
FLANGE TO THE FWD EDGE AT  
THE 1<sup>ST</sup> RIB.

FRACTURED PIECE  
OFF THE 65B01191  
STA 1480 SIDE FTG

REAR VIEW  
OF STA 1480  
BULKHEAD

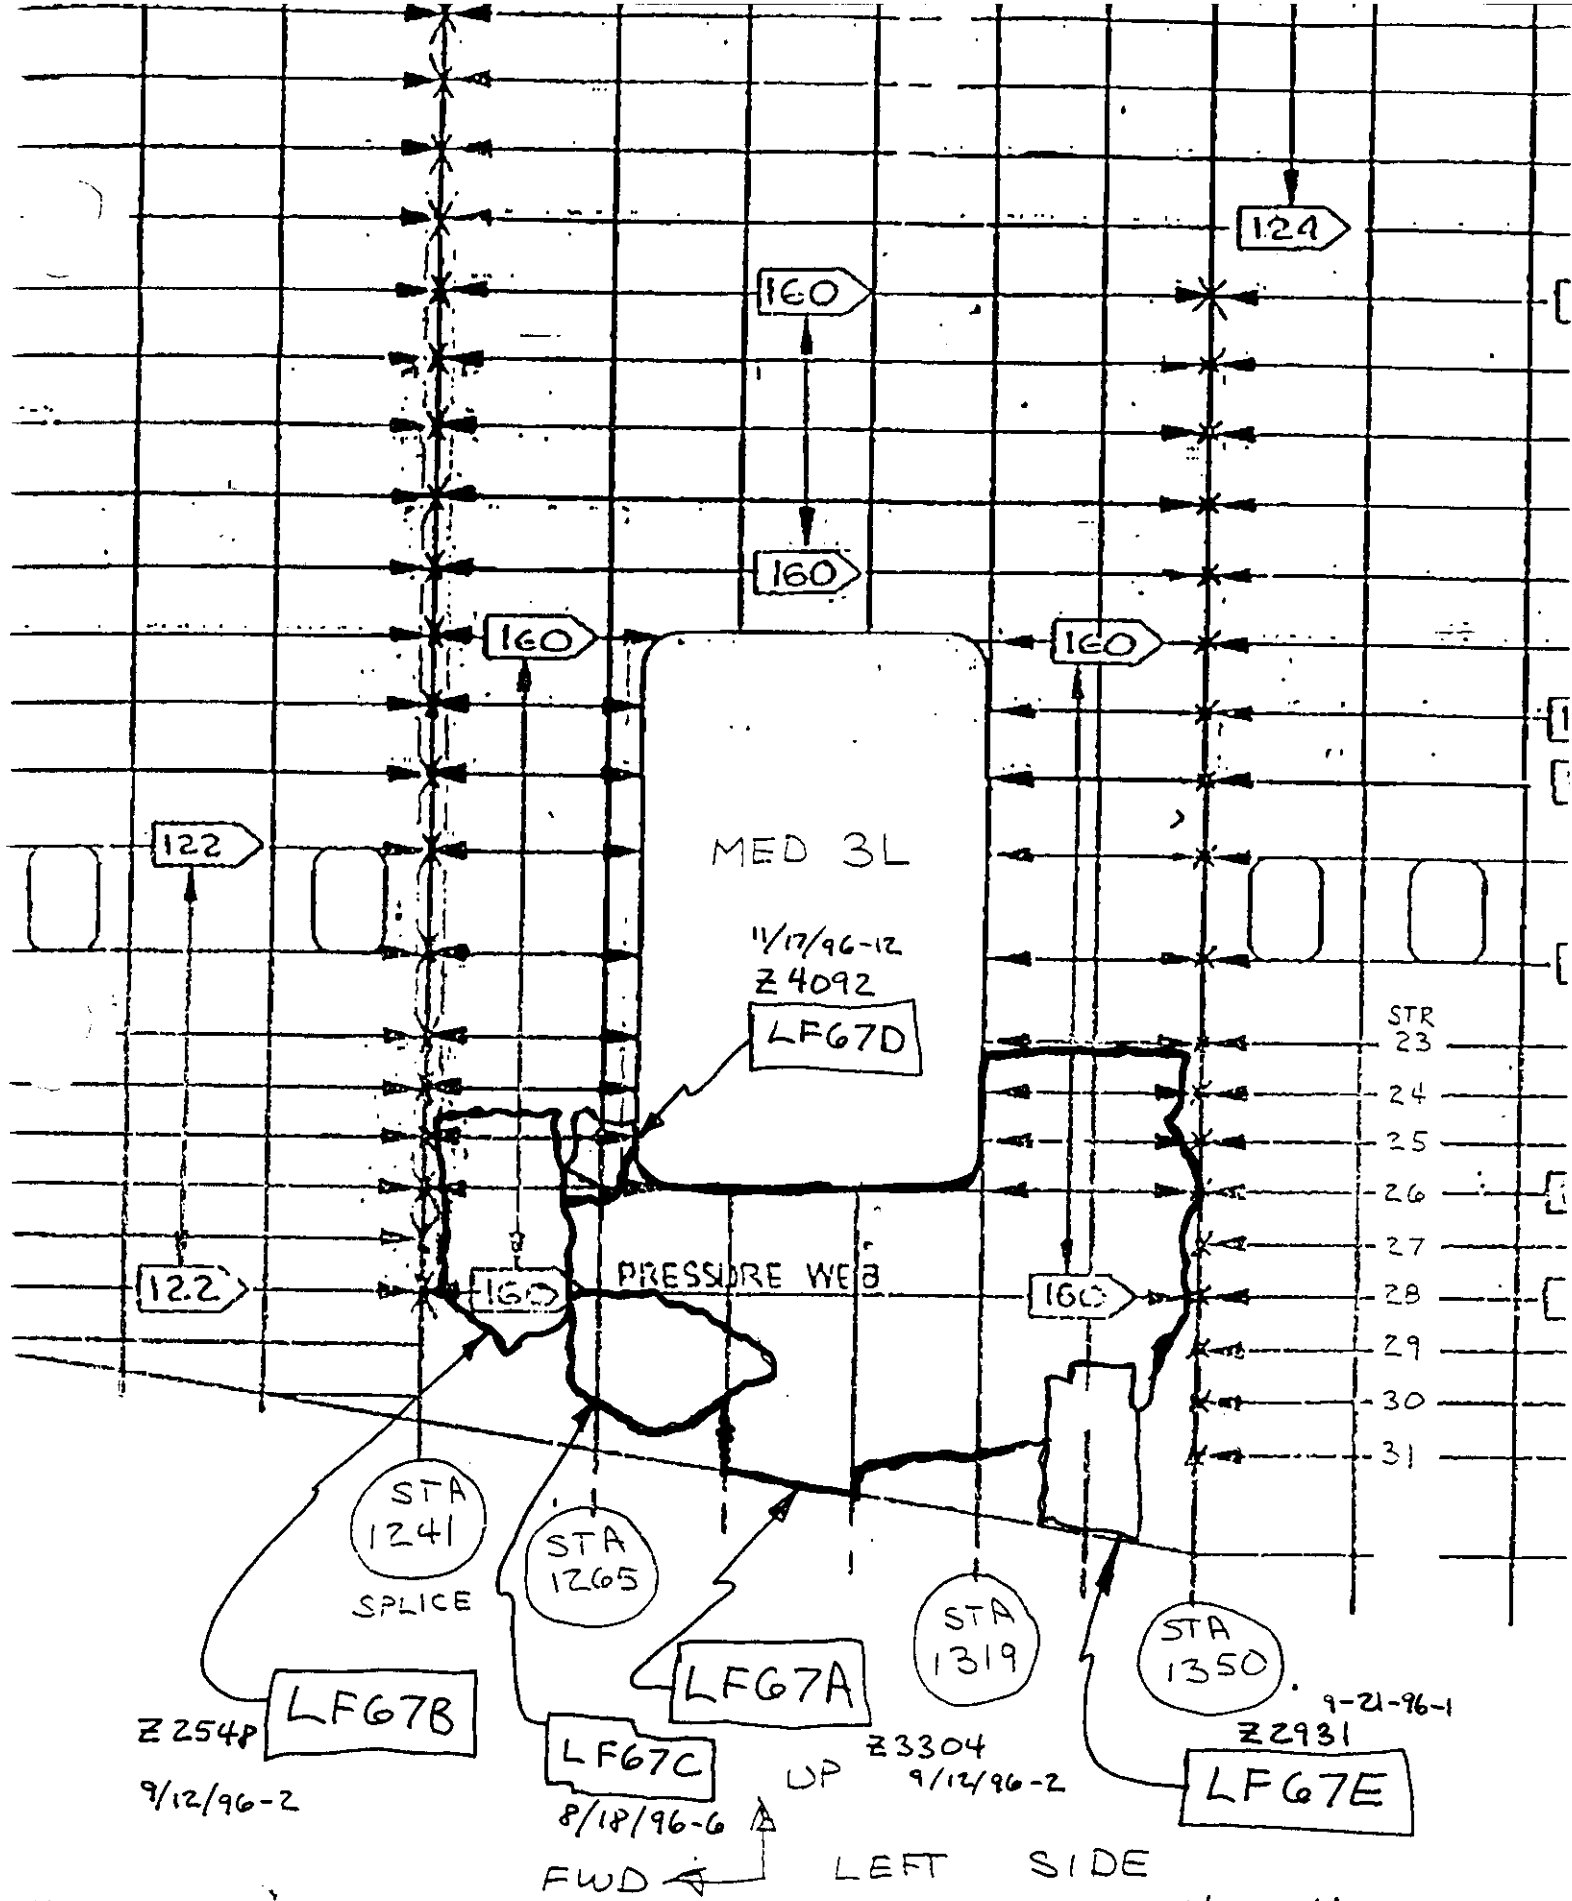
LF67D Z4092 11-17-96-12

LF67D is a piece of fuselage outer skin, disbonded from its underlying doubler, at the lower forward corner of the main entry door 3L cutout. This skin was covered by the steel corner doubler, that is part of LF67A. This part mates to LF67A. The exterior is pock-marked and both sides are scored. THIS SECTION IS SLIGHTLY BOWED INWARD.

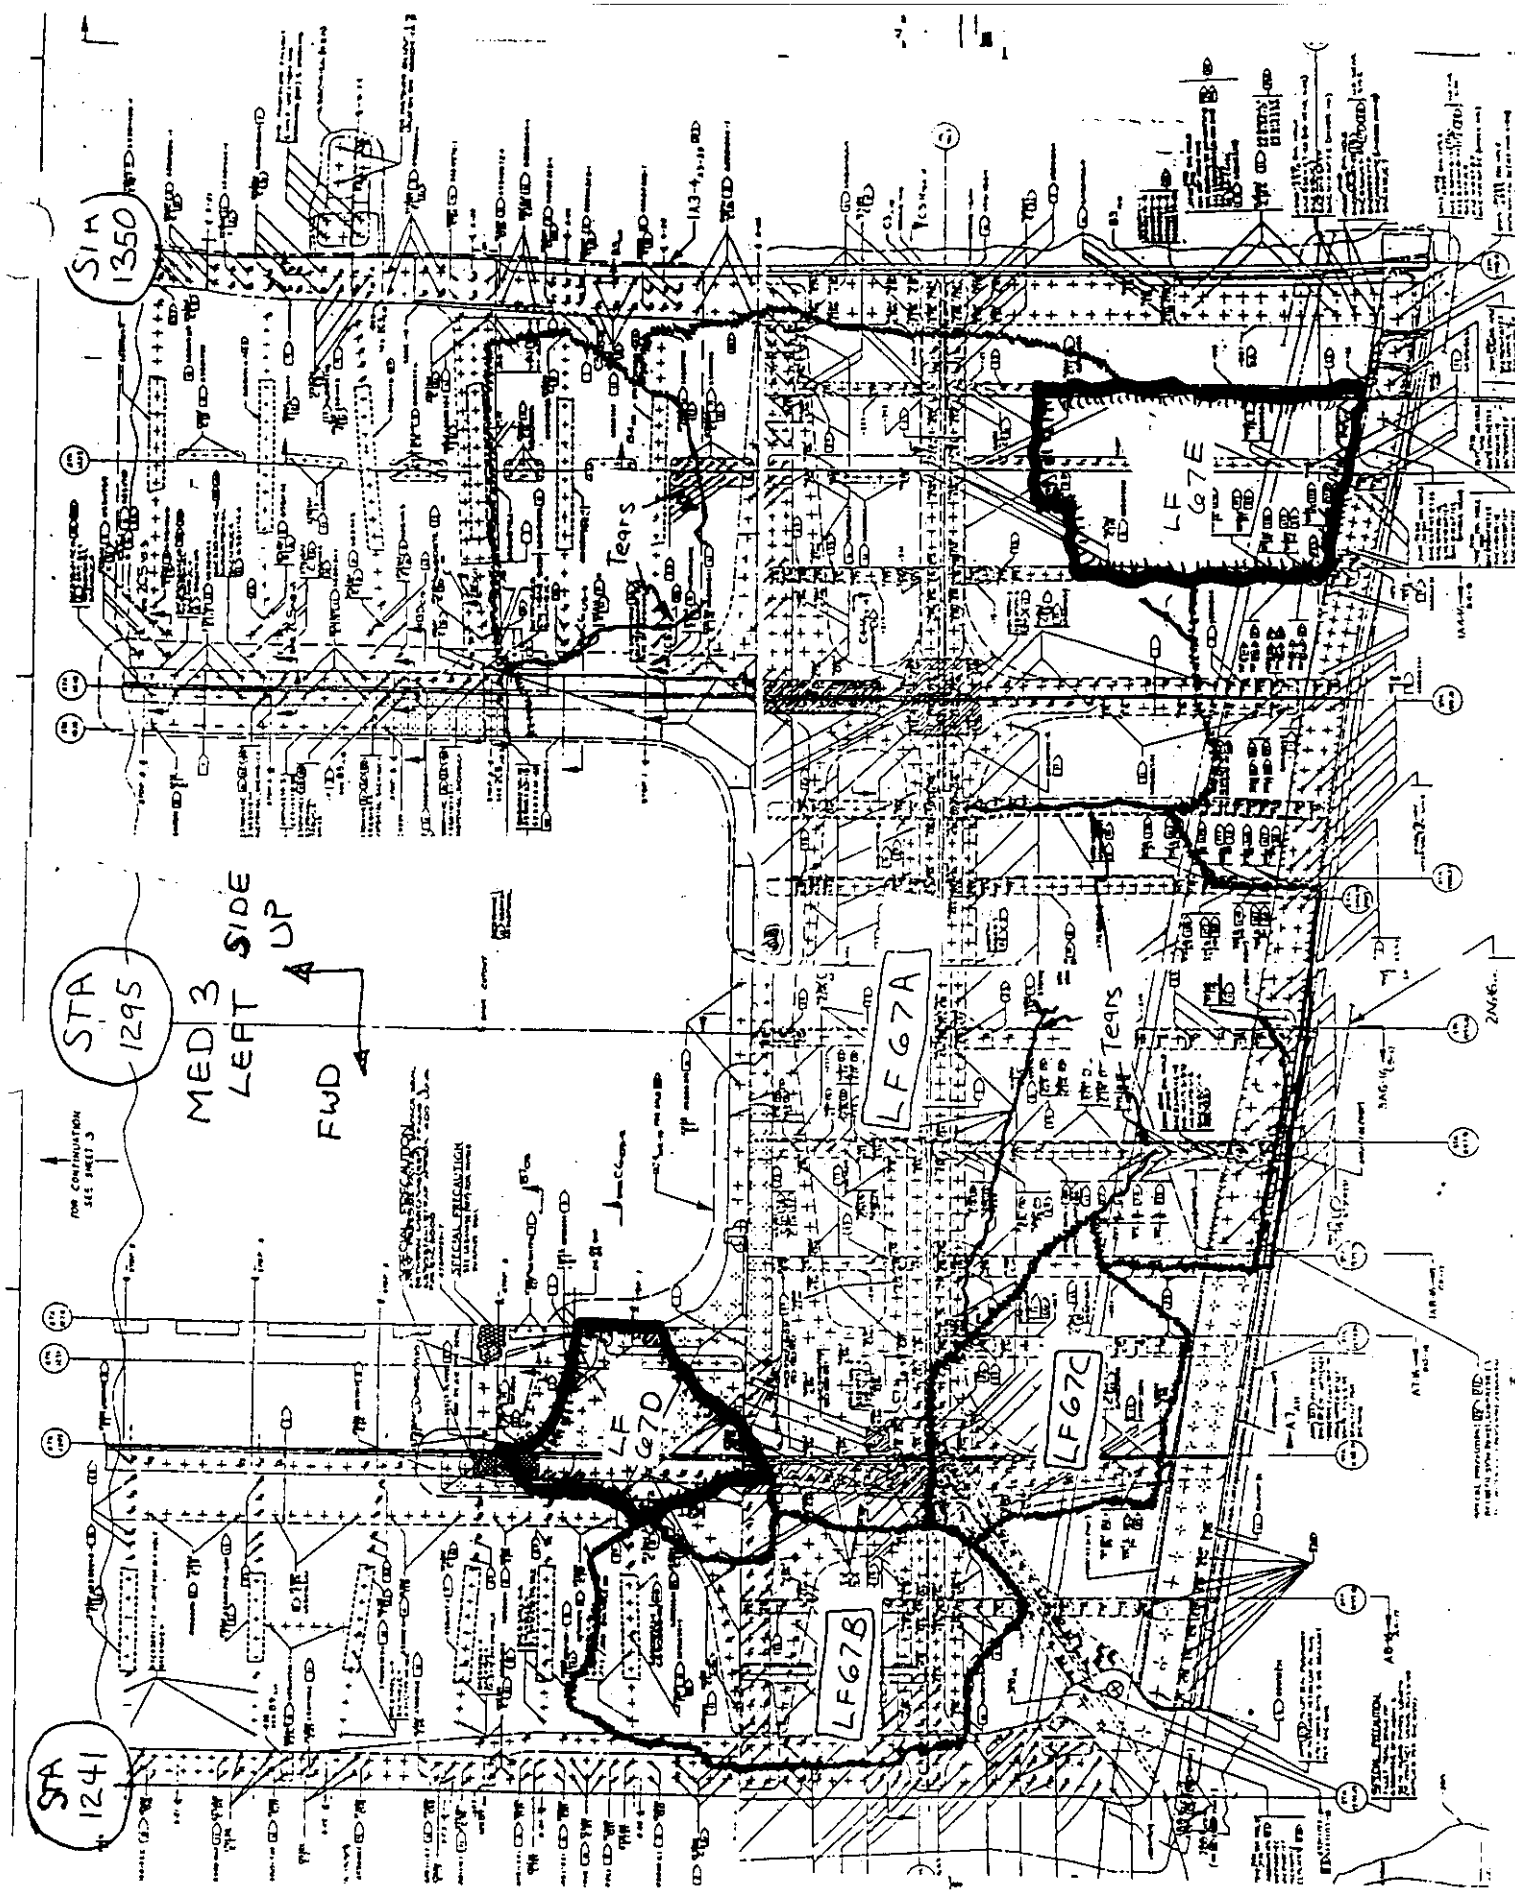
LF67E Z2931 9-21-96-1

LF67E is a piece of fuselage skin above the overwing longeron between Sta 1328 to 1340.

It is along the fastener lines at Sta 1328 and 1340. This part mates to LF67A, LF71A, and LF179A. THIS PART IS FOLDED 180°
