LF-5

65B00005 3

LOG # LF 5 RTS 10  
509  
 TARGET # LLS-46 (5)  
 COORD: LAT 40-38-42  
 LONG 72 39 07  
 DEBRIS FIELD # 3  
 Pg 115 (near field)

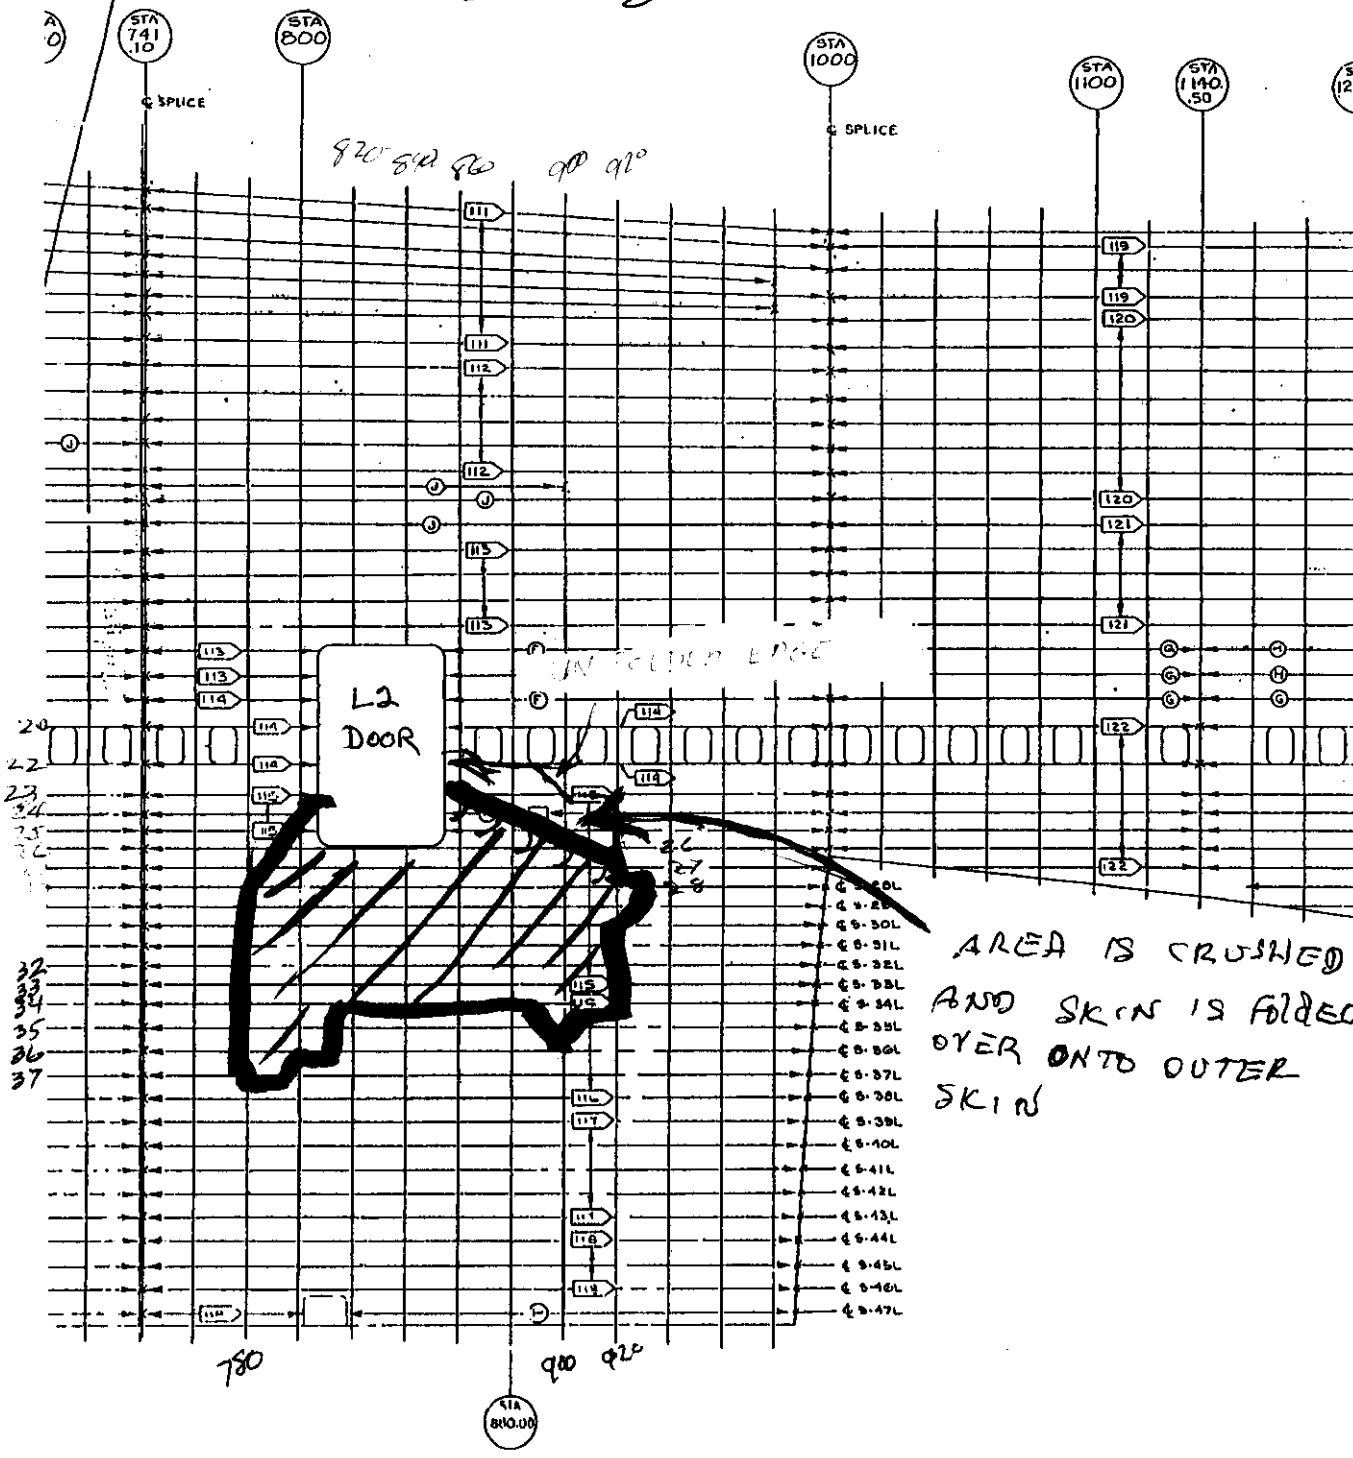
NOTED DAMAGE!

1- FUSELAGE FRAME STA 840 BENT FWD

2- FUSELAGE SKIN + STRINGERS FROM STA 920-900 BENT FWD.

3- FUSELAGE SKIN COPIES OUTWARD FROM S27L @ STA 930 TO STA 853

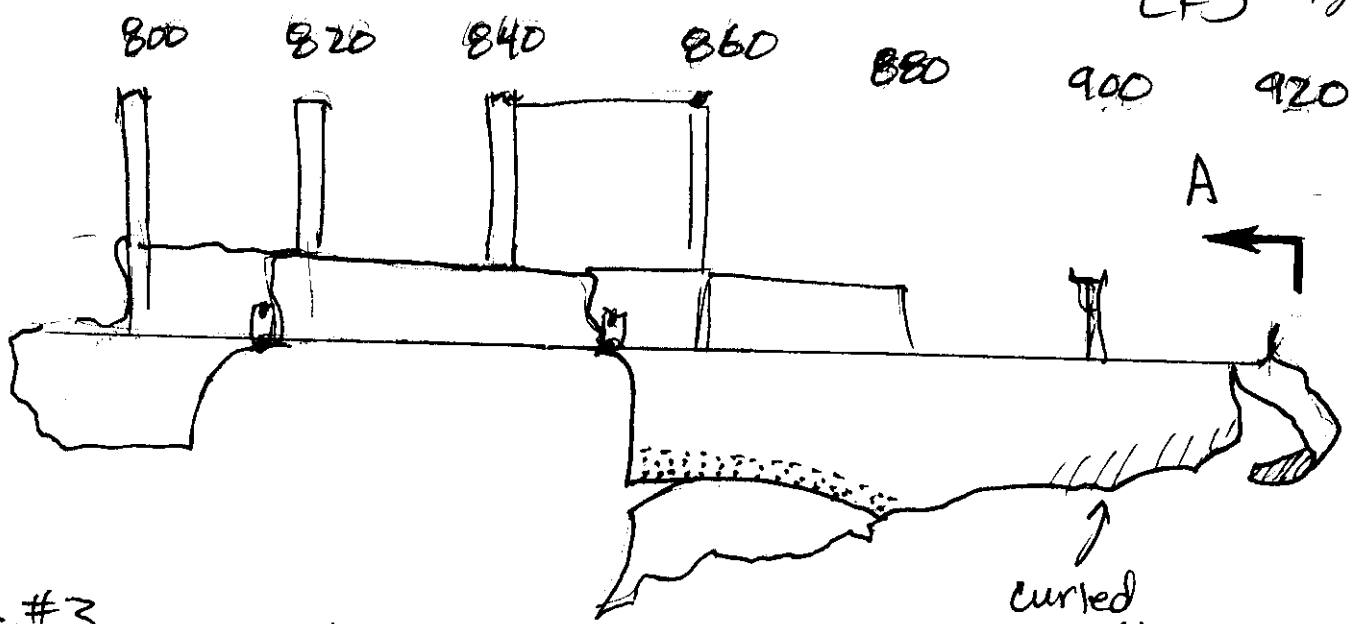
Area #3  
 Red Tag  
 #A022

VIEW LOOKING DOWN  
 LHS

curled  
 Fwd/down

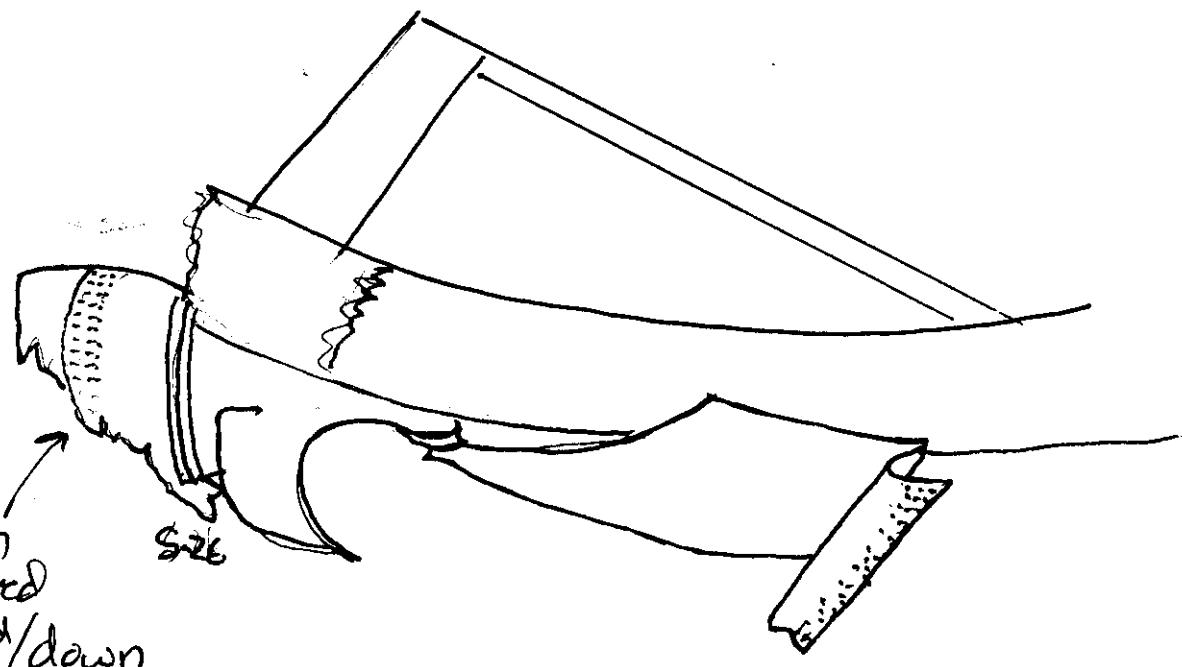
VIEW A-A  
 LOOKING AFT

skin  
 curled  
 Fwd/down
