LOG # LFS2

TAG # C611

SKIN & STRINGERS, STA 2020 TO 2160, S45L TO S45R

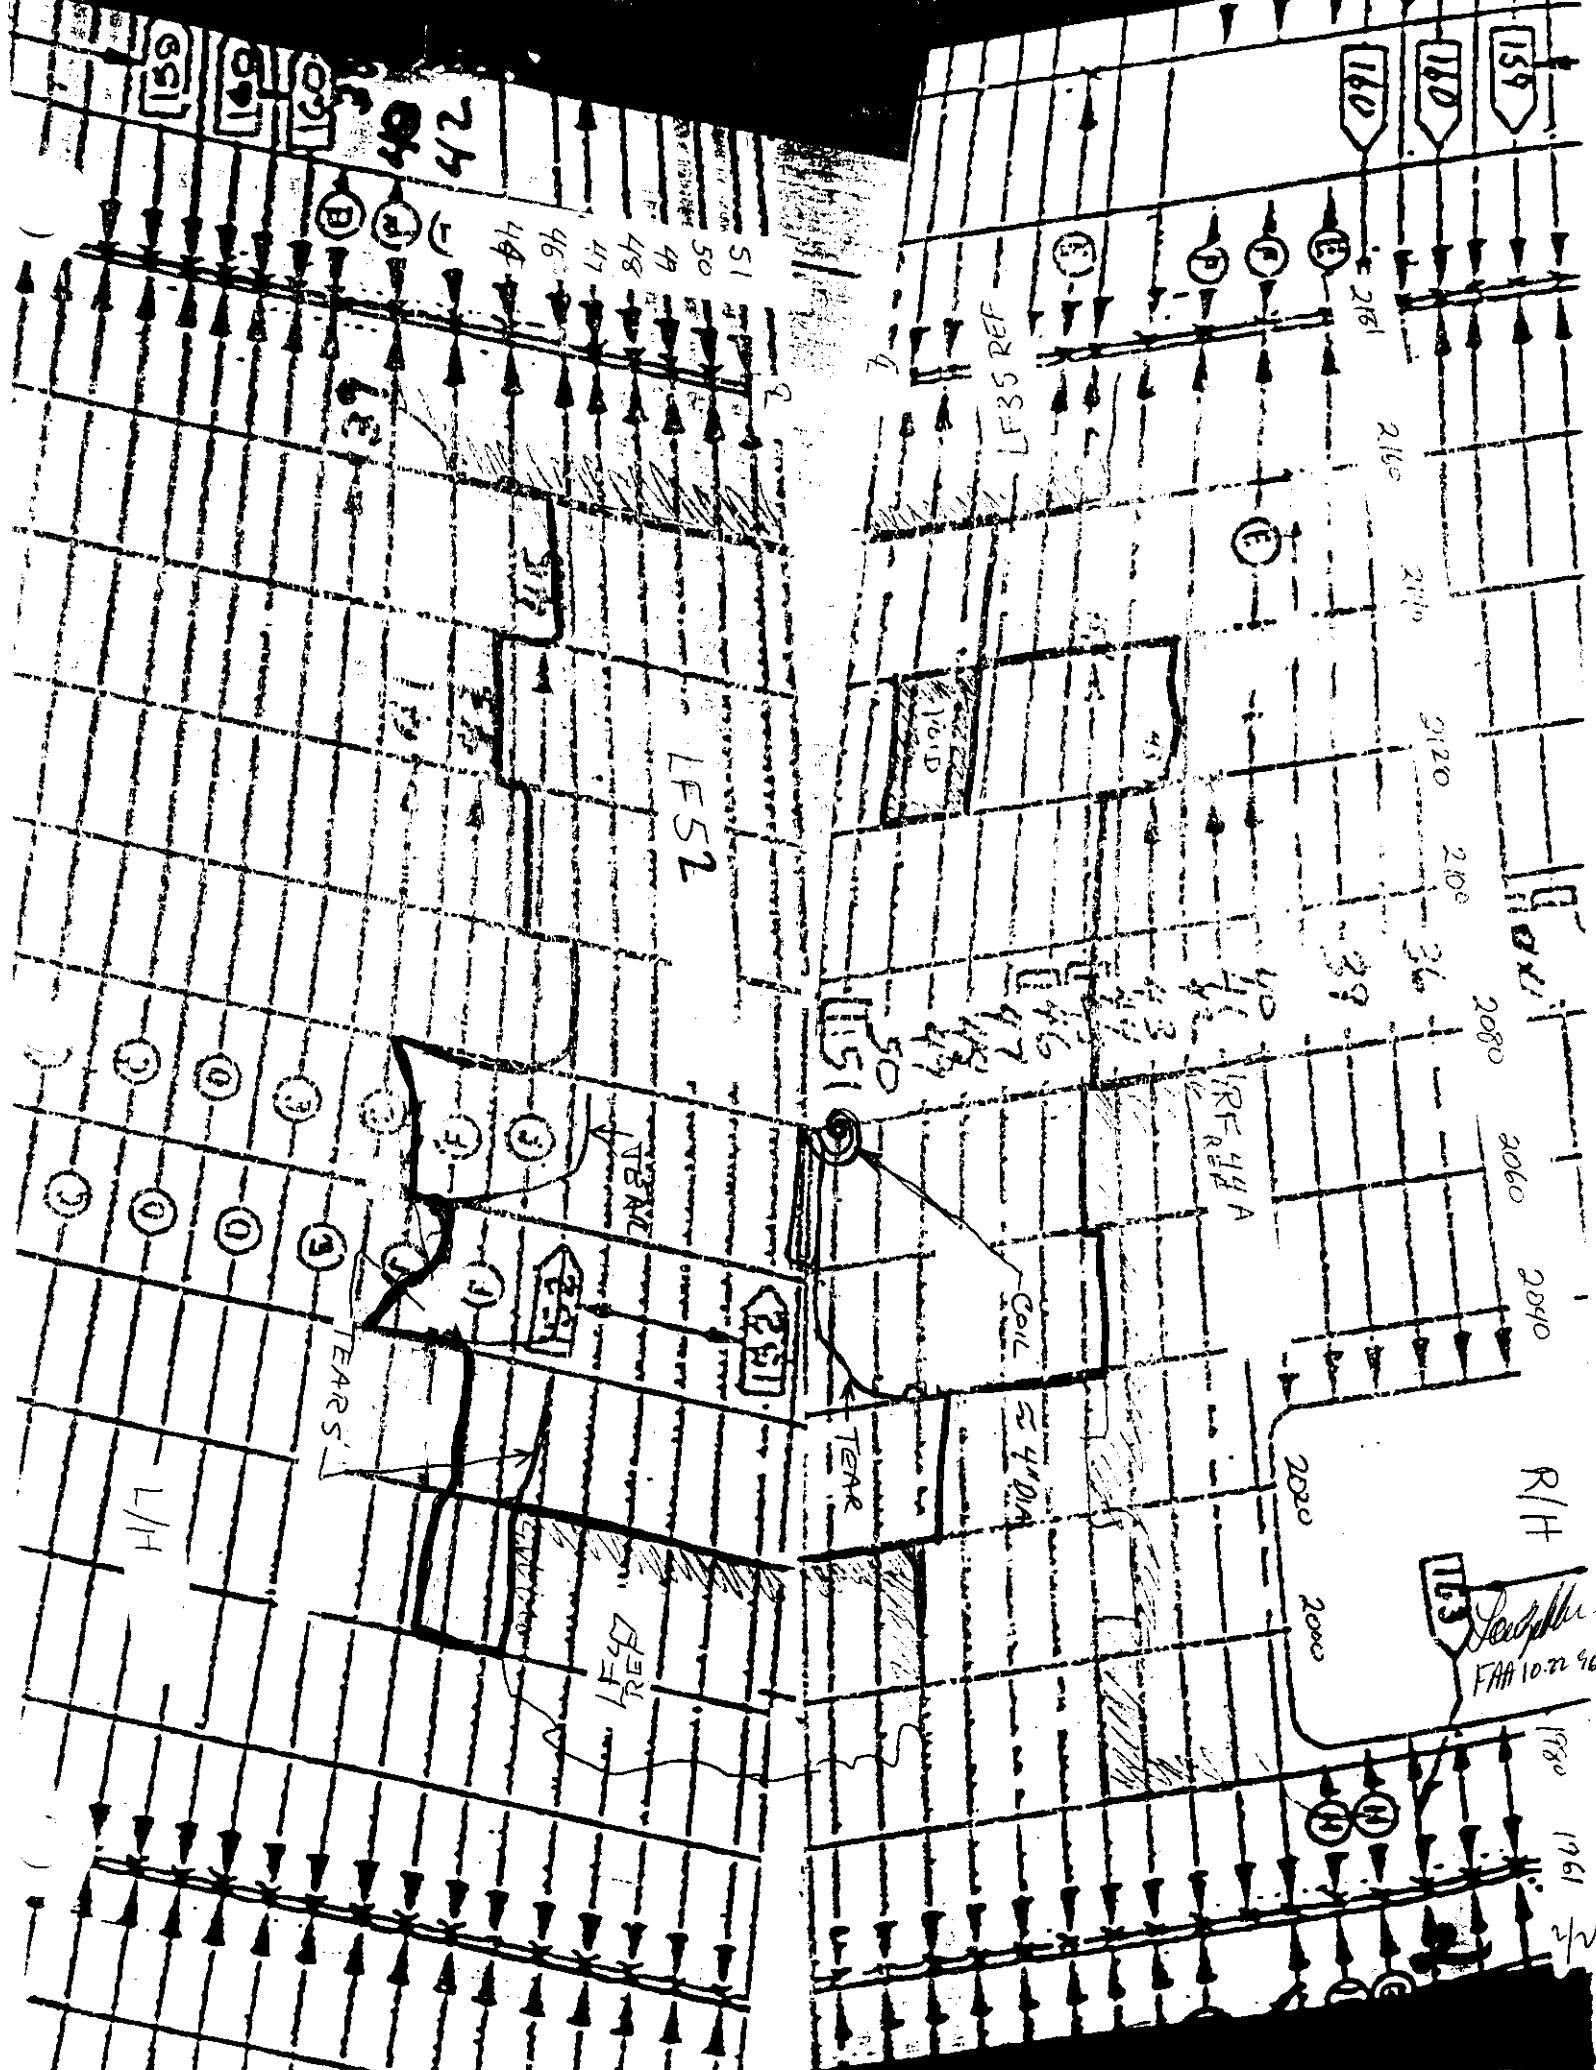
- RED PAINT IS VERY DARK BTWN S46L & S51R (NOT SOOT OR FIRE APPEARANCE)
- MULTIPLE OUTWARD PUNCTURES AND TEARS WITH MOST COILINGS AFT AND ORIGIN IS WITHIN 1" OF FRAME/SKIN INTERSECTIONS
- 1 COIL OUTWARD AND AFT RUNS FROM STA. 2060 TO 2080, BTWN S51L & S51R,  $\approx 4"$  DIA  $1\frac{1}{2}$  COILS
- BENT  $\approx 90$  OUTWARD @ STA 2060 BTWN S51L AND S46L
- ABOVE S46L @ EACH TEAR, SKIN ROLLED AFT AND OUTWARD  $90^{\circ}$ - $120^{\circ}$
- STRINGERS ARE CRUSHED AT EACH FRAME AND MOST FRACTURED INTO 20" SEGMENTS
- SKIN DIMPLED INWARD  $\frac{1}{2}$ " TO 1" BETWEEN STRINGERS (CORRUGATED METAL APPEARANCE)

REFER FIRE AND EXPLOSION GROUP NOTES FOR FIRE DAMAGE
