LOG # LF 53 <sup>10-10-96</sup>

**GREEN C-700**

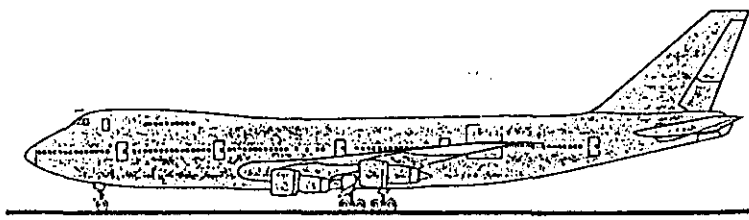
LF53

This section of fuselage skin measures approx 12' x 4 1/2' and encompasses station locations 1680 thru 1800 and stringer location S46L thru S51L, (C) and S51R + S50R. Stringers S47L, S48L and S50R are missing, S49L missing aft 1760. Remaining stringers are fractured and cracked. Stringer S50L is missing section between STA 1700 thru 1740. Fuselage skin between stringers S51R and S51L sheared and rolled inward from STA 1800 to lap seam (STA 1741). Section of fuselage skin from STA 1720 to lap seam (STA 1741) curled out from S49L to S46L. Skin is sheared at STA 1700 (from S47L thru S49L. Also skin pulled free of rivets between S50L and S51L.

NO EVIDENCE OF FIRE OR SOOT DAMAGE
