LOG # LF6 11-11-96  
SOS

Belly Skin from Aft end of section 42,  
from Front Spar Bulkhead to STA 740.

Section 42 AF Belly Skin

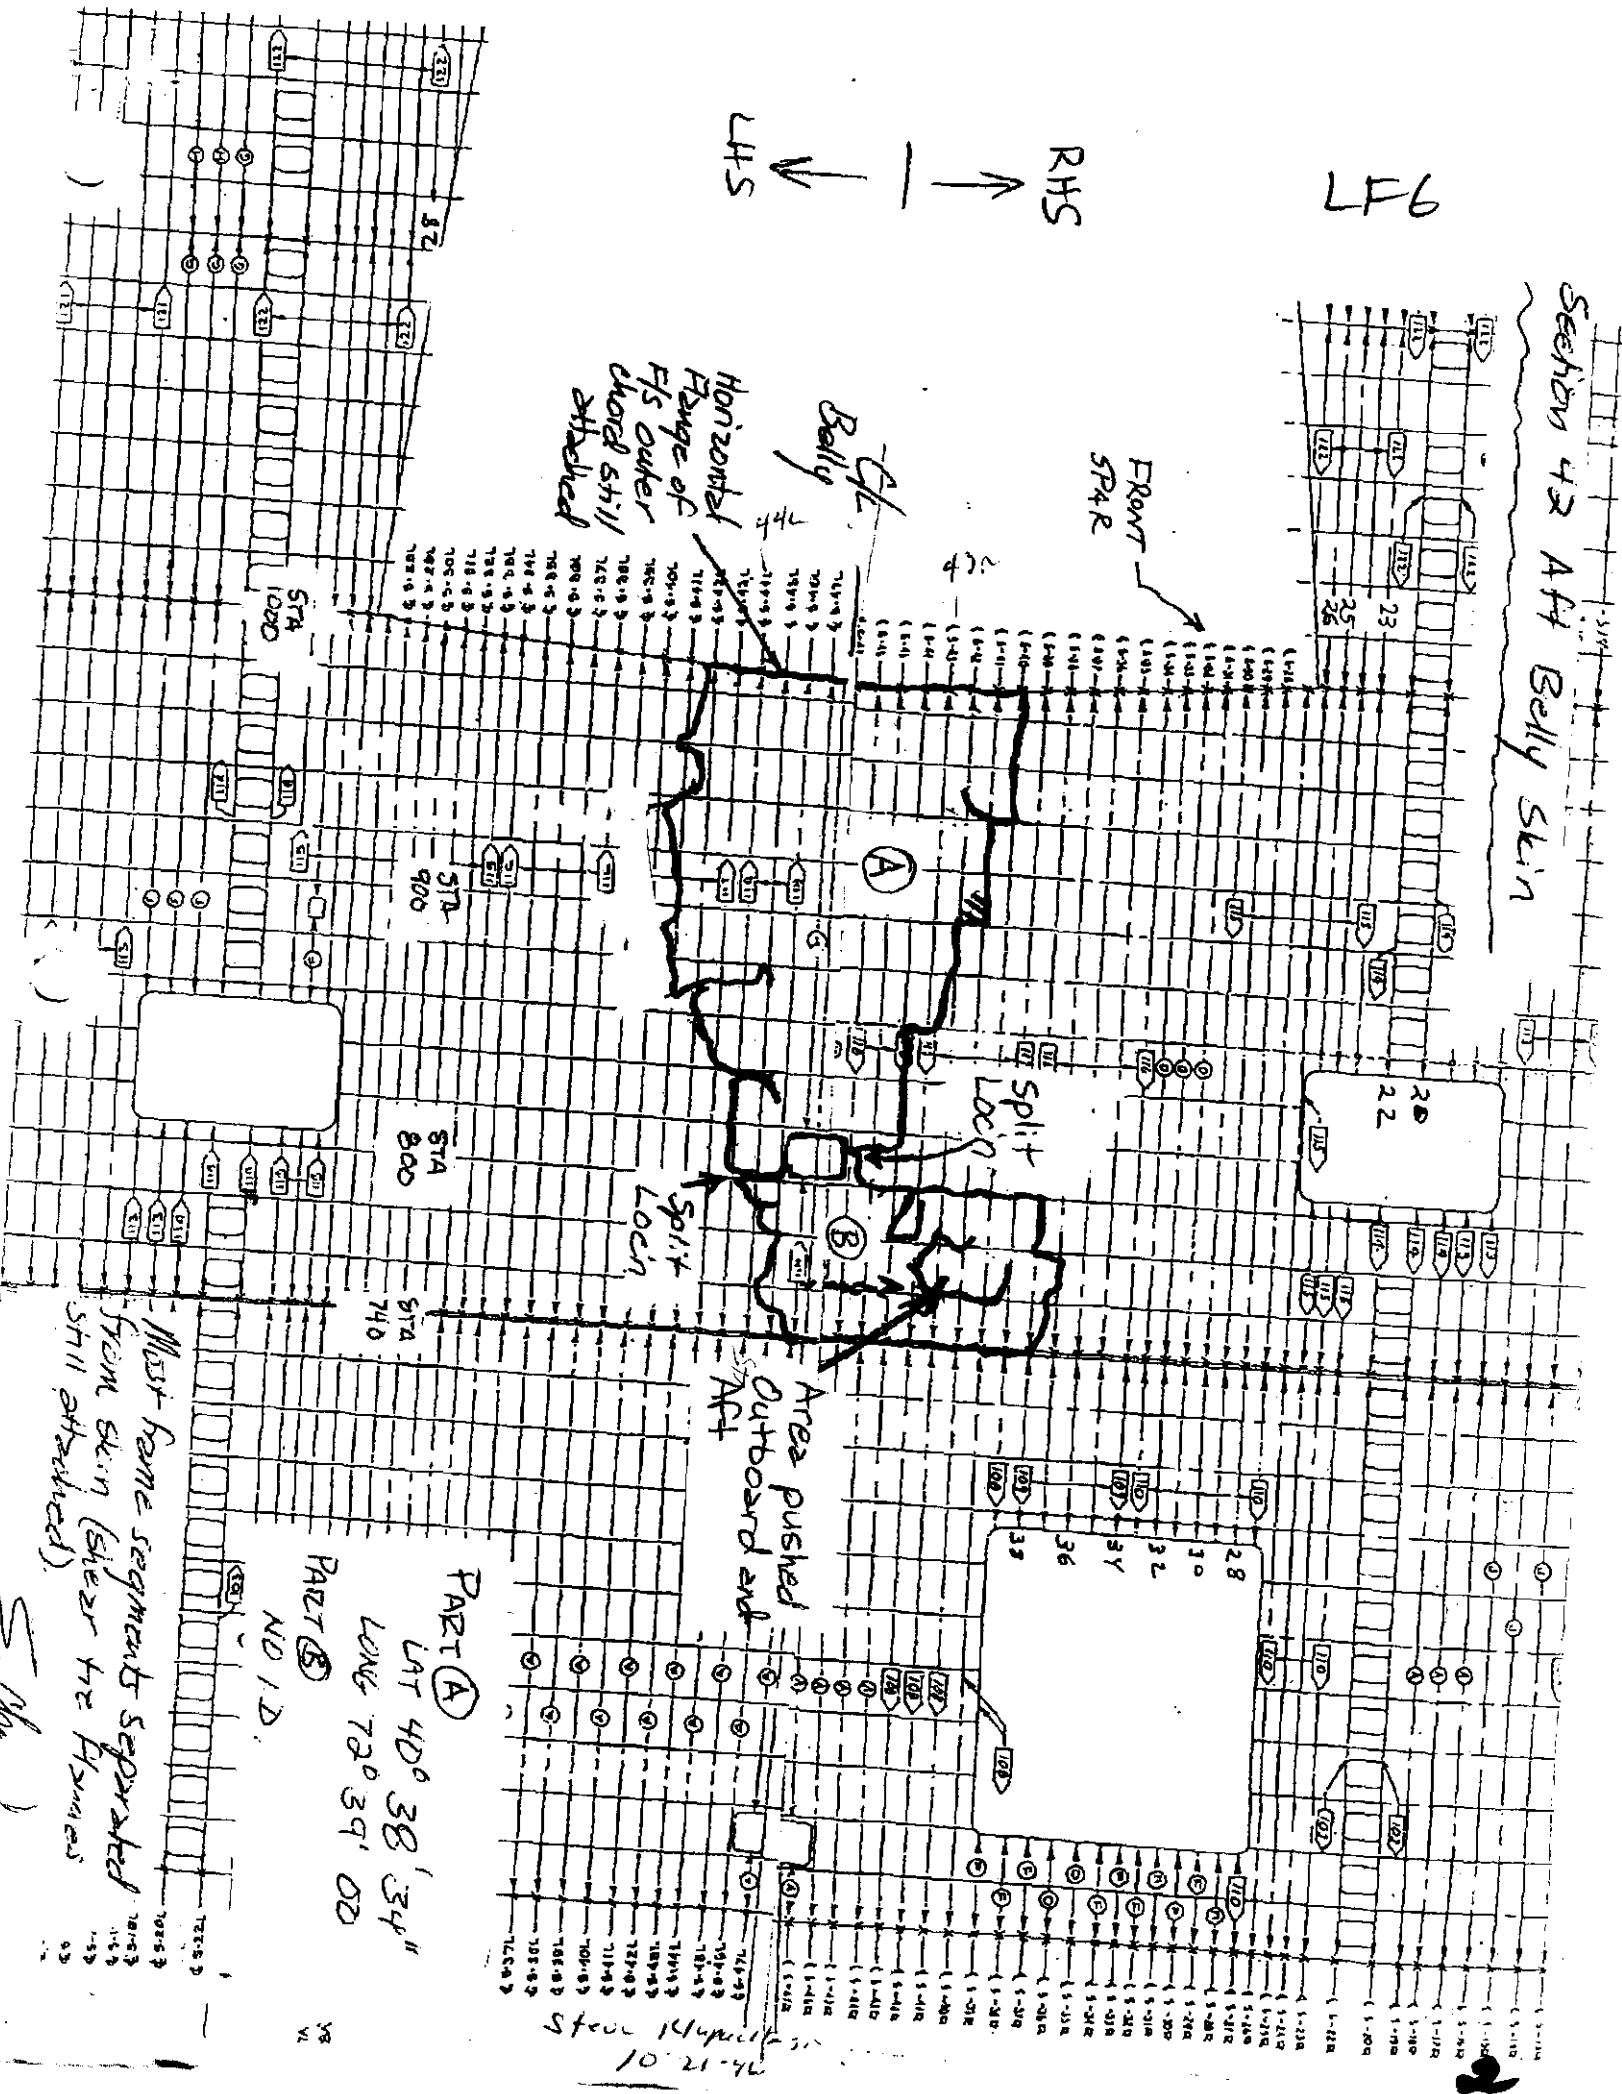
LF6

Debris is in 2 parts, Part (A) and (B) as shown on next sheet. Parts are separated through the electrical access hatch centered at 810. Most frames are not attached to the panels (except for the skin flanges of the shear ties). There are 4 of the deep web portions of frame web attached from STA 900 to 960 with some cargo floor attached. The horizontal flange of the front spar outer chord is still attached to the panel (billed at extrusion radius). No obvious sign of fire damage.

PART (B) HAS CONSIDERABLE WATER IMPACT DAMAGE (SKIN PUSHED INBOARD BETWEEN STRINGERS) & RESULTING BROKEN STRINGERS AND SKIN TEARS. NO FRAMES ATTACHED.  
R. Brackley IAM 10-24-96 at Peachtree Field 9/29/96  
Steve Klumpert I-AP 10-21-96  
B. Hocking (BOEING) 10/24/96

Horizontal Range of F/S Outer chord still attached

Area pushed Outboard end

Must have segments separated from skin (shear the H/waves still attached)

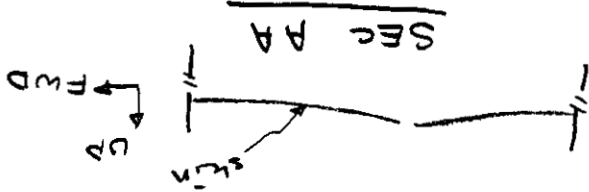
NO Shear Tie.  
Holes open.  
Holes appear  
round and  
clean.

Holes give the very  
slight 'impression'  
that the rivet  
tipped fwd and  
inbd.

Skin is not  
puckered at  
fastener holes.

Str 4IR  
holes feel  
like rivets  
tipped  
fwd. like rivet  
tipped fwd.

Skin is not  
puckered.

Very Shallow,  
gentle inbd  
displacement,  
see SEC AA

At Sta 980:  
Btwn Str 4OR to 4IR  
no shear tie remains.  
Generally, inbd of Str 4IR,  
the shear tie skin  
flange only, is  
attached to the skin
