LOG # LF60

TARGET # (232) GREEN

DEBRIS FIELD GREEN

SKIN PANEL SEGMENT, STA 2020 TO
STA 2040, STG 36L TO S-41 1/2 L

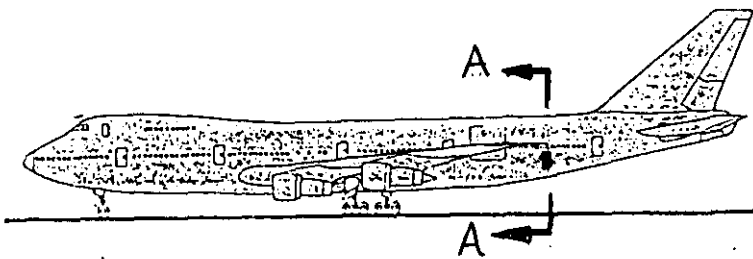
VIEW A-A

- 1) THE PANEL EXHIBITS INBOARD BULGING OF THE WEB BETWEEN ADJACENT STRINGERS INDICATING AN INWARD-ACTING PRESSURE CONDITION ON THE OUTBOARD SURFACE
- 2) ON THE LARGER SCALE, THE SEGMENT IS DEFORMED INBOARD TOWARD THE CENTER OF IT'S CIRCUMFERENTIAL LENGTH. IF THE PANEL IS PLACED OUTBOARD SIDE FACE DOWN, WITH ITS ENDS AT STG'S 36L AND 41 1/2 L RESTING ON A HORIZONTAL SURFACE, THE HEIGHT OF THE CENTER OF THE SEGMENT ABOVE THE HORIZONTAL IS 8 1/2 INCHES.

- 1) STG'S 37L THRU 41L REMAIN ATTACHED TO THE PANEL.
- 2) ALL STRINGERS ARE GROSSLY DEFORMED. THE ENDS OF THE STRINGERS ARE EITHER TORN, FLATTENED OR TWISTED AND ARE BENT OUTBOARD.

- 1) A STABILIZATION INTERCOSTAL REMAINS ATTACHED TO A SIDE WALL OF STG 39L. THE INTERCOSTAL IS CONSIDERABLY DEFORMED AND IS FLATTENED AGAINST THE PANEL BETWEEN S-39L AND S-40L.
- 2) THE REMNANTS OF ANOTHER INTERCOSTAL REMAIN ATTACHED TO STG 41L SIDE WALL.
- 3) A FRAME-TO-SKIN SHEAR TIE ATTACHMENT LEG REMAINS ATTACHED TO THE SKIN AT STA 2040, BETWEEN STG'S 39L AND 40L
- 4) THERE IS NO APPARENT SOOTING OF THE PANEL
- 5) FRACTURE FACES APPEAR TO BE DUCTILE FAILURE
