LOG # LF61 RS  
10/10/96

TARGET # C 1083 GREEN

DEBRIS FIELD GREEN

A SEGMENT OF THE B.L.  $\phi$  WEB, STA 1460 TO 1480, FROM TOP OF KEEL BEAM BOX TO BOTTOM OF PRESSURE DECK,

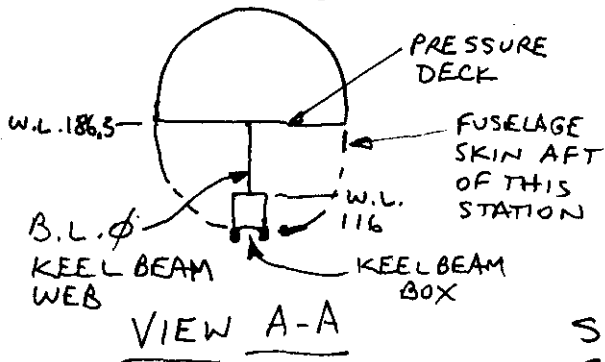
- 1) THERE APPEARS TO BE LIGHT SOOTING OVER DIFFERENT REGIONS OF THE PANEL
- 2) FRACTURE SURFACES APPEAR TO BE DUCTILE FAILURE

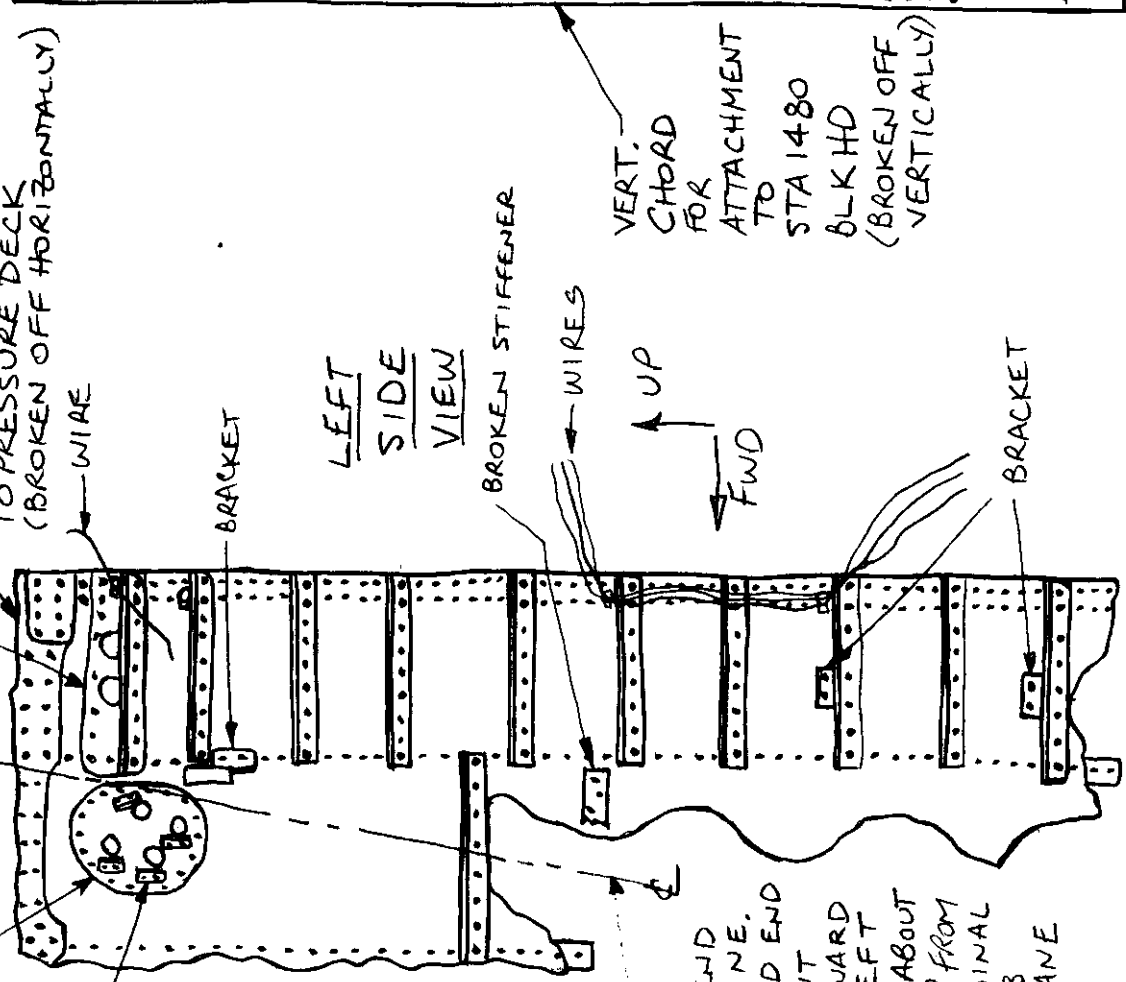
LEFT SIDE VIEW

BEND LINE, FWD END BENT TOWARD LEFT AT ABOUT 40° FROM ORIGINAL WEB PLANE
