LOG # LF64 RTS
10-10-96
 TARGET # GREEN
 COORD: LAT _____
 LONG _____
 DEBRIS FIELD Z 2520

SKIN SEGMENT, STA 990 TO 1000,
 STG 32L TO 34L

SEGMENT IS JUST FORWARD OF THE
 WING CENTER SECTION ON LEFT SIDE
 OF AIRPLANE.

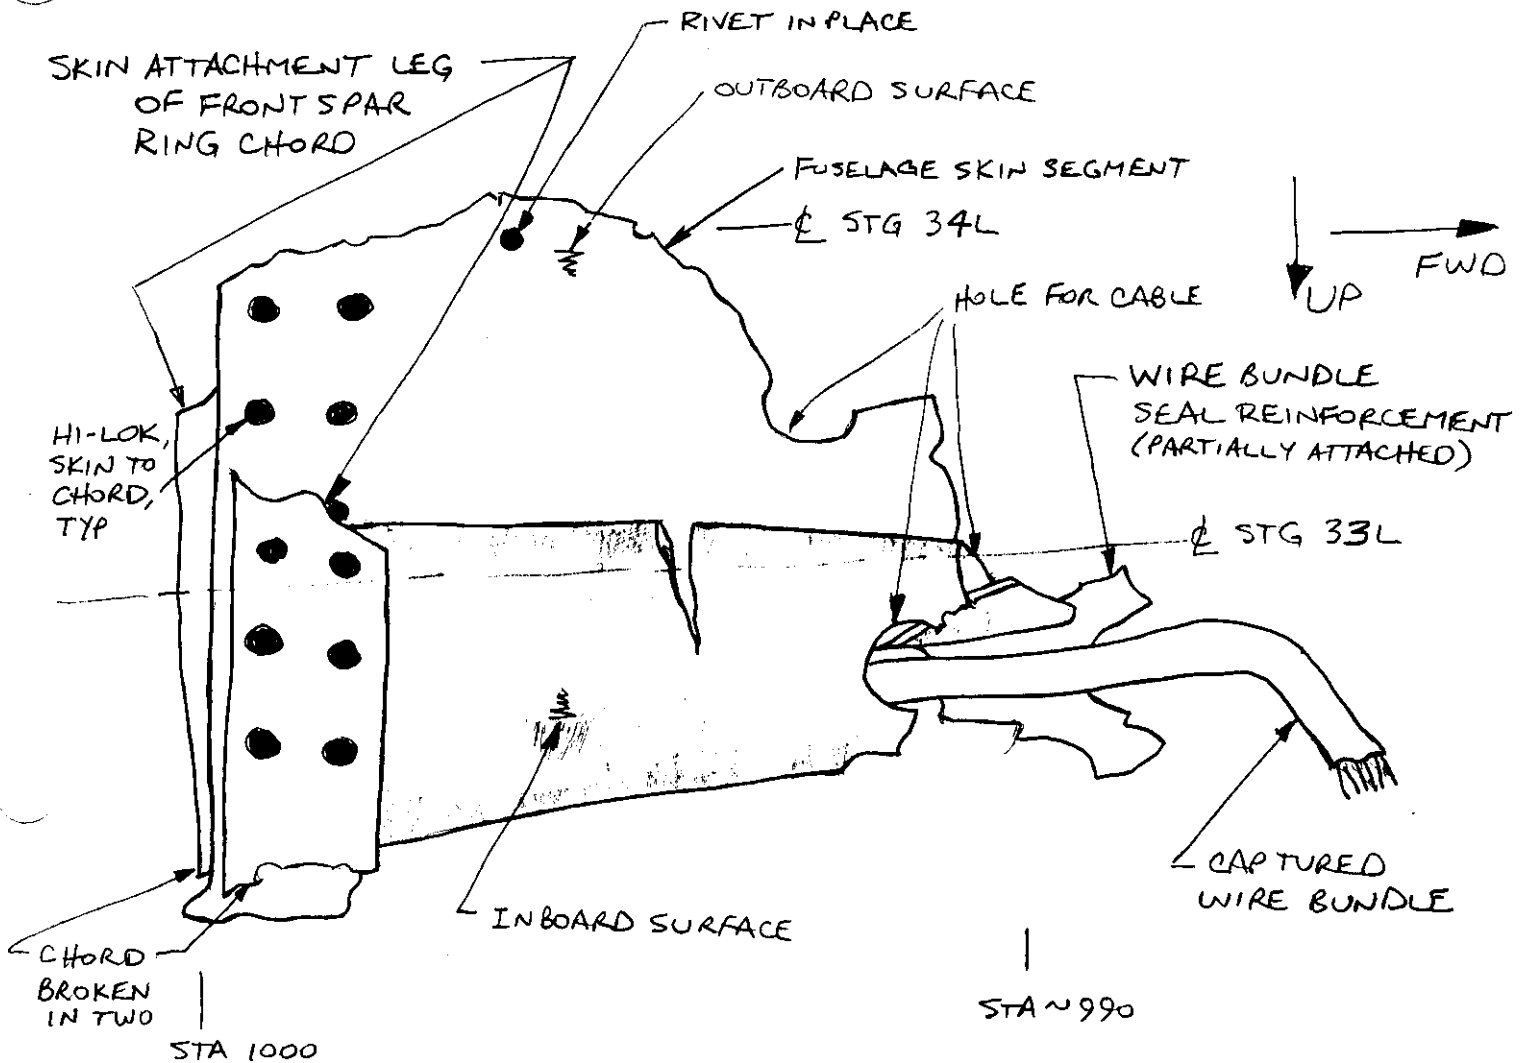
SKIN SEGMENT, STA 990 TO 1000, STG 32L TO 34L

SKIN IS DRAMATICALLY COILED WITH VARIABLE OUTSIDE RADII. AT STA 1000 THE CURVE RADIUS IS ABOUT 1 1/2 INCH. AT STA ~990 THE CURVE RADIUS IS ABOUT 1 INCH. ~~THERE IS LIGHT SOOTING OF THE OUTBOARD SURFACE.~~

FRACTURE SURFACES APPEAR TO BE DUCTILE FAILURE.

NOTE: NO SOOT OR FIRE DAMAGE APPARENT.
CJH:JAM
10-13-96

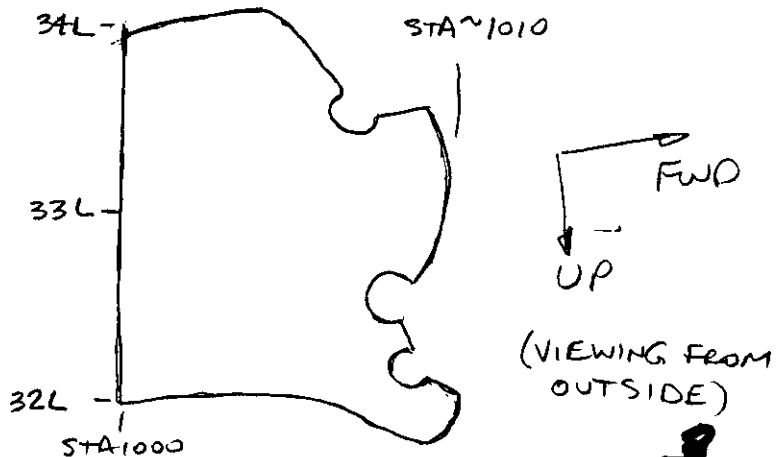
IF THE COILED SKIN WERE UNCOILED, THE SEGMENT'S SHAPE WOULD APPEAR AS SKETCHED →
