LOG # LF 69 RTS
10-10-96

DEBRIS FIELD GREEN
TAG Z2586
9/16/96-2

LF 69 Crown skin from Sta 1241 to
Sta 1438, Str 5L to PR

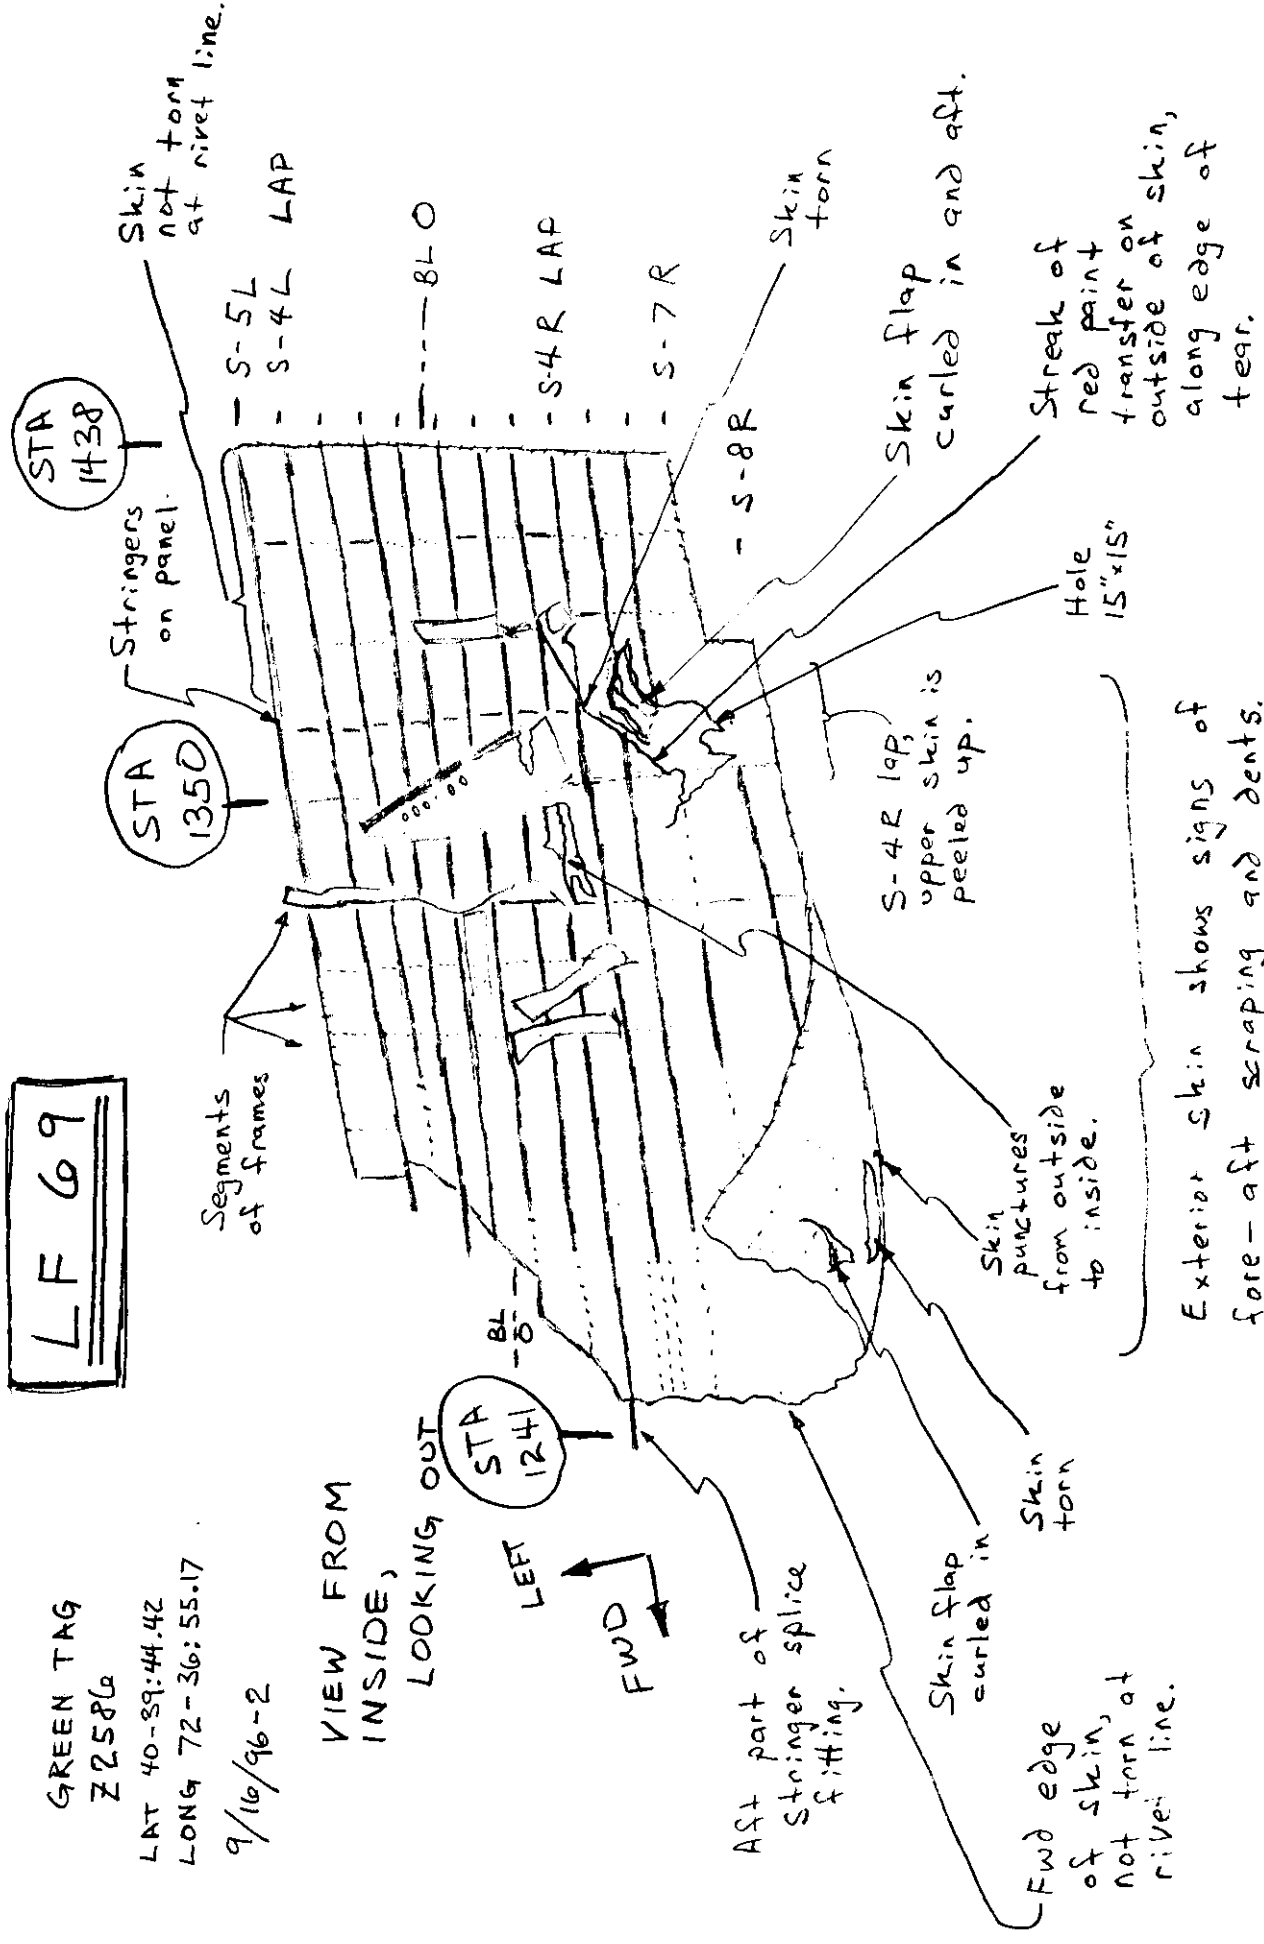
LF 69

The skin is, generally, broken along the fastener lines, except the entire front edge and along the aft, left edge, below str 5L.

The stringers are, generally, attached.

Some frame segments remain.

The Sta 1350 bulkhead outer chord is attached to the panel. A portion of the Sta 1350 upper bulkhead frame remains.

No signs of soot or burning.

The fwd, right corner is curled in and aft.

The fwd, right portion of the panel shows signs of fore-aft scraping and dents on the outside. The skin is torn in several places. A large hole, with the skin flap curled in and aft, exists aft of Sta 1350, on the right.

Ast part of
Stringer splice
fitting.

S-4R lap,
upper skin is
peeled up.

Fwd edge
of skin, at
not torn at
rivet line.

Streak of
red paint
transfer on
outside of skin,
along edge of
tear.

Exterior skin shows signs of
fore-aft scraping and dents.
