LOG # LF7 Rev A <sup>1014RTS</sup> SR

DEBRIS FIELD Yellow (#2)

LHS skin Assemblies from Debris field #2. Panels in vicinity of Door #1L and NW. See next sheet for location of three panels labeled (A), (B), & (C).

2728 Boeing TWA  
7/29/96

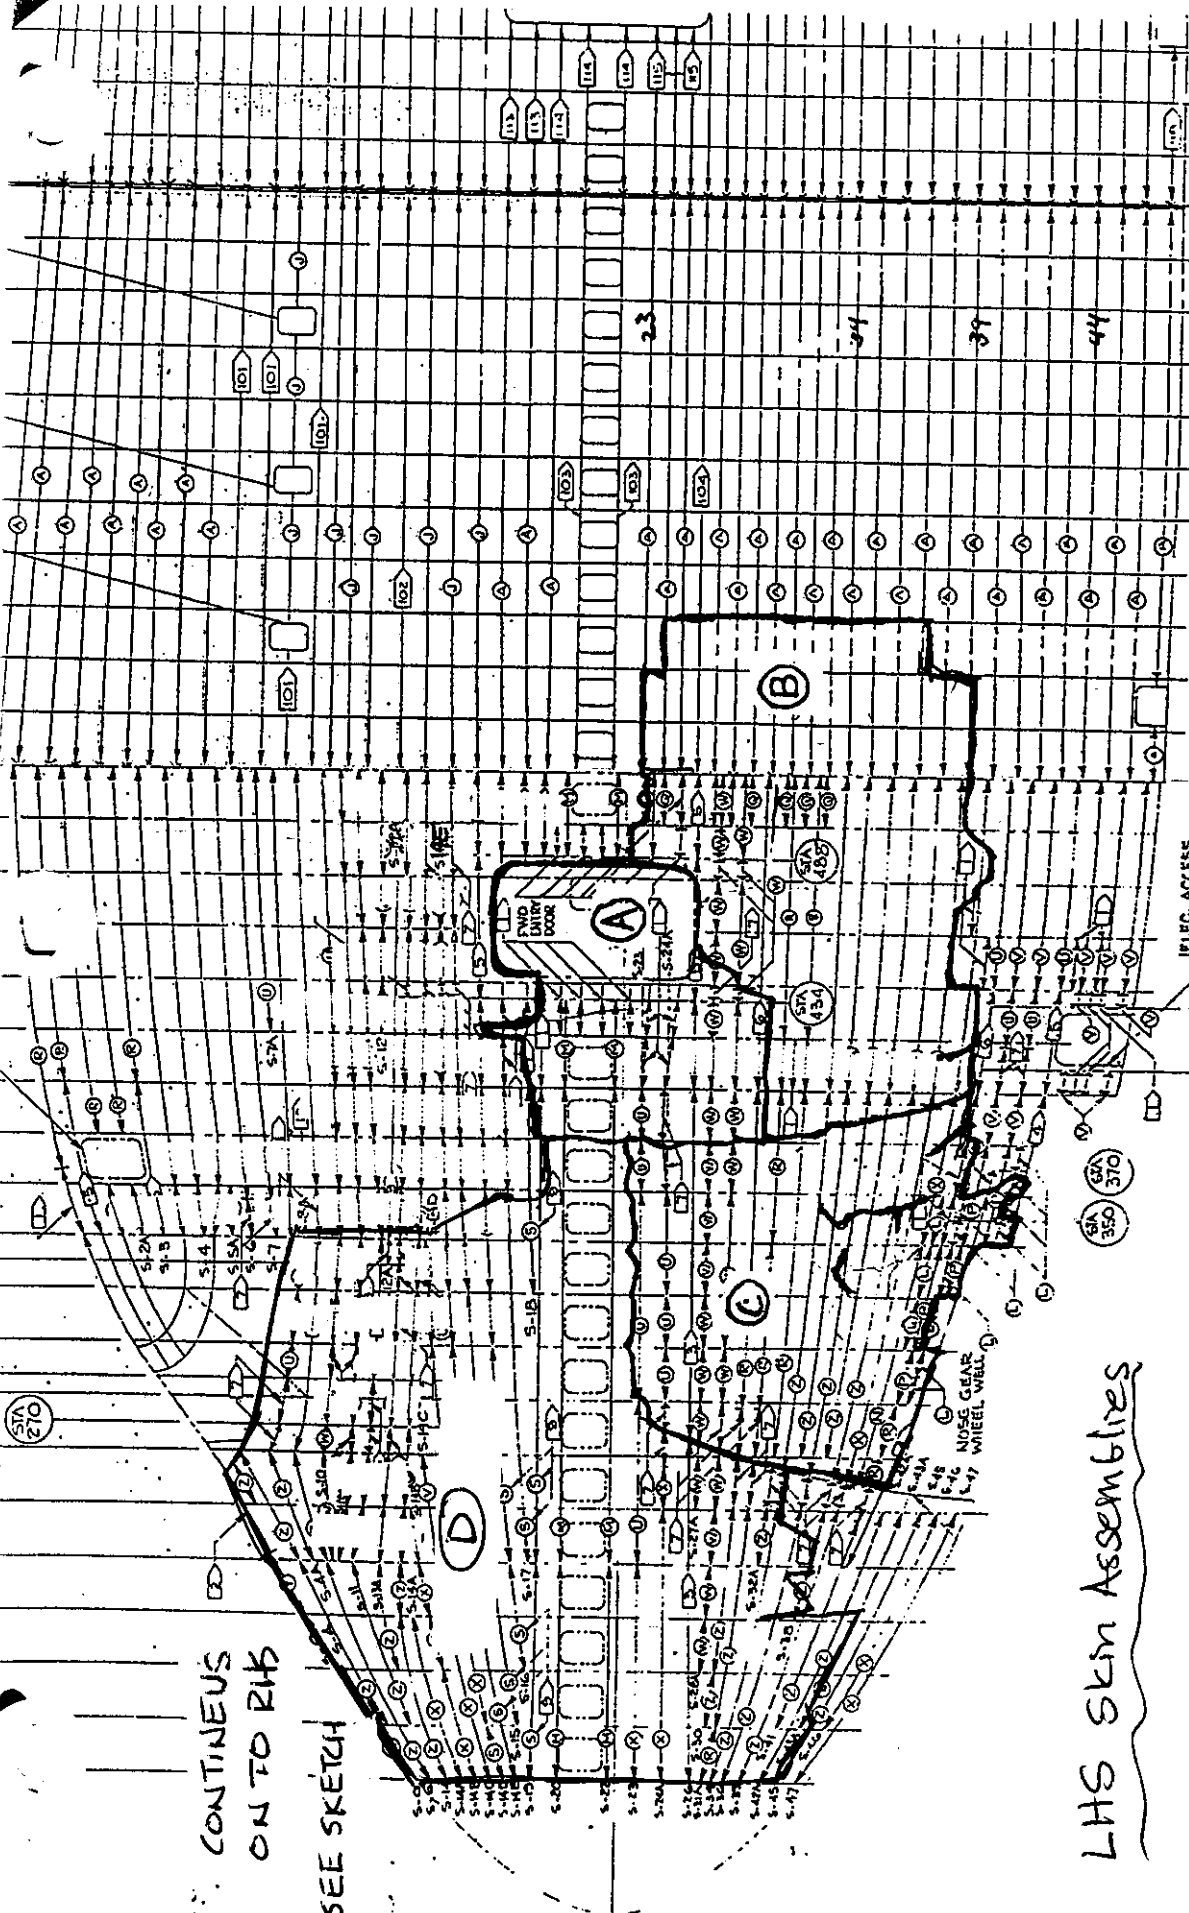
LHS Skin Assemblies

STA 434 edge frame in good condition from S-18 down to end @ S-30.

STA 400, 420 frames mostly intact.

Lwr aft door corner intact. Most of failure is along lwr row of S-23 lap splice.

Section is still close to original curvature with 75% of frame structure intact.

This panel looks very clean. The STA 280, 300, and 320 frame are mostly intact. At STA 340, the lower 4 bays of the cheek frame remain with only lwrmost bay still fastened. STA 360, 380 are almost completely gone except for a few bays in vicinity of S-34 lap. A small portion of the torque box remains between STA 340-360 (vertical web and approx 6" of horizontal web).

No signs of fire damage

- A Fwd Door Surround and Door 1L
- B Lwr Aft Door corner surround into section 42.
- C Lwr 41 from N/W to window belt.
