LOG # LF 72 *10/23/96*  
 TARGET # no tag  
 COORD: LAT \_\_\_\_\_  
 LONG \_\_\_\_\_

Circular Stairway Cutout in Upper Deck Floor, Header Floor Beams and Truss and associated structure.

Consists of Sta 440 & 520 upr deck floor beams  
 Sta 440 LBL 65 to RBL 65  
 Sta 520 LBL 47 to RBL 46 (The L/H otbd end is on LF4.)

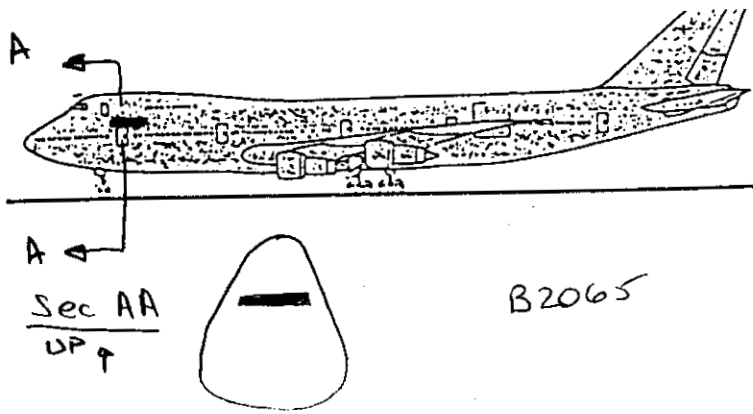
The Sta 440 upr deck floor beam is crushed, upr chord is deflected down approx. 6" at LBL 20 and aft. The web is mangled. At RBL 42 the lwr chord is bent up at approx a 45° angle.

The Sta 520 upr deck floor beam is bent down at approx LBL 30.

The entire LF 72 is twisted and mangled.

No signs of soot or burning.

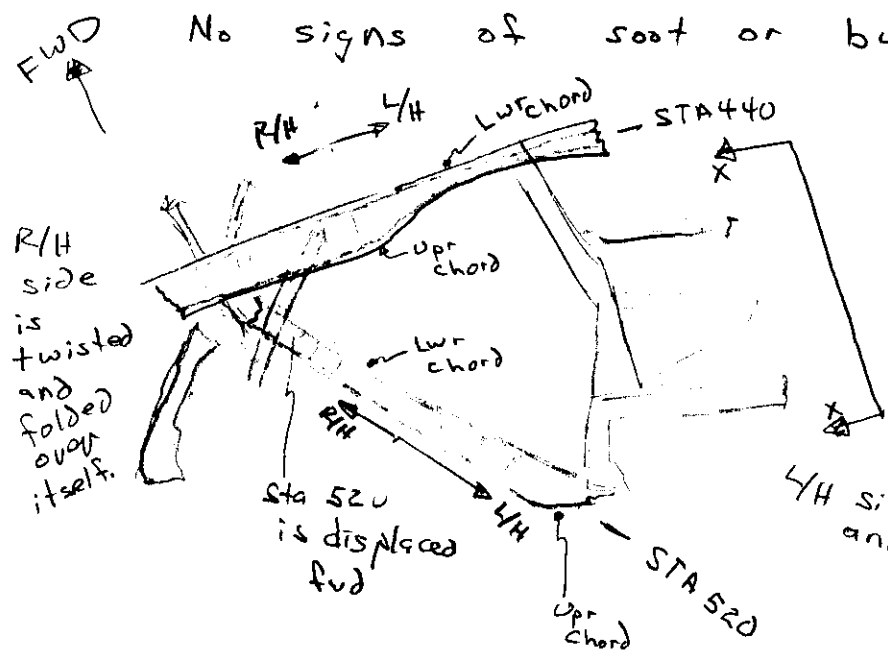
Skin rivet tails have been pulled through the Stringers. The rivets remain with the skin on part LF19A.

Most fastener heads 'flanges' pulled off →

Hi-Lok  
 Some Hi-Lok heads are complete, on the frames.

View looking forward, from below.

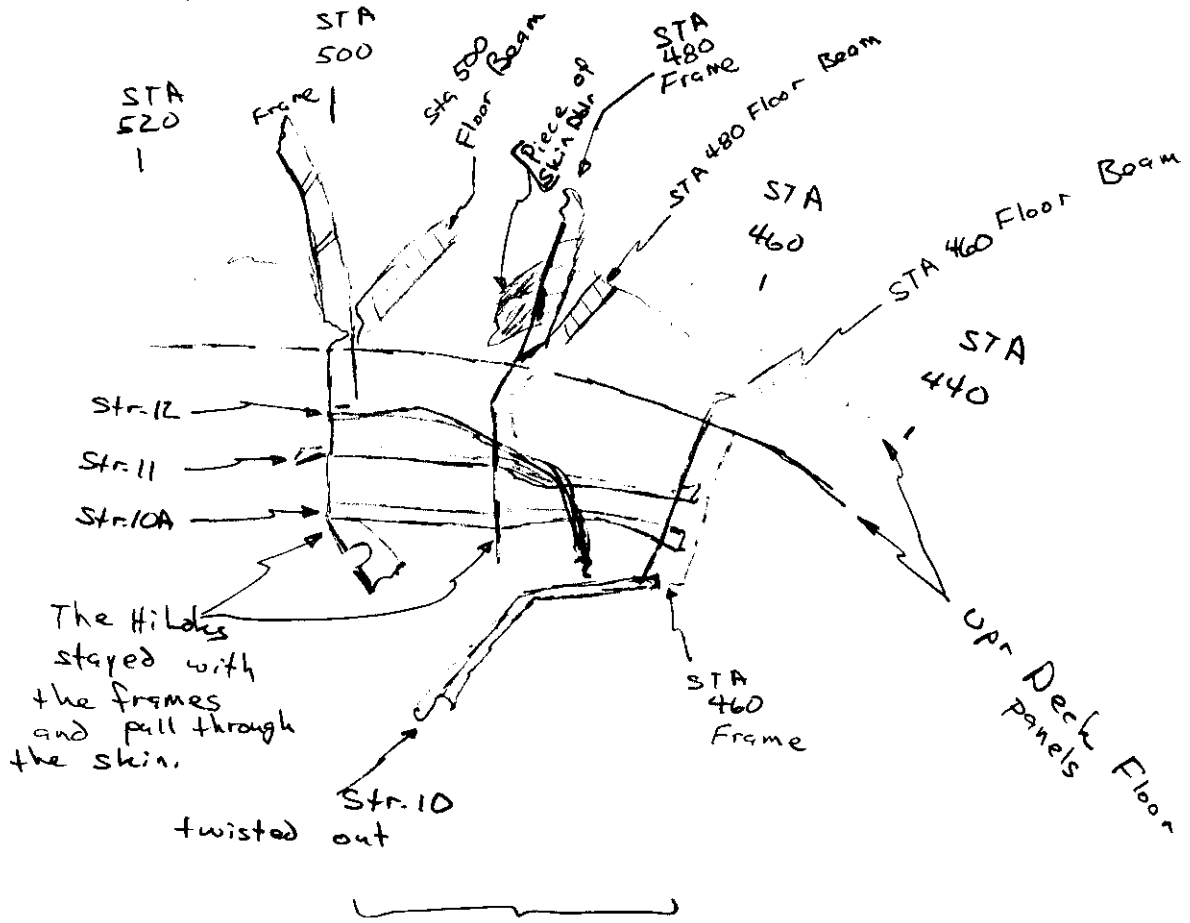
View looking Inbd on L/H side

The Hildes stayed with the frames and pull through the skin.

The stringers in this area had the rivet tails pulled through from the outside. The rivets are on the skin, part LF19A.

Typical Stringer puckered out, rivet tails pulled through.
