LOG # LF 89

SKIN PANEL

STA 885 TO STA 938, S'35L TO S'38L

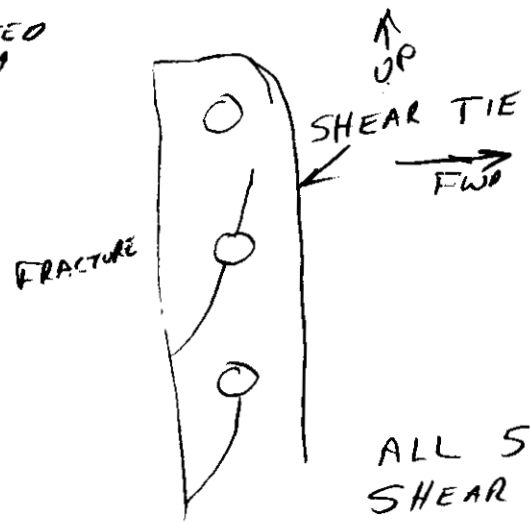
LF 89

ALL 5 SHEAR TIES HAVE SIMILAR TEARS

FOLDED INWARD

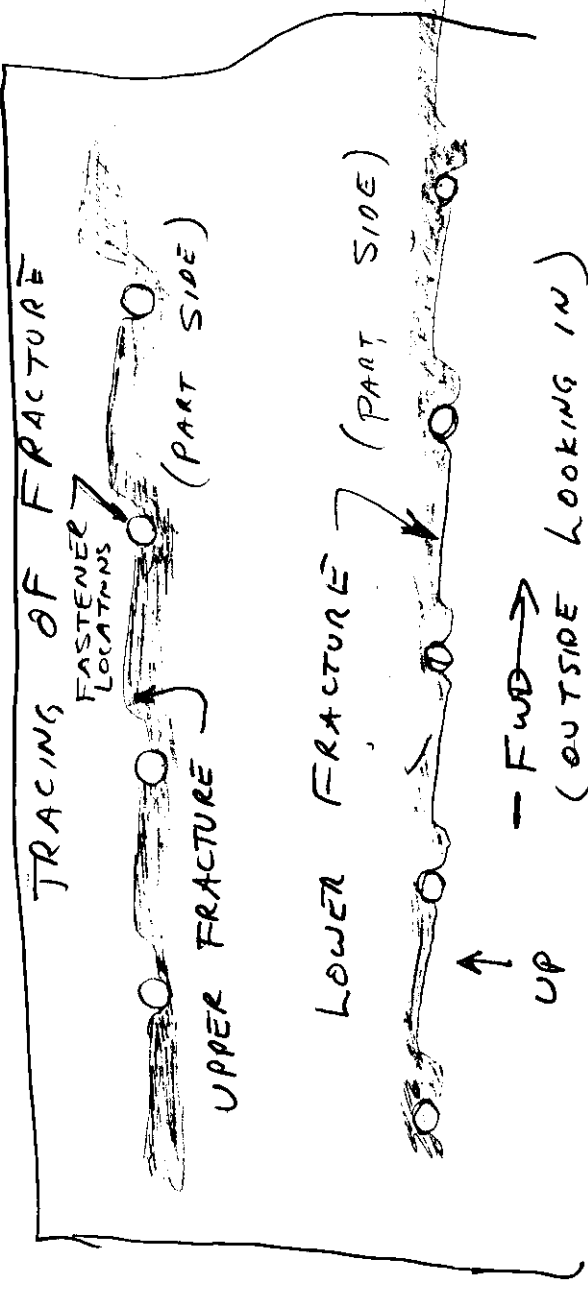
LF 89

> direction of crack propagation
