## BS 1480 Bulkhead Assembly Approximately LBL 8 to LBL 75

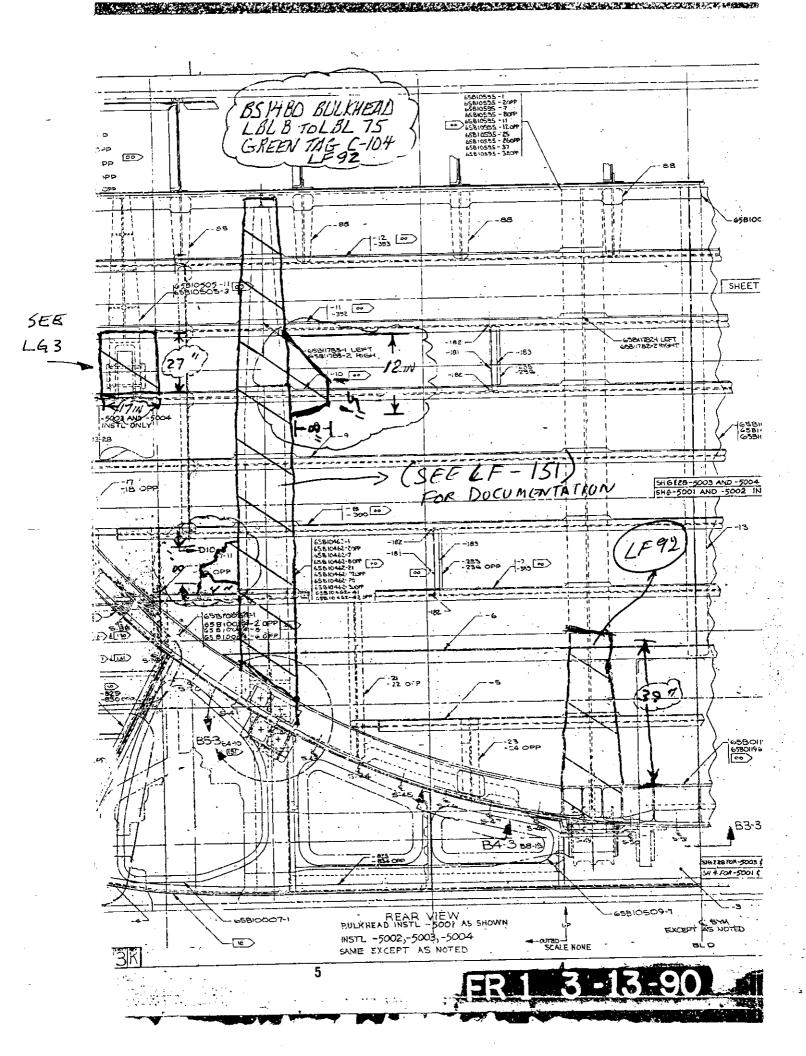
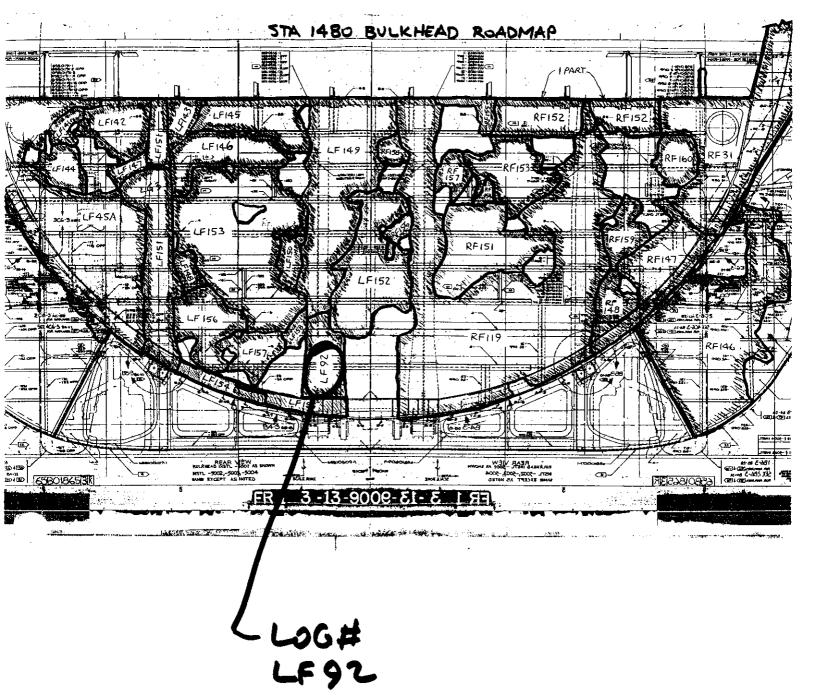
•			
	Log Number Debris Field Target Number Coordinates: Latitude Longitude	LF92 Green C104	19-3 No	New Tog., BETAUSE THE PROM LG	No.15. GIVES. IS PIECE WAS	= C-2468 RG
	Body gear trunnion fittings 65B11782 and 65B10462 are attached to the body gear assembly, see LG3, and a portion of 65B10005 web as shown on attached illustration.					
	Inboard trunnion fitting lates The outboard rod end no that failed. The inboard	t connected to t	the trunnion fitting	contains a small portio	n of structure or linkage	
	Horizontal stiffeners located on the aft side of web have torn away at the radius and departed. A segment, the same width as each trunnion fitting, of horizontal web assembly 65B01865-6 is attached at each trunnion fitting.  To LG3 RH 324/97 7BC Starter Various types and lengths of wiring and conduits are attached twelve inches above \$45R and \$46R.					
	Various types and length	s of wiring and	l conduits are attach	TC LG3 KH ed t <del>welve inches abov</del>	324/97 1BC Sto 16 e S45R and S46R. 3	14 14/77

Structure has minor surfa	ace abrasions at	t random locations t	hrough paint laver. Pri	imer remains No visibl	le l
	indication of soot.  Segment of 14	brizontal	i beam ar	lached on a	aH side 6	WEILG.
1>"	LF92" CRATED See attached roudmap	2-26-97 , ps.	, removed from	_"LG3", hung	on mackupat F.	'S 1480 Bulkhad
2	SEE LF 149					
	Denris Santa 3-24-97	ago IAM				
	Dru Todaya Bhandahudu	TWA 3/19/9	7
