LOG # LF 96

SKIN STA 780 TO STA 800

LEFT STR 37 TO S-40L

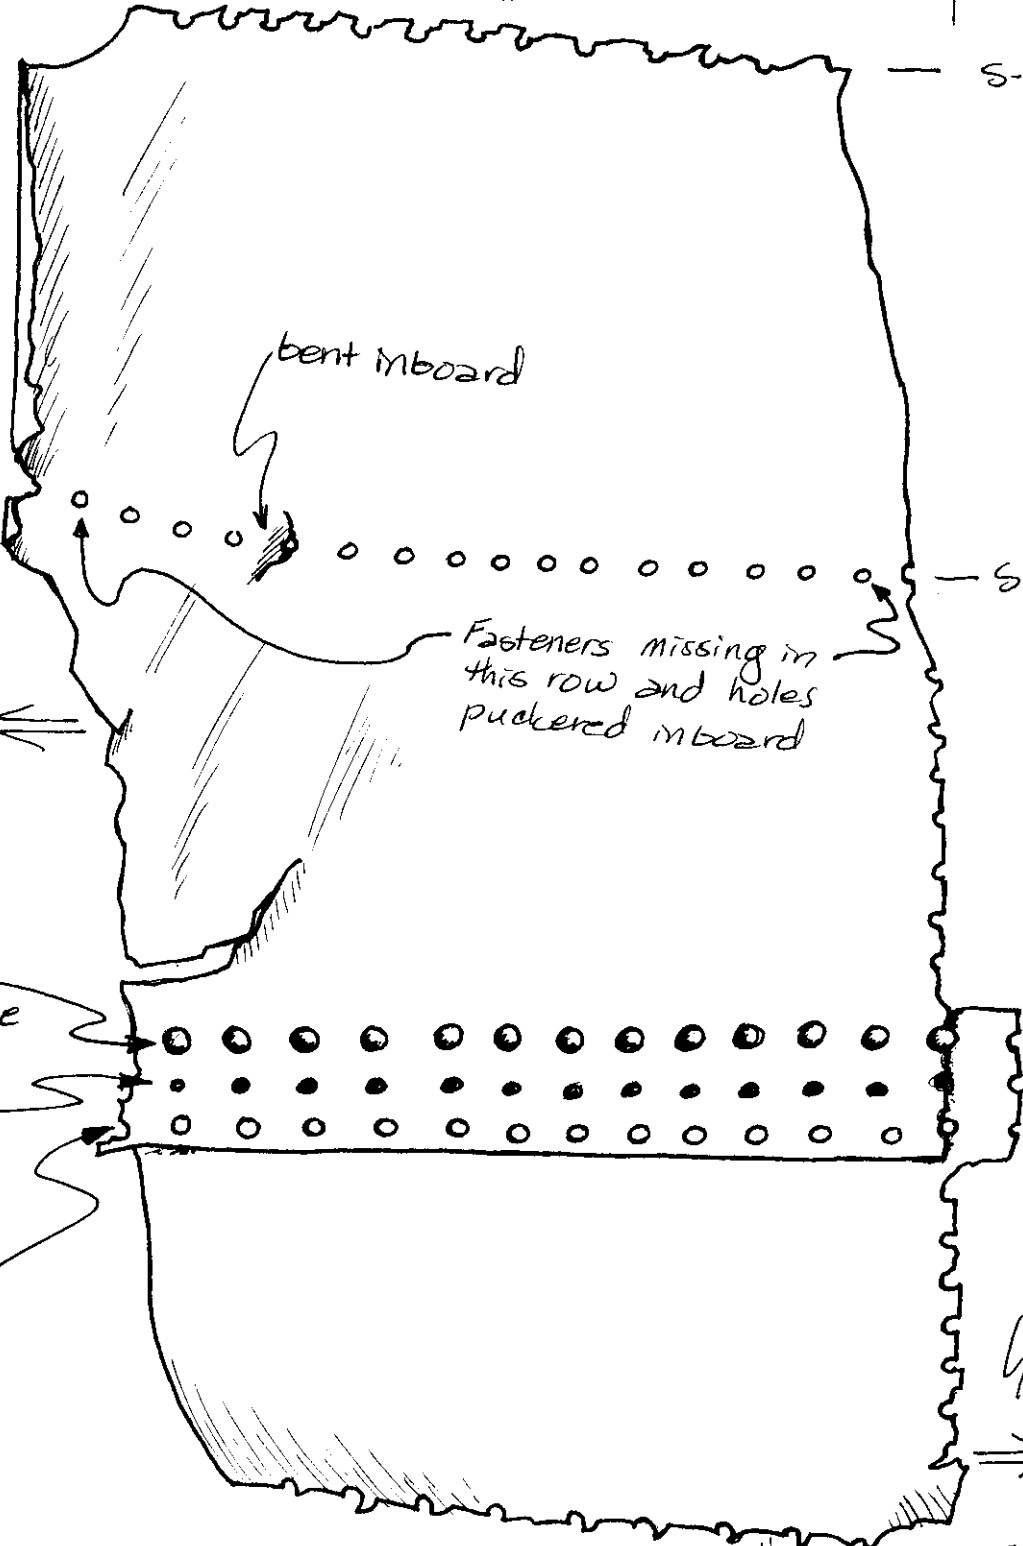
LF 96

SMALL PORTION OF FUSELAGE SKIN
FROM LHS LOWER LOBE. NO FRAMES
OR STRINGERS REMAIN ATTACHED AND
ALL STRINGER FASTENER HOLES ARE
OPEN. THIS SEGMENT MATCHES UP WITH
LF1 (FWD), LF5 (UP), LF24B (AFT) AND
LF22-6 (DOWN).

THERE IS NO EVIDENCE OF FIRE DAMAGE OR
SOOTING.
