Nose Gear Assembly

Log Number LG1
Debris Field Yellow
Target Number B001
Coordinates:
 Latitude _____
 Longitude _____

TWA - REPHLD

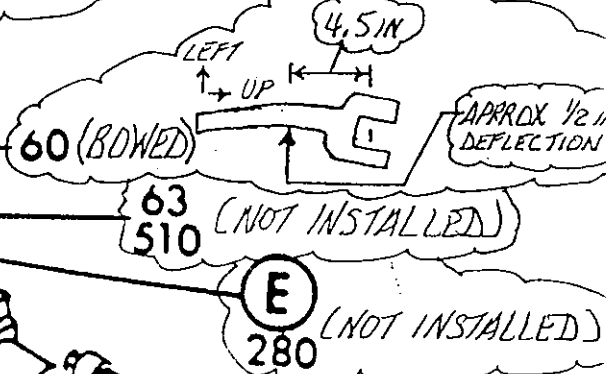
NOSE GEAR ASSY
 IPC 32-21-01-01
 FIG 1, SHEET 1
 SEE LF 18 FOR
 ATTACHING ITEMS

Nose gear assembly is attached to trunnion fittings. Trunnion fittings tore from fuselage structure. See LF-18. for description of attaching fuselage structure.

Right tire, wheel, outer hub, not attached to nose gear assembly.

IPC 32-21-01-01, fig 1, sheet 1, item 60 link was bent as shown on illustration.

Balance of gear assembly has no visible signs of significant damage.

General scratching through paint layer only. No visible signs of soot.

ITEM 60
 TO LINK JOINT
 DEFLECTED .3 IN TO THE LEFT

RIGHT TIRE, WHEEL,
 HUB, AND BRAKE
 NOT ATTACHED TO
 GEAR ASSY.
