Right Wing Gear Wheel Well Doors

Log Number LG10
Debris Field Green
Target Numbers Z3322, Z3348
Coordinates:
 Latitude _____
 Longitude _____

Right Wing Gear Doors

Log Number LG10
Debris Field White and Green
Target Numbers White D2032, White D2033, White D2034; Green D2395
Coordinates:
 Latitude _____
 Longitude _____

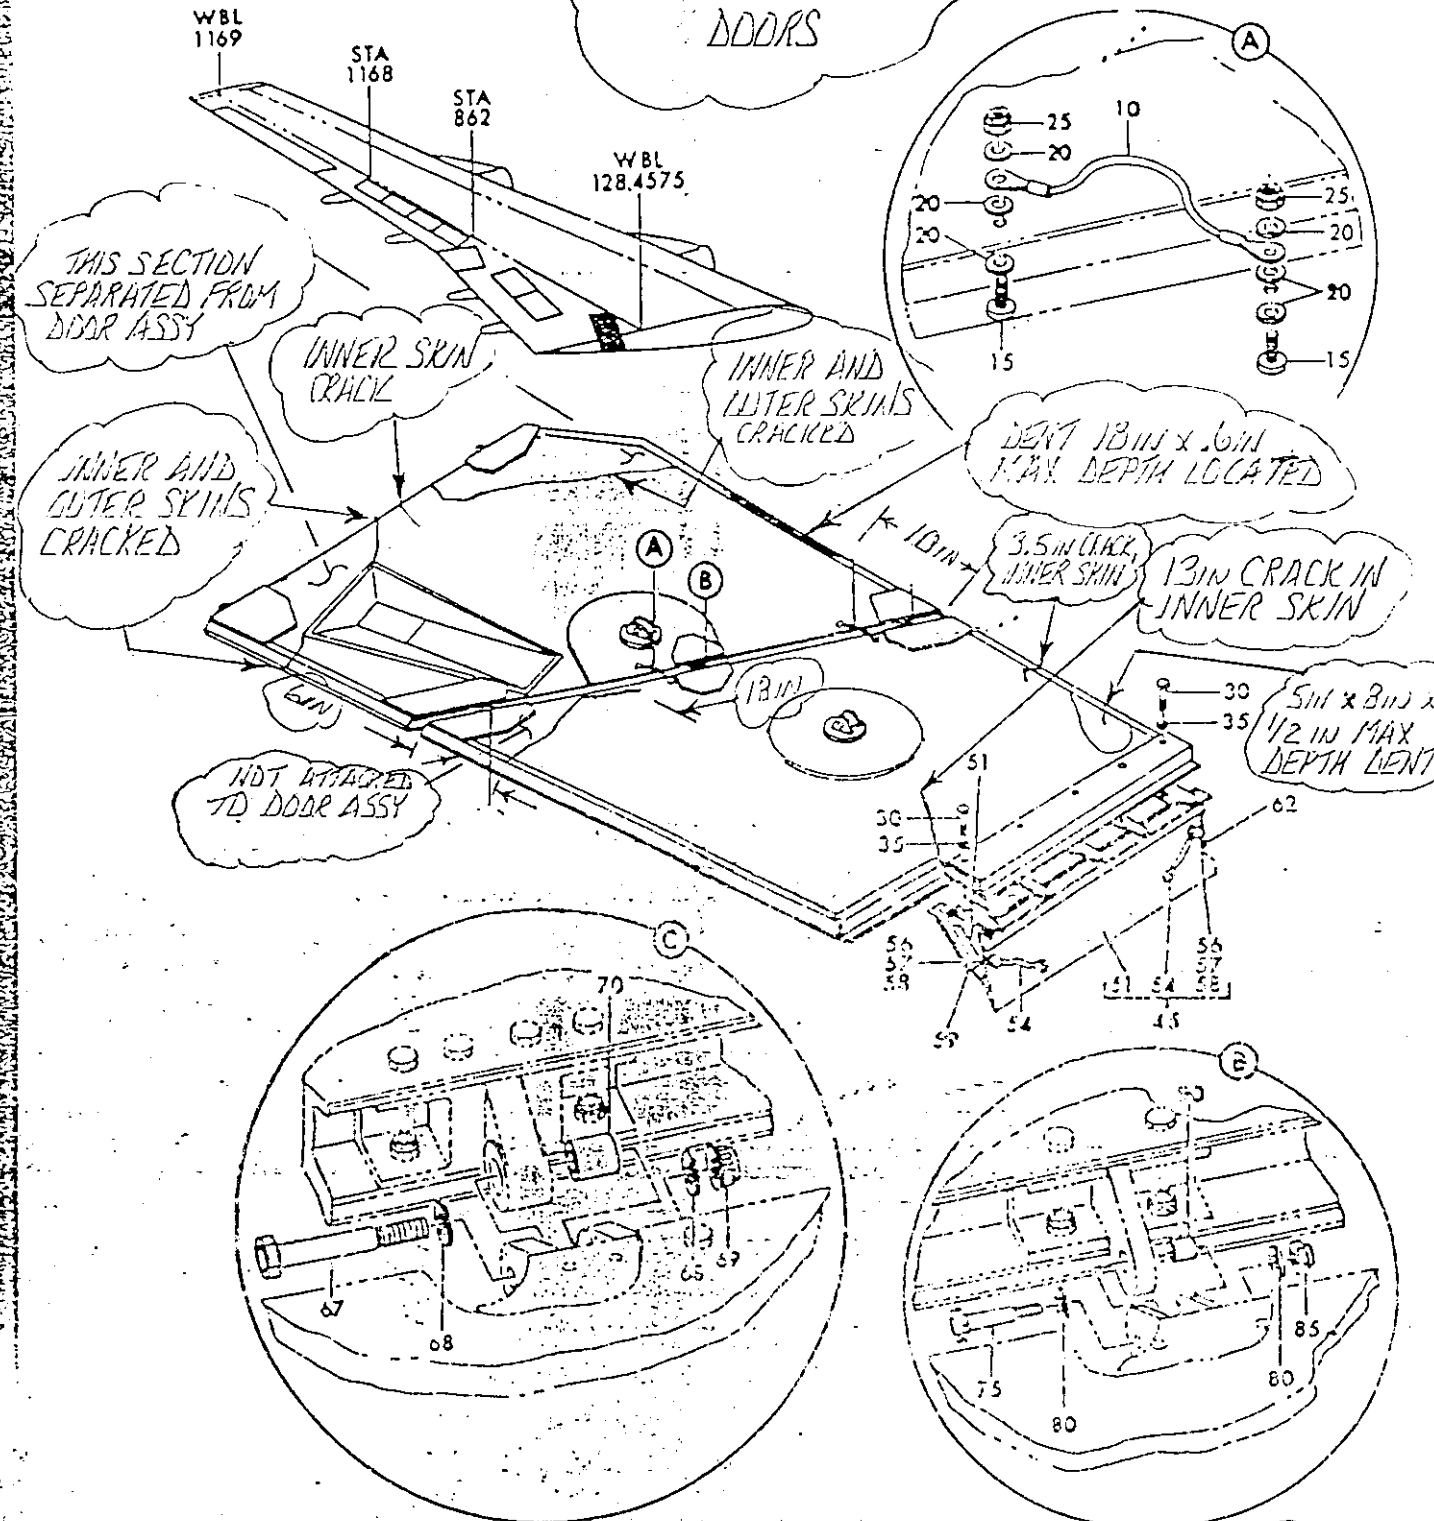
DOOR ASSY-WING LANDING GEAR
FIGURE 1

Outboard Door (D2033)

Outboard corners separated from door assembly. (D2032, D2395)

Outboard corners have hinge fittings attached.

Rod assembly is attached.

Forward edge has been dented midway as shown on illustration.

Structure has minor surfaces abrasions. No visible indication of soot.

Inboard Door (D2034)

Inner skin has cracking and a dent as shown on illustration.

Aft outboard corner has approximately ten inches not attached.

Two inches of rod assembly attached.

Both hinges are in tact with outboard door attached.

Structure has minor surface abrasions. No visible indication of soot.

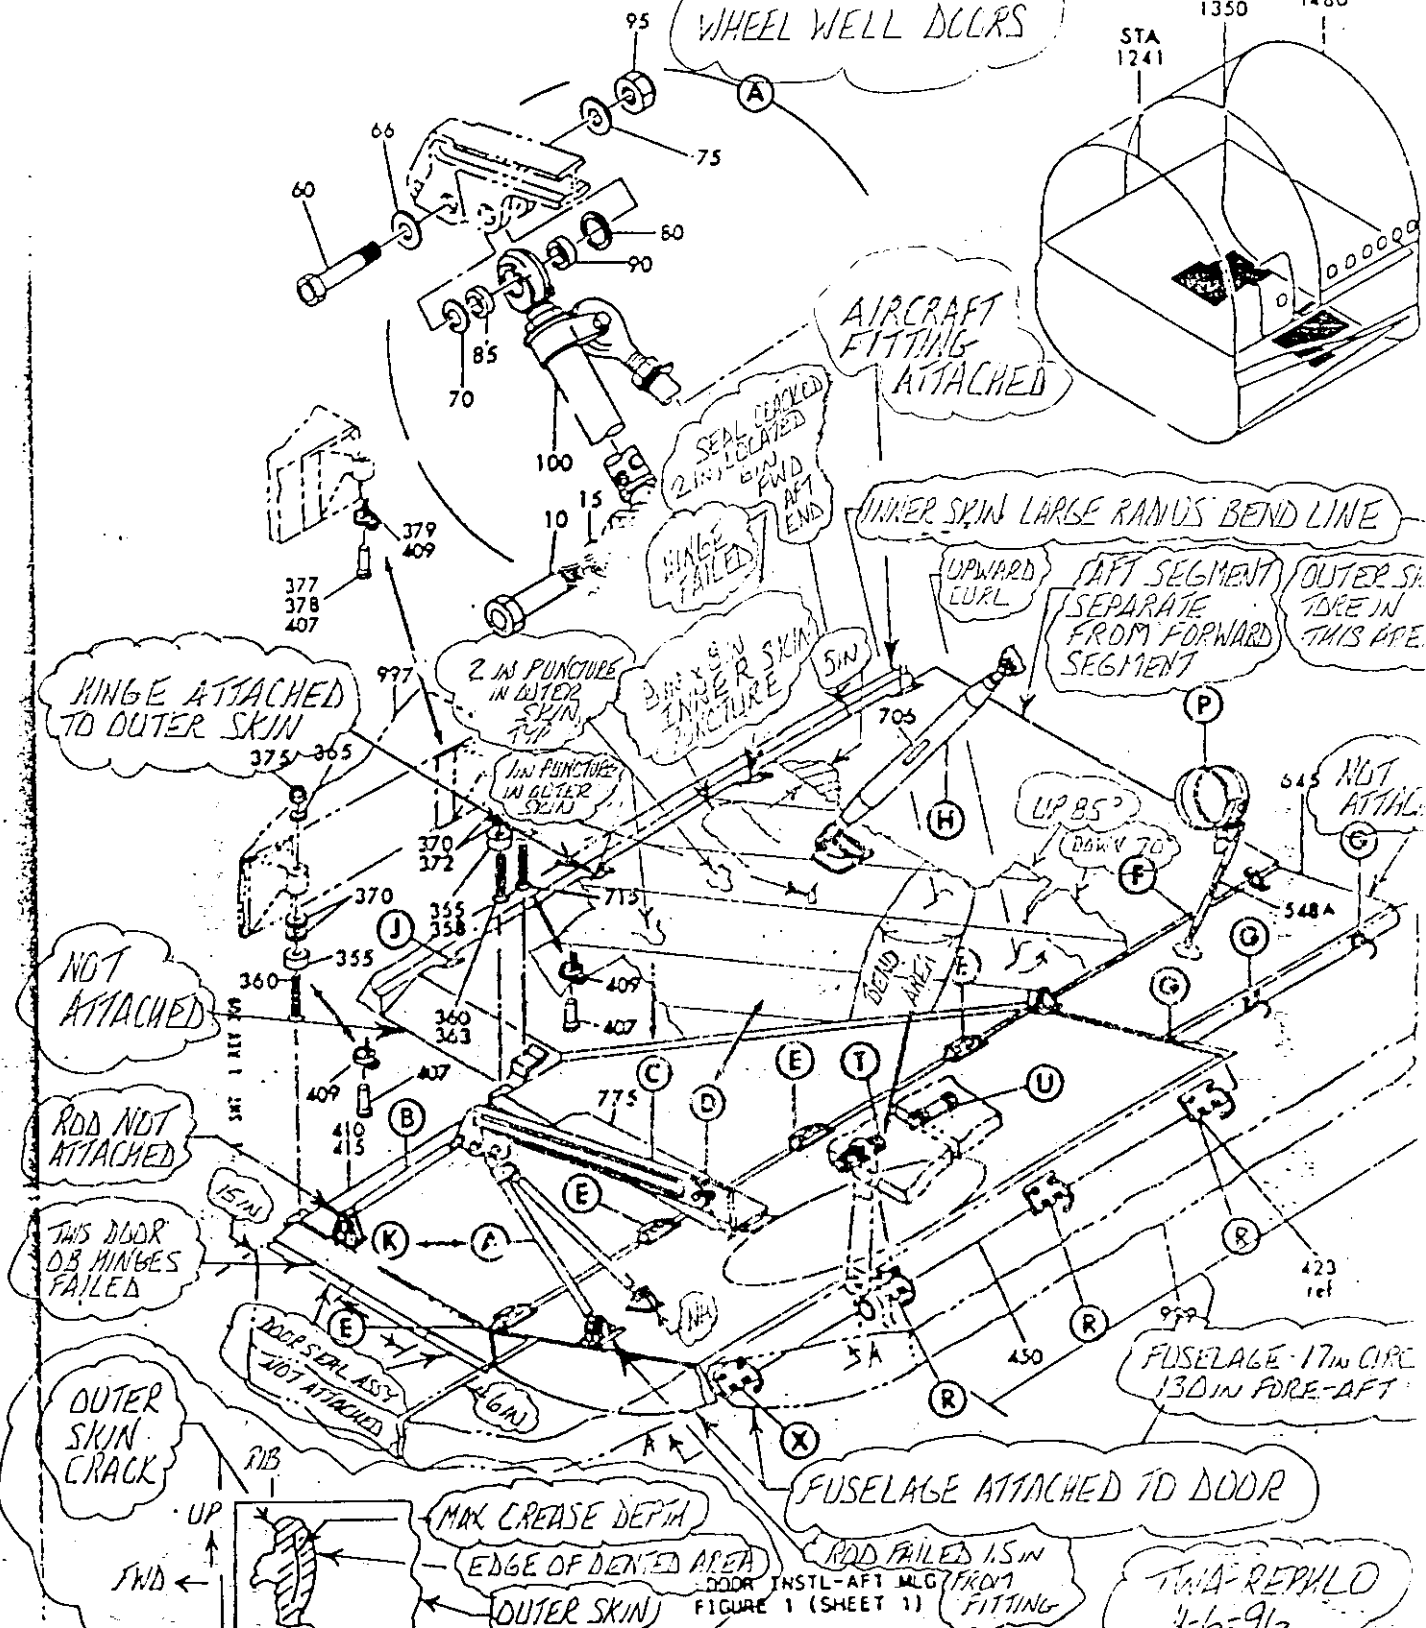
RIGHT BODY GEAR WHEEL WELL DOORS

Inboard Door (Z3322)

Outer skin has a puncture and a crack as shown on illustration.

Rod failed at threaded area adjacent to door fitting.

Aft rod arm not attached to door assembly.

Third and fourth hinges aft are not attached to door assembly.

Structure has minor surface abrasions. No visible indication of soot.

Outboard Door (Z3348)

All hinges failed.

Rod and fitting not attached to door.

Aft inboard corner attached to inboard door.

Inner skin is cracked running forward where rod fitting was located..

Forward inboard corner area has structure not attached to door assembly. See illustration.
